UKOPA Technical Seminar – May 2012

Pipeline Inspection and Repair Case History

Pipeline Integrity – Case study 1

- UKOP 14” Thames Mersey Multiproduct Pipeline
- Built late 1960s (ca 45years old)
- API 5L Grade X42 – ANSI Class 600 (ca 90barg operating)
- Transports refined fuel – Gasolines / kerosines / diesels
- First ILI – 1992. Then 1997, 2002 and Q1 2011

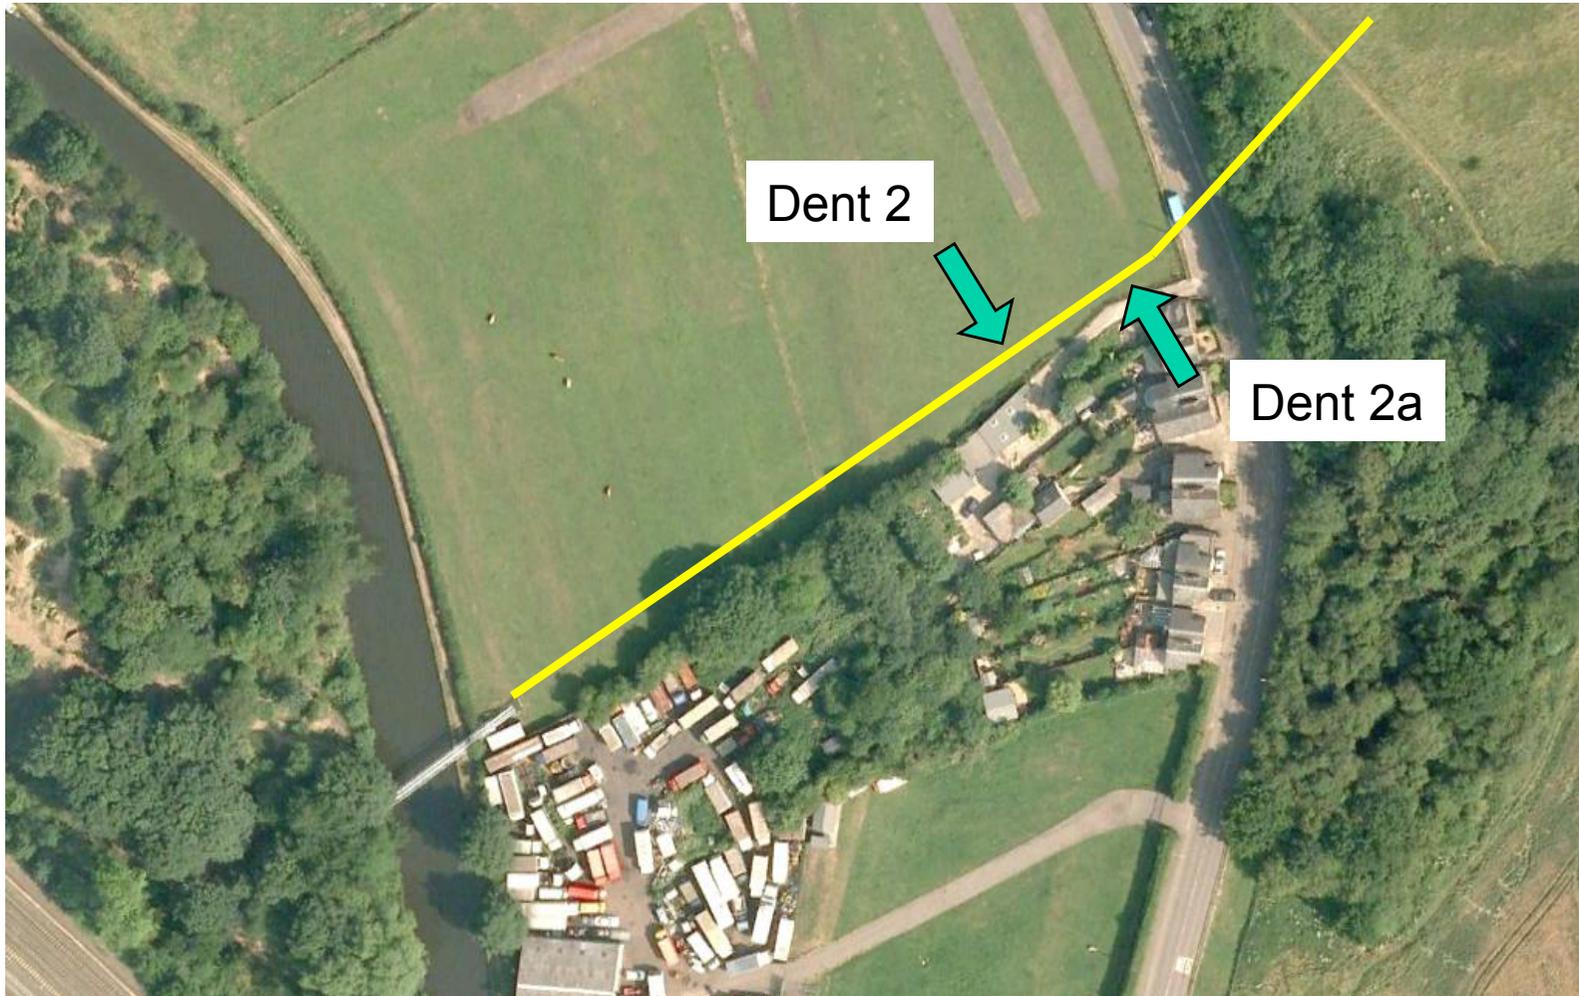
Pipeline Integrity – Case study 1

- 2 investigations of note:
- Dent One 1.8% dent/metal loss/shorted casing – sleeve had crushed spacer and pipe resting on casing - wrap repair. (Previously reported in 2004 as not a dent but a touching casing)
- Dent Two is 6% dent with associated metal loss – cut out repair completed in March 2012) (Previously reported in 2004 as exaggerated reaction of sensors to girth weld and no metal loss)
- Dent Two was adjacent to another Dent (2a) investigated and removed at same time
- Dent Two believed to have been there from construction – 45 years!!!

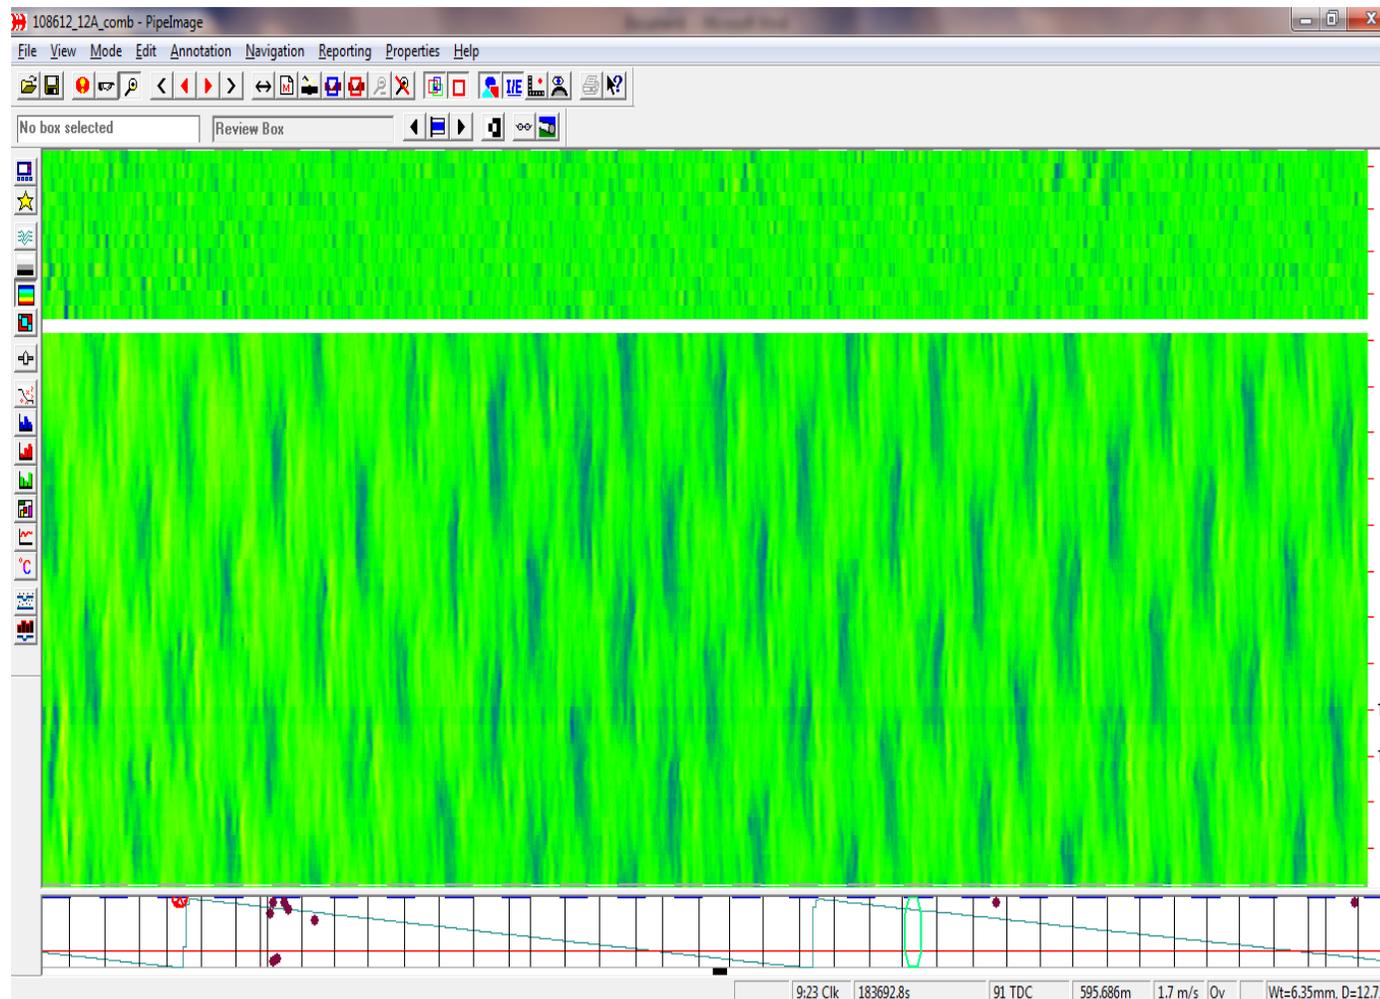
Pipeline Integrity – Case study 2 – standard pipe

- Analysis of results:
 - No significant external corrosion evident
 - No growth of internal defects
 - 6 dents may have associated metal loss
 - 11 corrosion features need investigation/repair
 - Very significant areas of general internal corrosion clusters (8m to 600m in length!) previously unreported because of tool accuracy – there for 45years
