Feeder 1 & 9 – Humber Estuary

Rob Earl
Senior Engineer, NTS Investment
25th May 2011

Humber Estuary

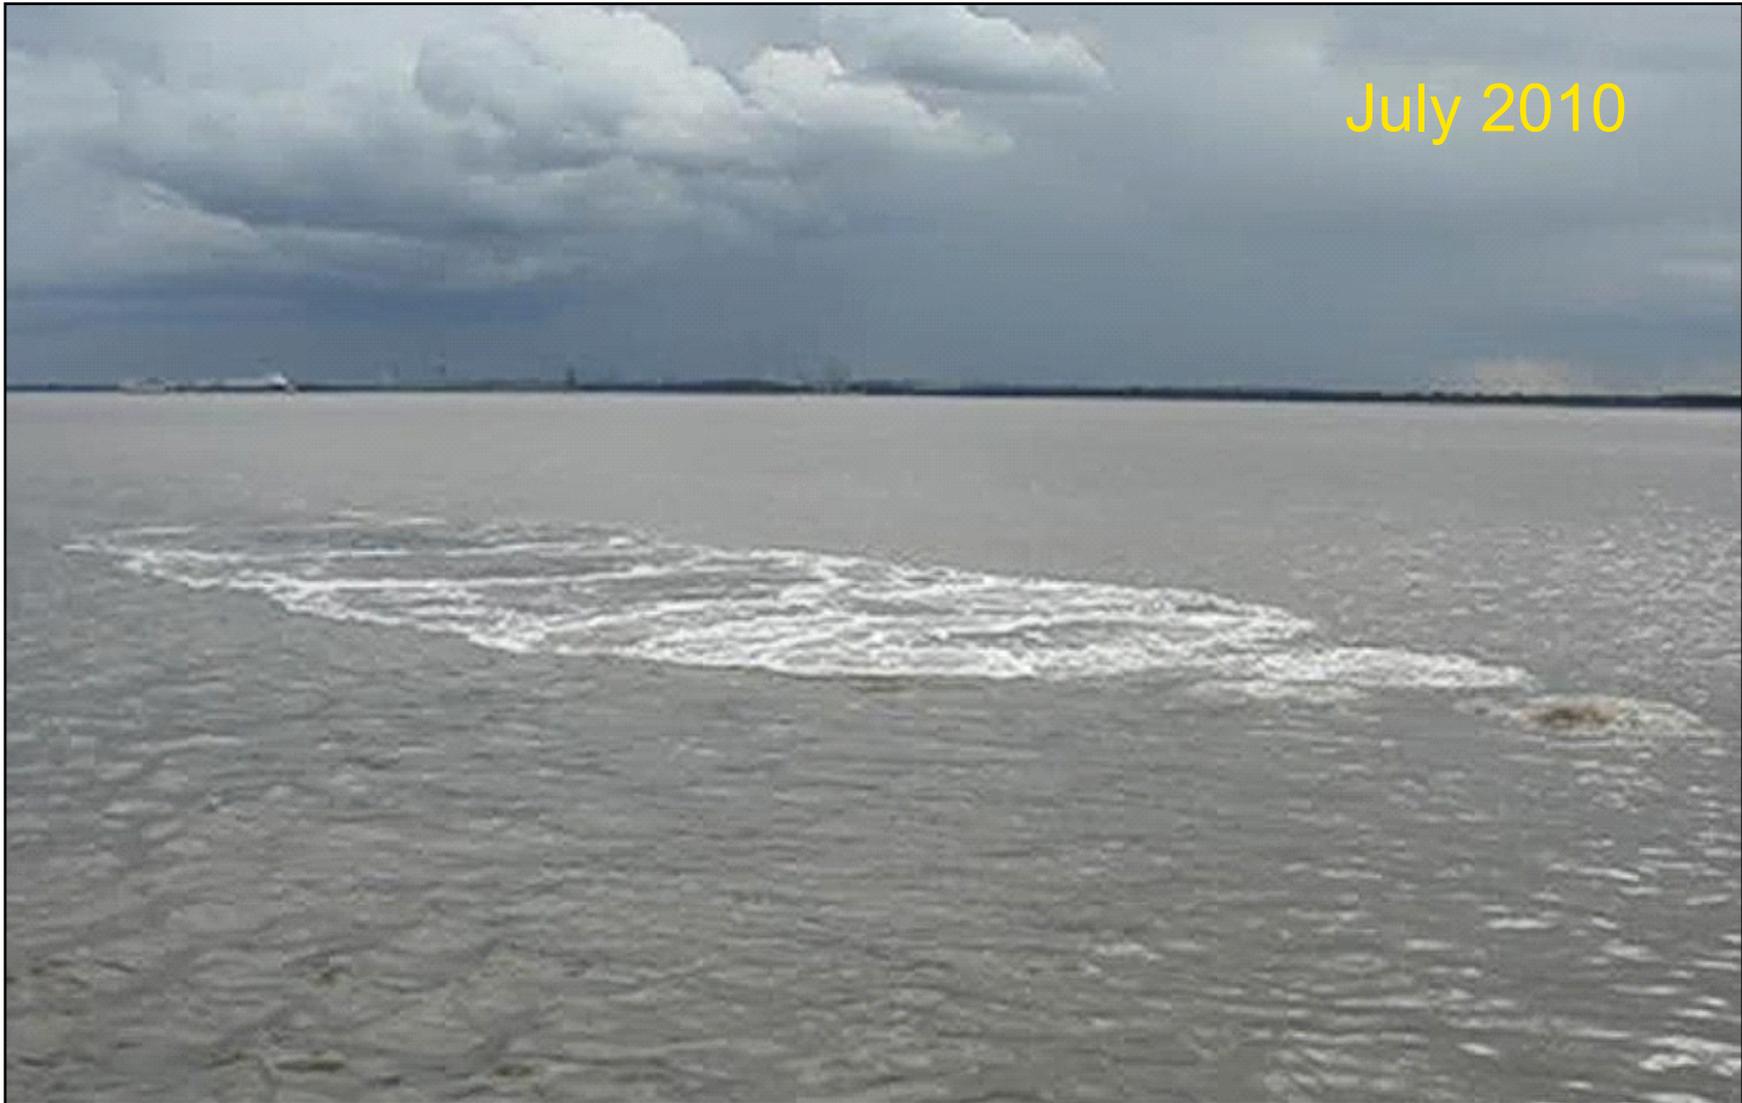
Feeder 1

- Remedial History
 - Large rock placement – 2000
 - Smaller localised rock placement – 2002 & 2004
- Annual Surveys until 2009
 - Exposed and free spanning in two areas
 - Managed as an acceptable risk
- June 2009 Survey highlighted a big increase in the free spanning sections beyond acceptable levels
- July 3rd 2009 - Pipeline isolated by valve closures at Paull & Skitter AGI's
- March 2010 – Pipeline capped off

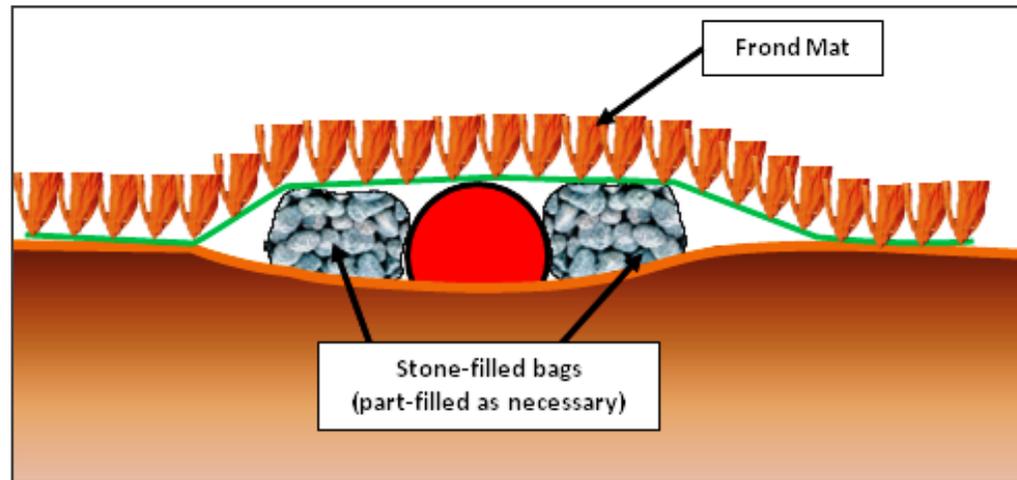
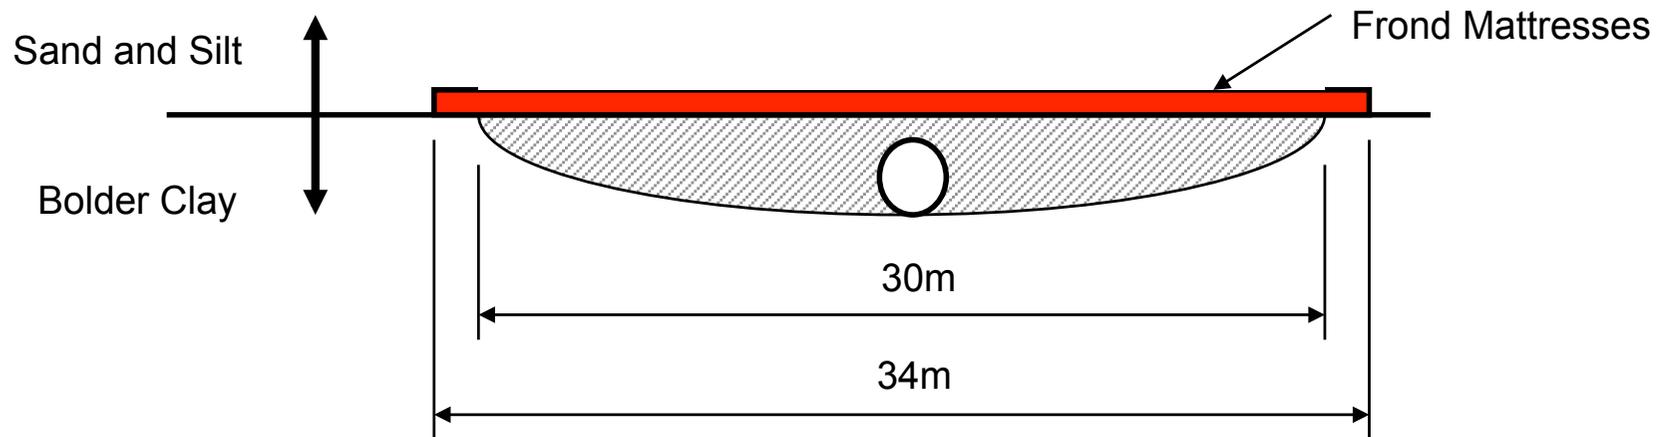
Existing Feeder 9

- Annual Surveys until 2009
- Survey frequency increased to 4 per year as part of the mitigation strategy
- August 2009 survey - 33.2m exposed section
- June 2010 survey – 4 sections exposed (72.6m total)
- Remedial Mitigation Plan produced
 - Emergency measures implemented
 - Short to medium term solution agreed

- Short & Medium Term
 - Complete current remedial works across 'At risk' section
 - 4 surveys per year to monitor seabed conditions
 - Emergency materials and equipment stockpiled
 - Emergency isolation procedure
- Long Term
 - Progress replacement pipeline through IPC process

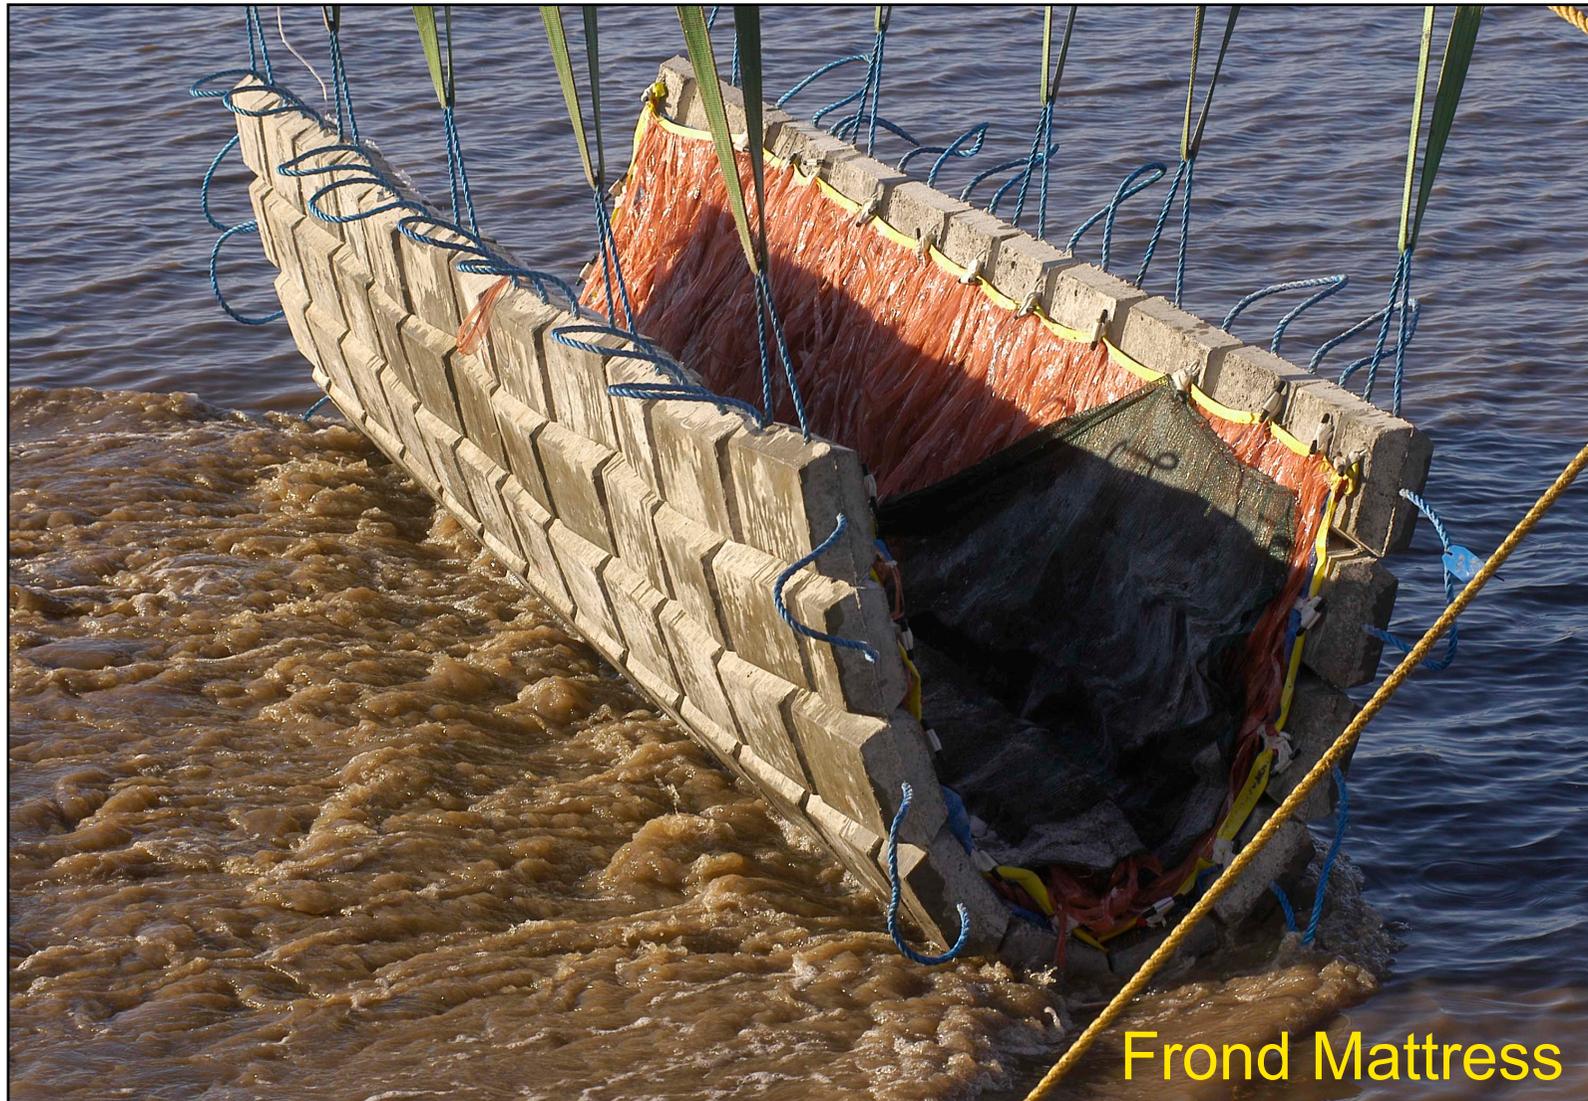
Frond Mattress

Feeder 9 – Remedials Strategy
