ILI Research (Sleeves) Phase 1A2

Report Number: 8093

Client: UKOPA

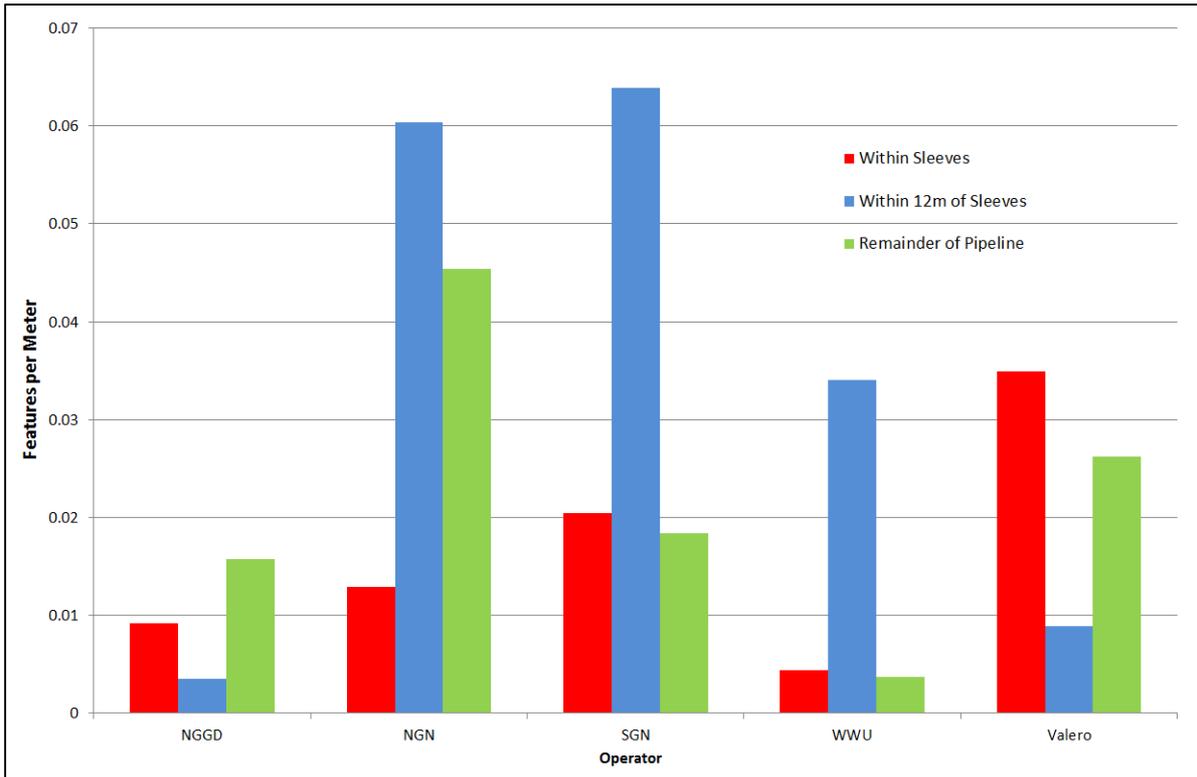
Figure 1 shows the count of external corrosion features per meter within sleeves, 12 m either side of a sleeve and for the remainder of the pipeline, for each pipeline operator. Three of the pipelines, NGN, SGN and WWU, show a significant increase in the number of features reported within 12m of sleeves.

Figure 1: Feature count per meter on all pipelines

It was concluded in Phase 1A1 that including external corrosion features within 12 m of a sleeve made a significant difference to both the number and depth of associated external corrosion features. This phase of work has shown that the observation is particularly evident in 3 of the 5 pipelines considered in this work.

Further analysis of data for the NGN pipeline shows that the majority of these observations can be attributed to one particular sleeve, where a total of 44 out of 58 external corrosion features within 12 m of a sleeve are associated to this location. Removing these features from the dataset reduces the count per meter for features within 12 m of a sleeve to 0.014 for the pipeline (compared with 0.060 per metre including the features). Analysis of the WWU and SGN pipelines has shown that the features within 12 m of a sleeve are generally evenly distributed throughout the pipeline.

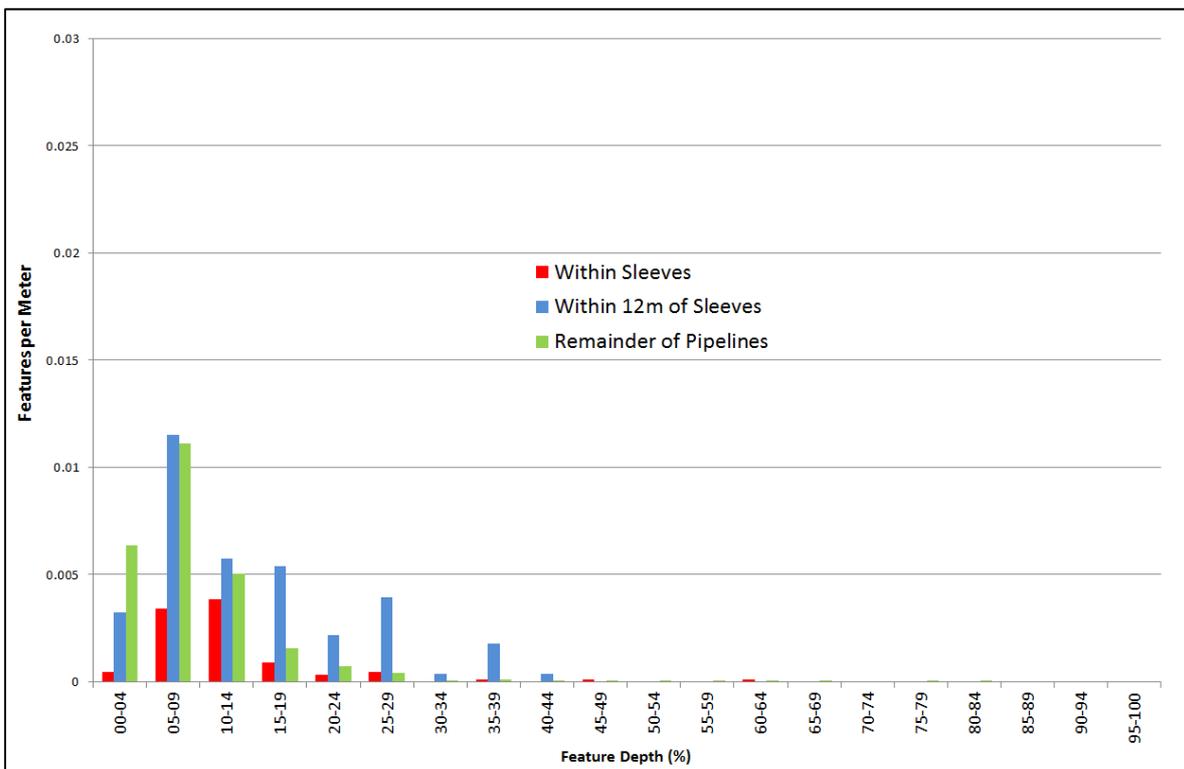
Figure 2 shows a feature depth distribution of external corrosion for all pipelines. This is broken down to features within sleeves, 12 m either side of a sleeve and for the remainder of the pipeline.

Figure 2: External corrosion depths banded for all pipelines

Figure 2 shows that in addition to there being a large number of features within 12 m of a sleeve, the features are also reported to be deeper, this observation is particularly apparent in data for the SGN pipeline. Feature depth distributions for each individual pipeline are presented in the respective Appendix of this report.

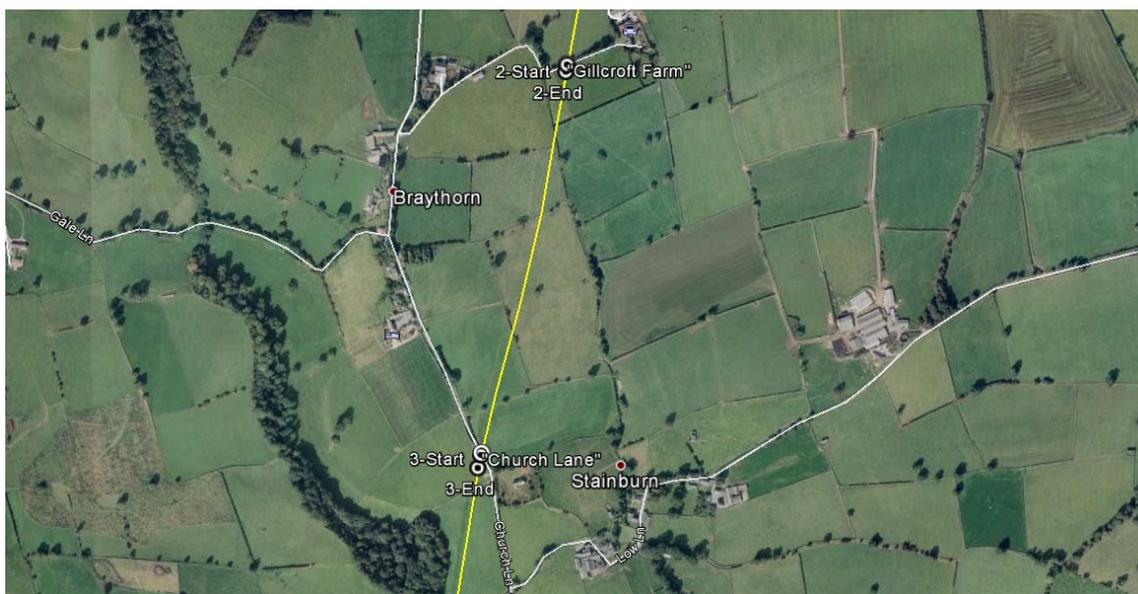
It has also been demonstrated that where GIS pipeline route information and sleeve location data is available, this can be used to align the pipeline and the ILI features geographically. This could be used to identify potential causes of the corrosion or plan work required. Figure 3 shows a comparison of the location information from the NGN sleeve data (white circles) and sleeves reported by the ILI (black circles with dots), based on the absolute distance reported by the ILI. This shows that while there is a difference between the actual locations from the two sources of data, it is still possible to align the two datasets.

Figure 3: Alignment of sleeve data and ILI data for the NGN pipeline

It has been demonstrated that where the required location information is available sleeve and ILI data can be linked, this process could be extended to a larger population of sleeves/pipelines. To ensure this process is successful it will require the GIS pipeline route information for each pipeline and an accurate coordinate or linear reference (chainage) for the sleeve location.

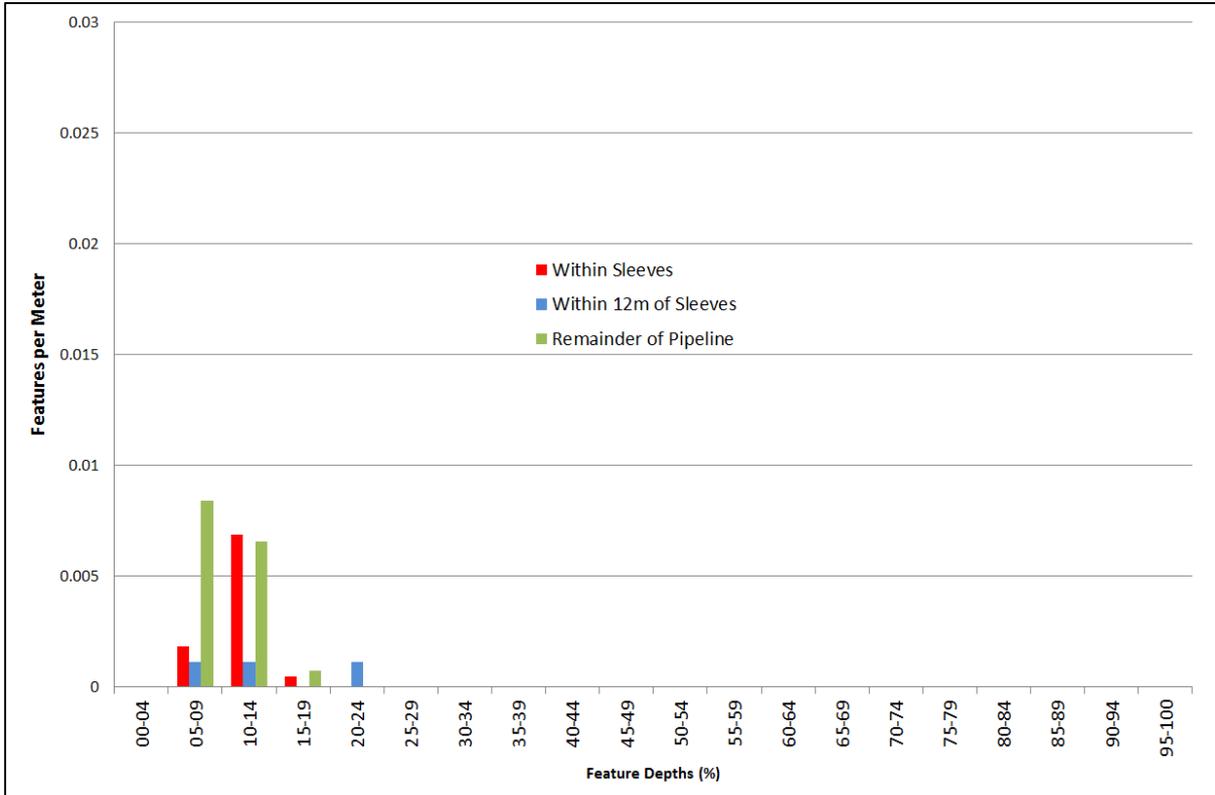
Figure A-1: Feature Distribution along the NNGD Pipeline

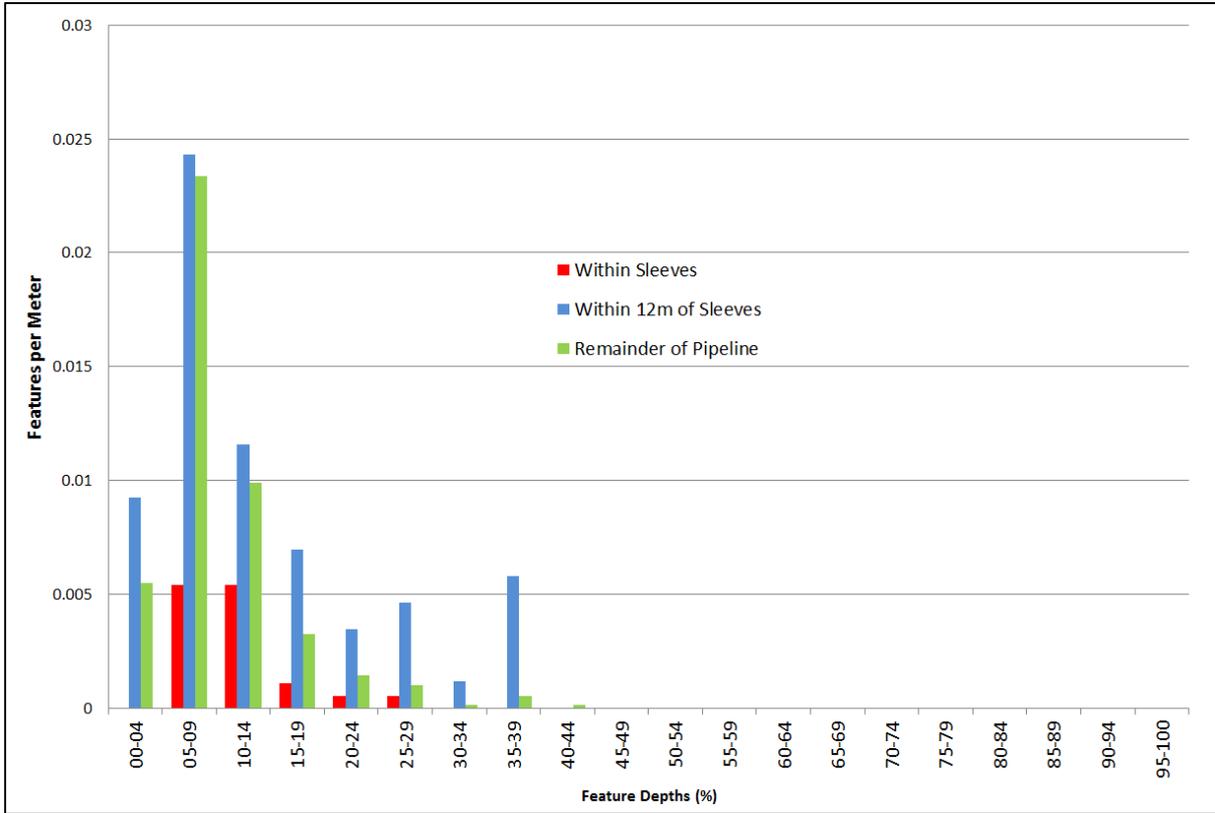
Figure B-1: Feature Distribution along the NGN Pipeline

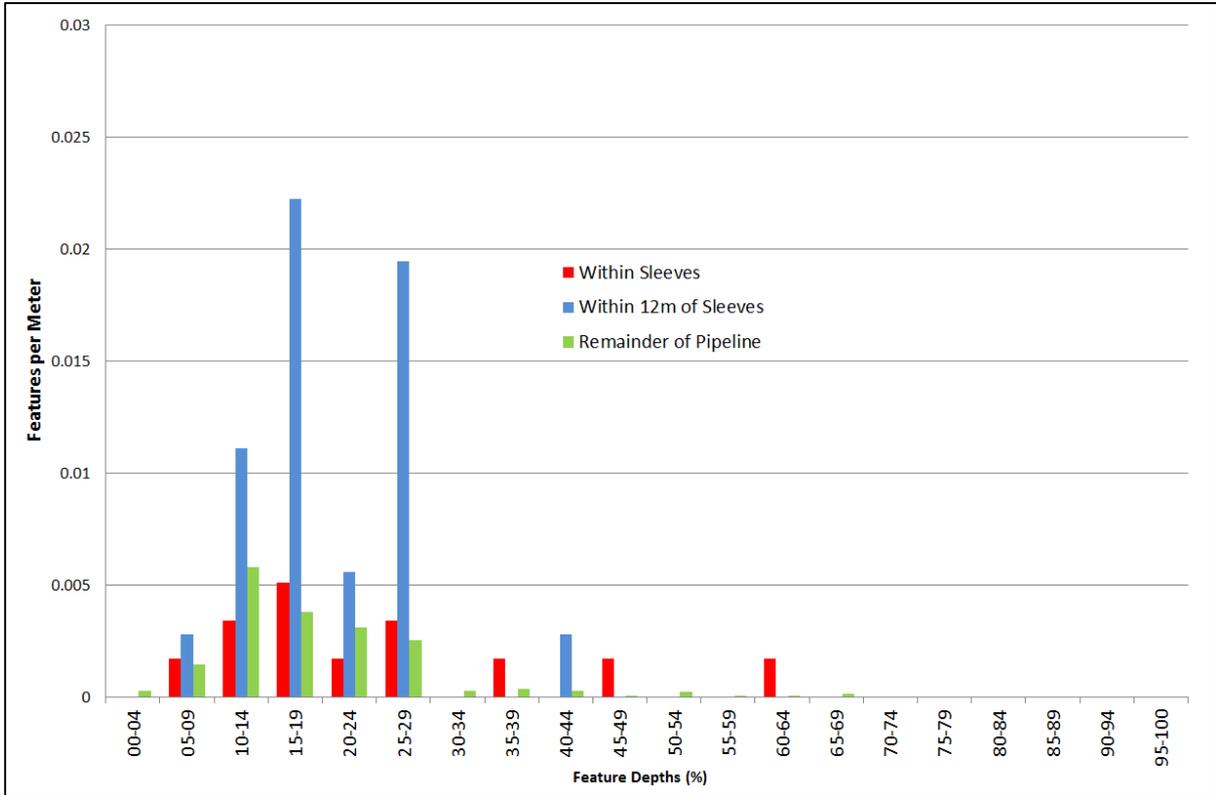
Figure C-1: Feature Distribution along the SGN Pipeline

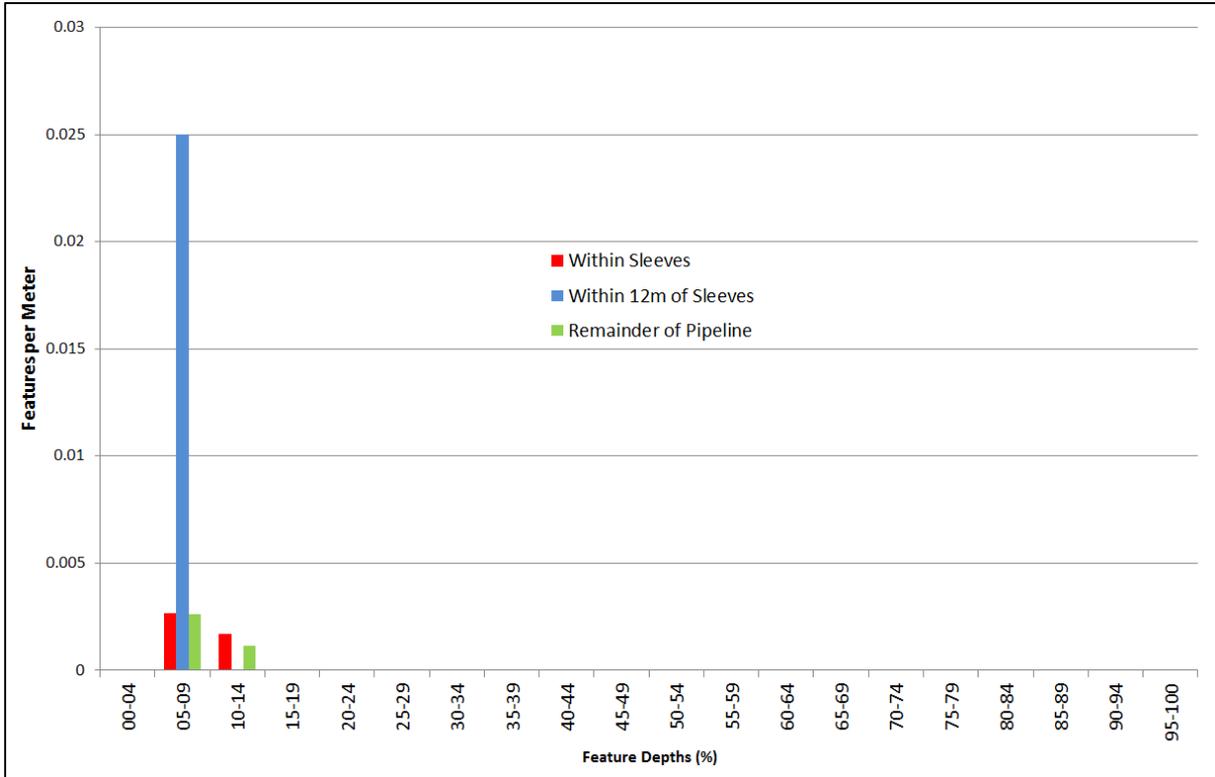
Figure D-1: Feature Distribution along the WWU Pipeline

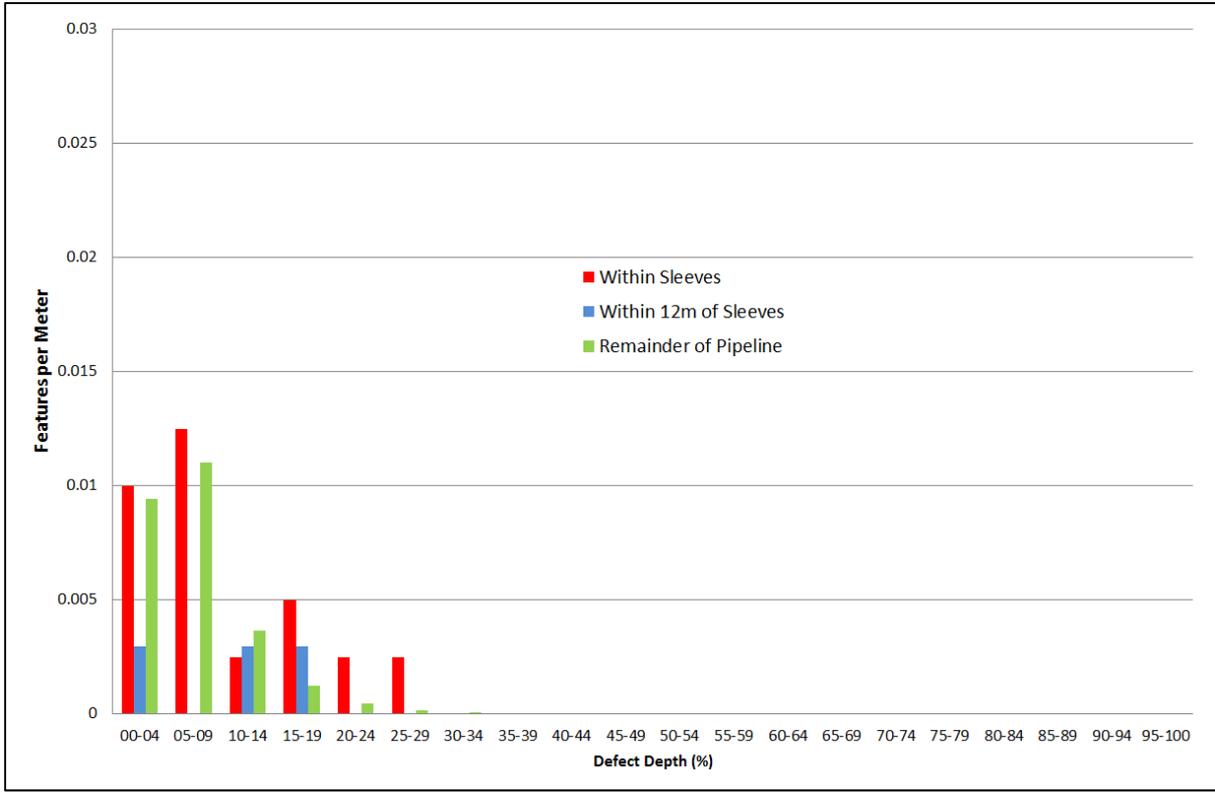
Figure E-1: Feature Distribution along the Valero Pipeline
