Fluxys Pipeline Incident 30th July 2004

- Village of Ghislenghien, Ath, 20 miles South East of Brussels
- 1066 mm (42") dia pipeline, X70, design pressure 80 bar, operating at 71 bar, commissioned 1992, designed and constructed to ASME 31.8
- Leak followed by subsequent catastrophic failure (rupture) and fire.
- 23 dead and about 140 people seriously injured.
- 3rd party construction team had recently built roadway and car park within industrial estate for Diamant Boart (factory owner).
- Distribution company, Electobel, had office and store on site, but no distribution pipes.
- Electobel and Emergency Services were on site investigating reported gas escape. Fluxys team on way to site to investigate when failure occurred about 1 hr after initial call.

UKOPA/04/0093

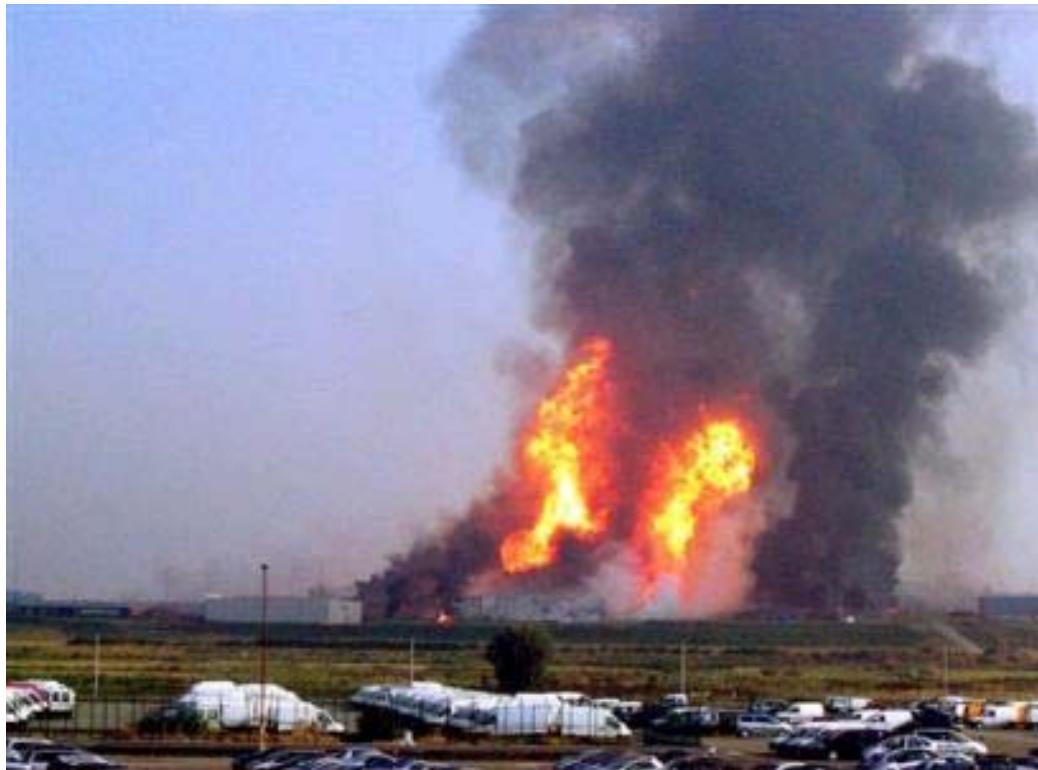
Pipeline failure fire

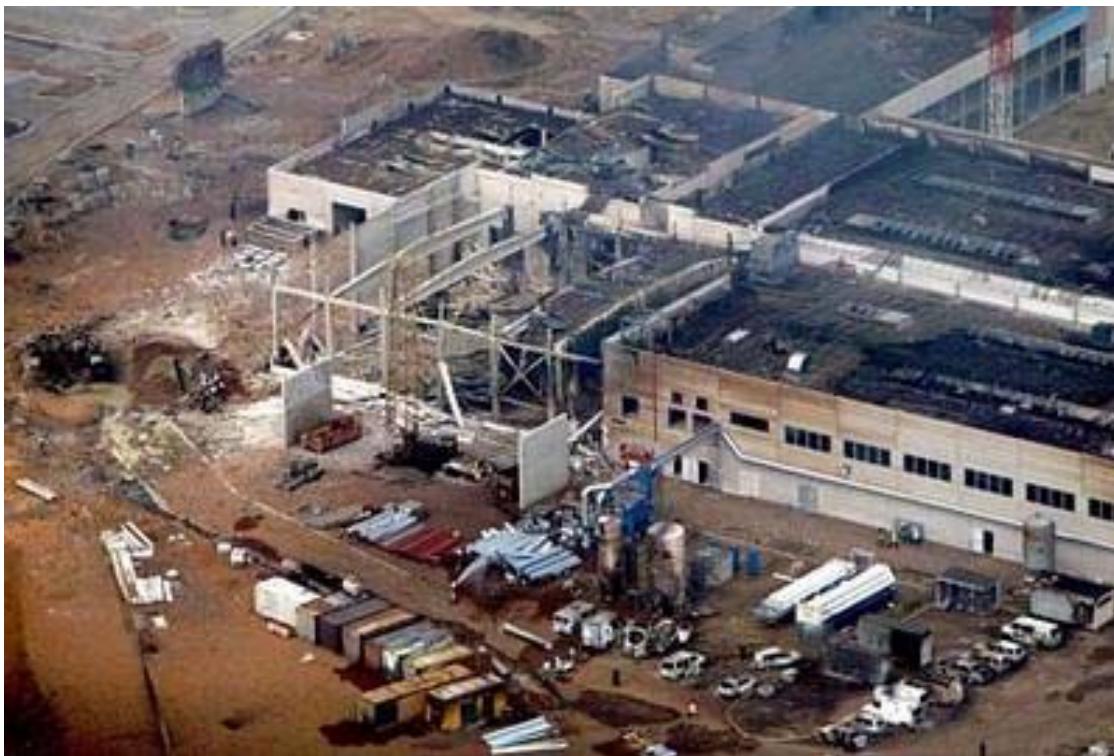
Pipeline failure

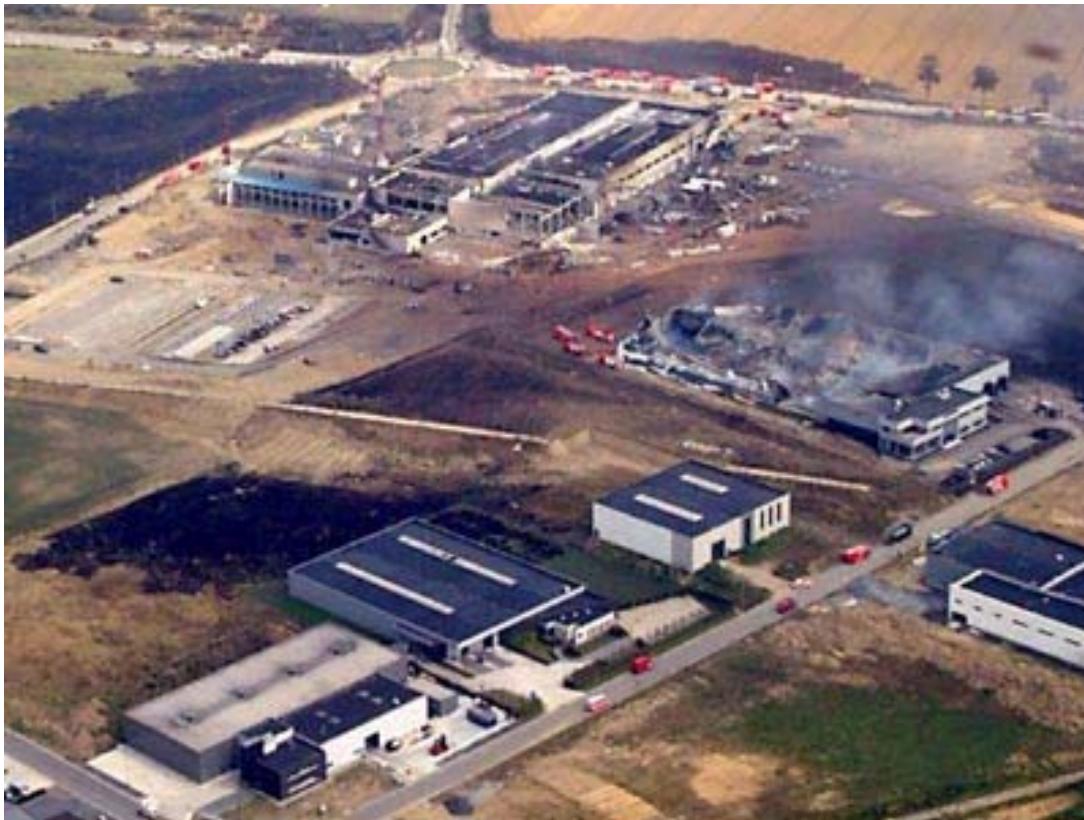
Pipeline failure

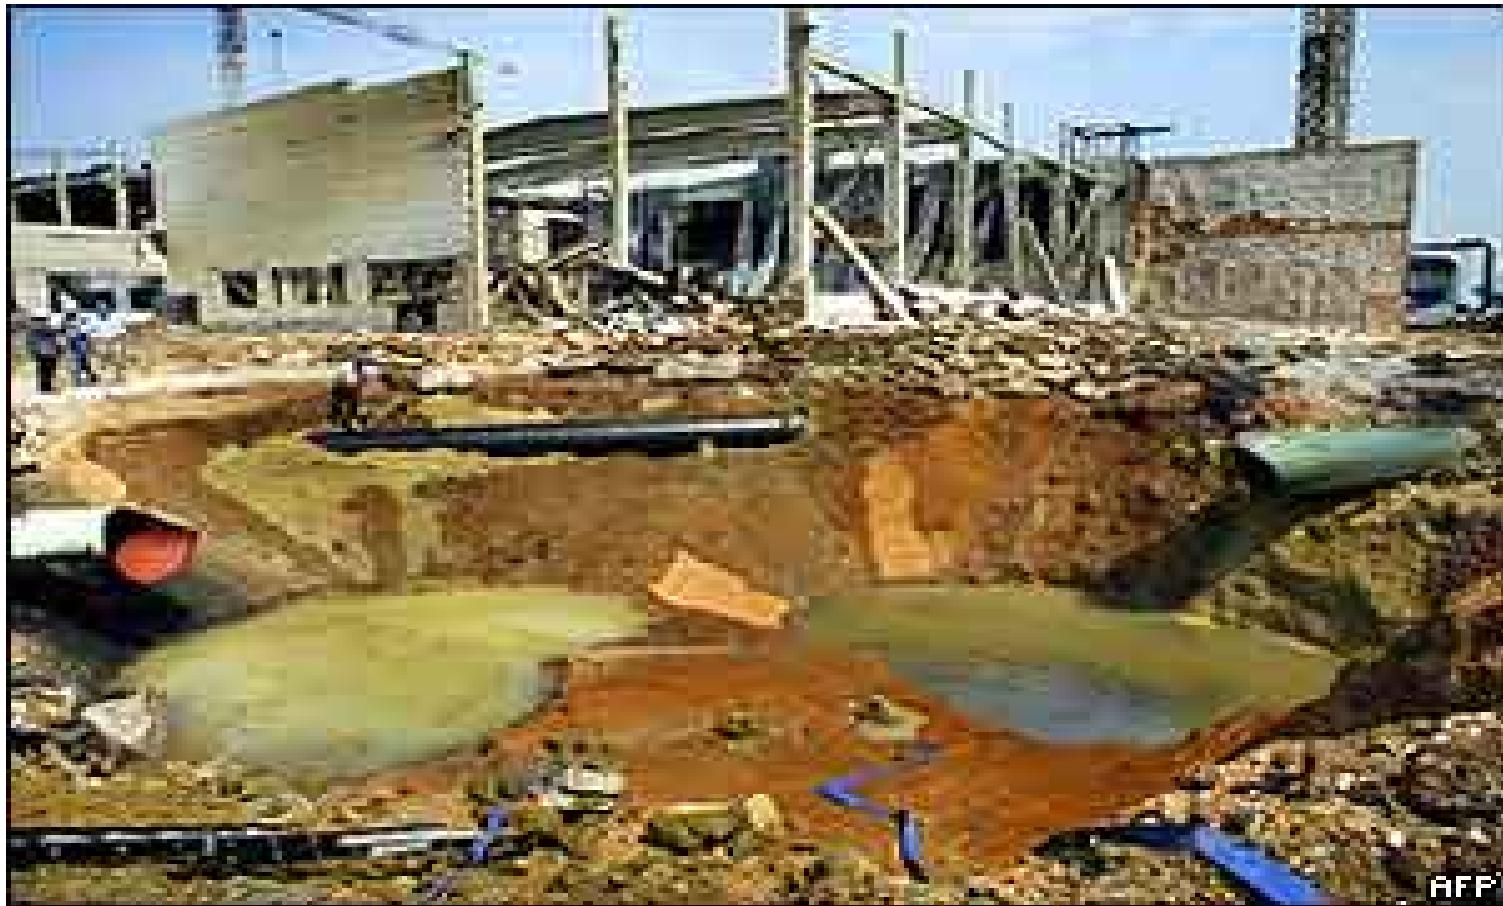
Pipeline failure crater

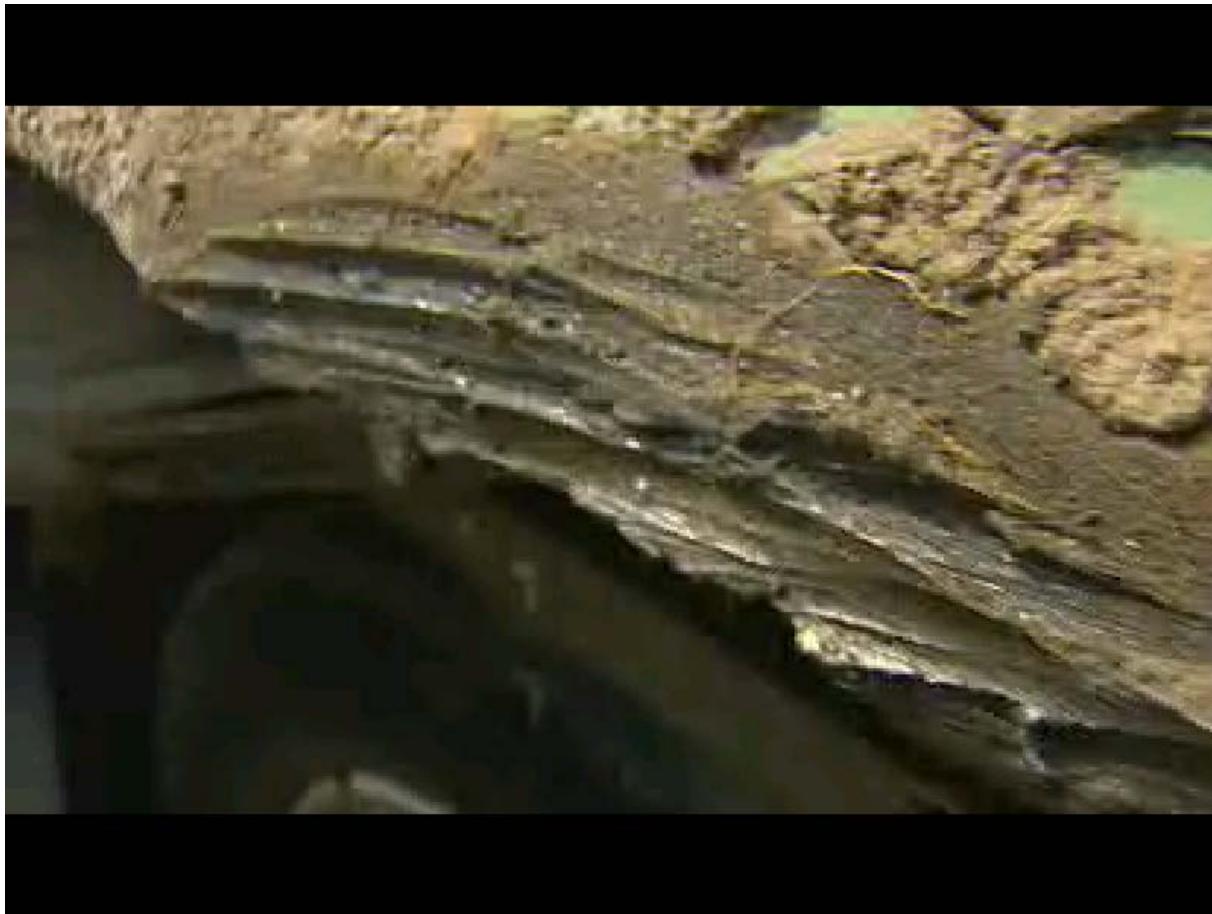
Pipeline damage

- Pipeline wall thickness 13.6mm (with no under-tolerance)
- Multiple cuts and gouges (parallel and regularly spaced) on the pipe in the area of the failure point. Similar damage present on adjacent pipe sections.
