Fluxys Pipeline Incident 30th July 2004

UKOPA/04/0093

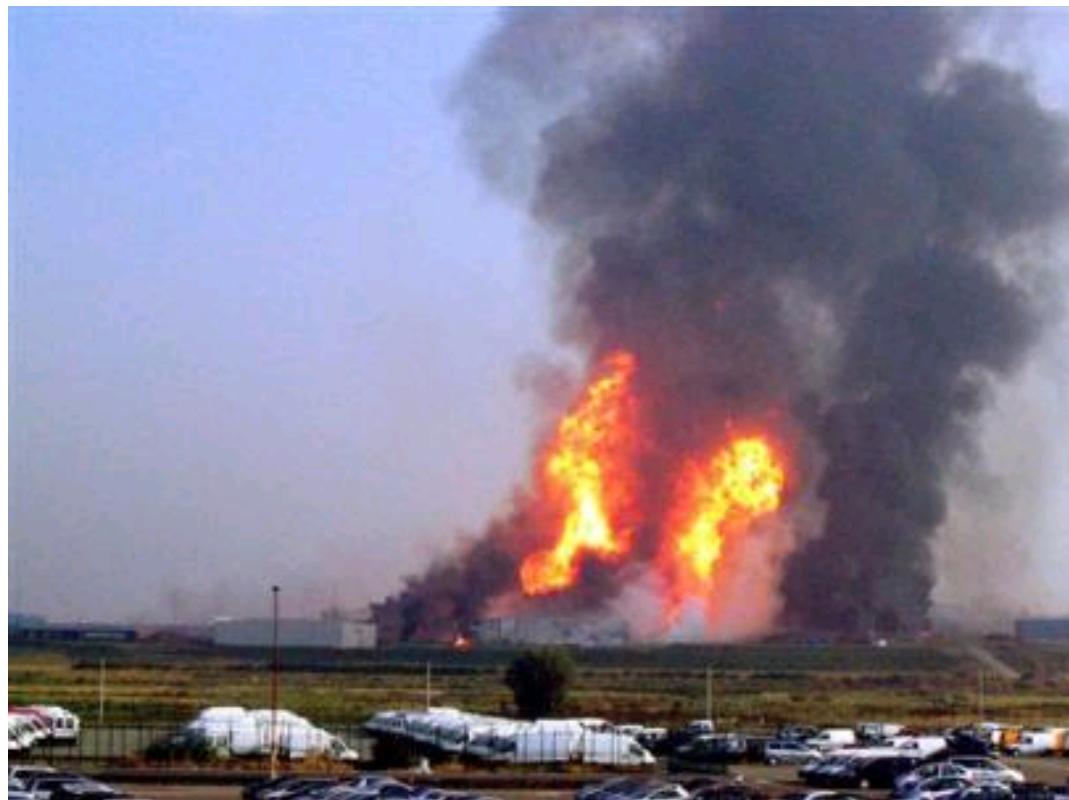
Pipeline failure fire

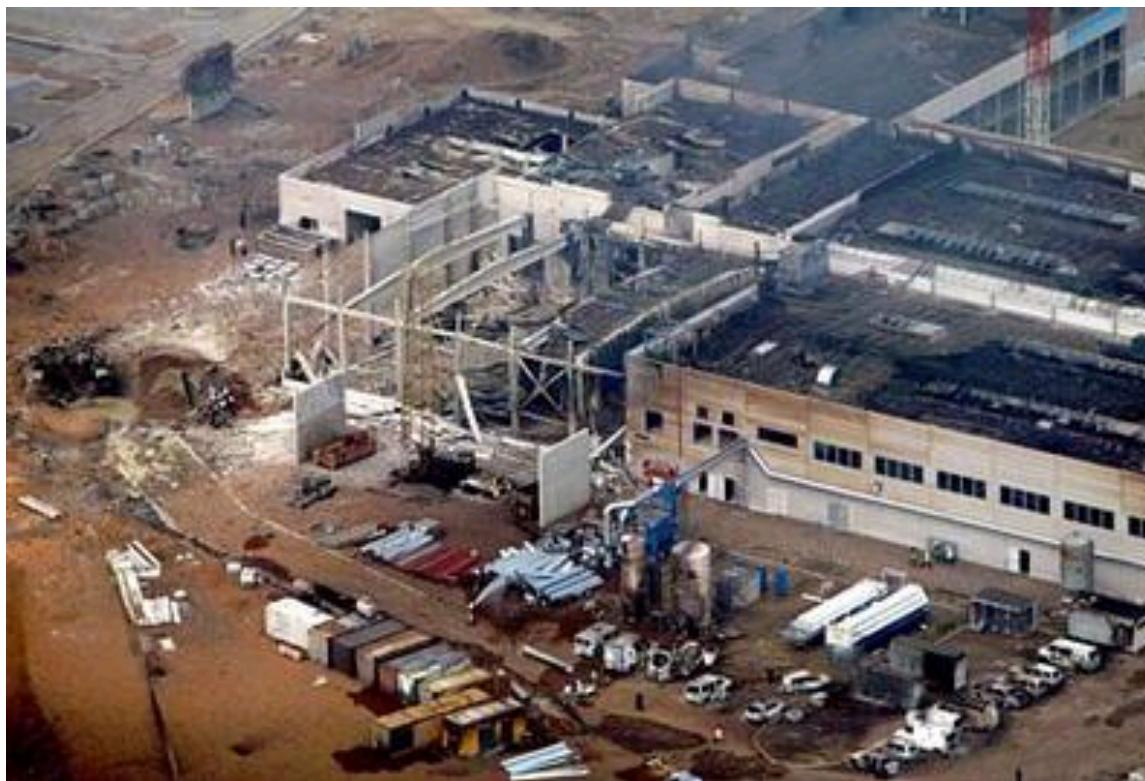
Pipeline failure

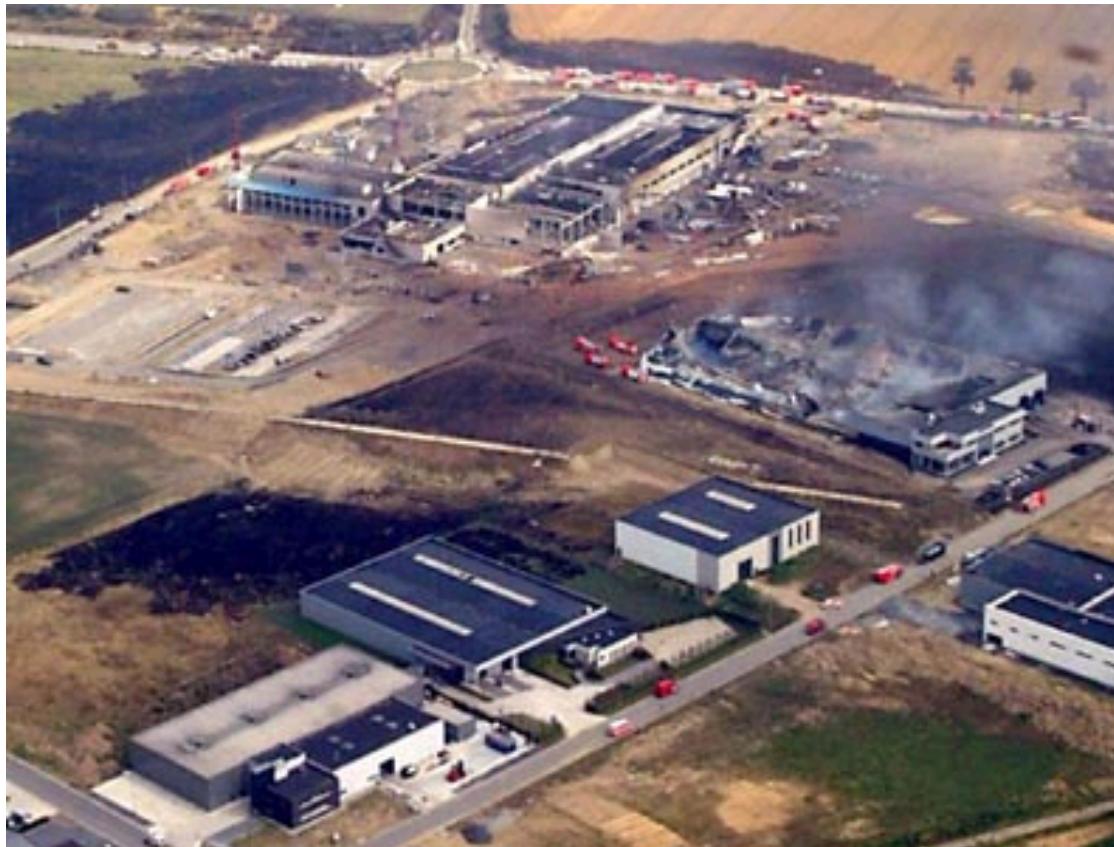
Pipeline failure

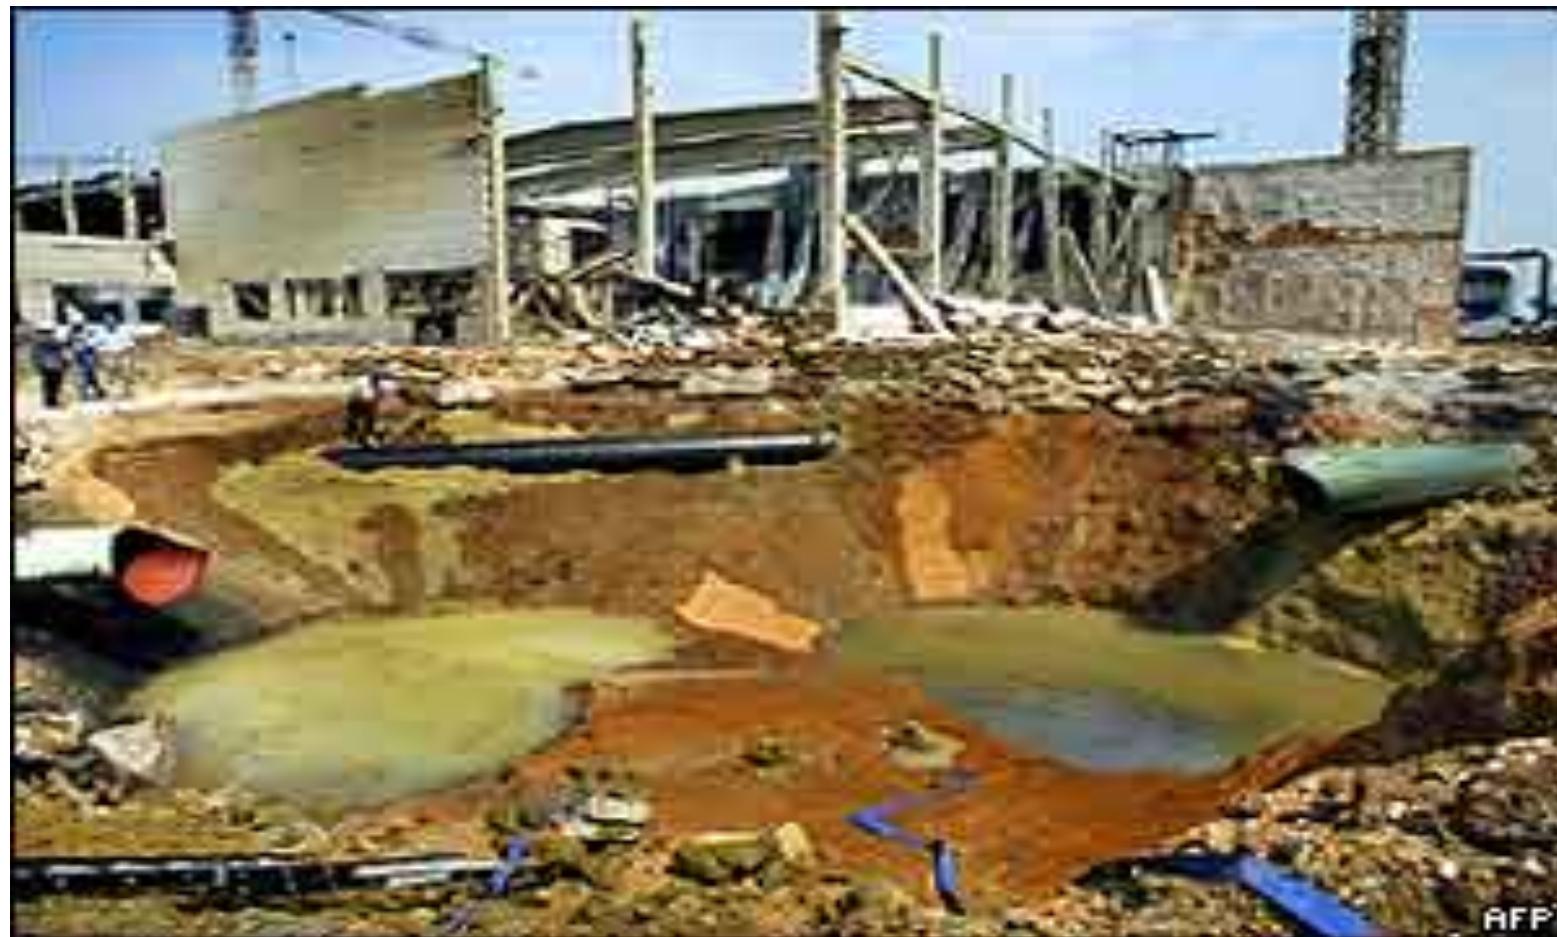
Pipeline failure crater

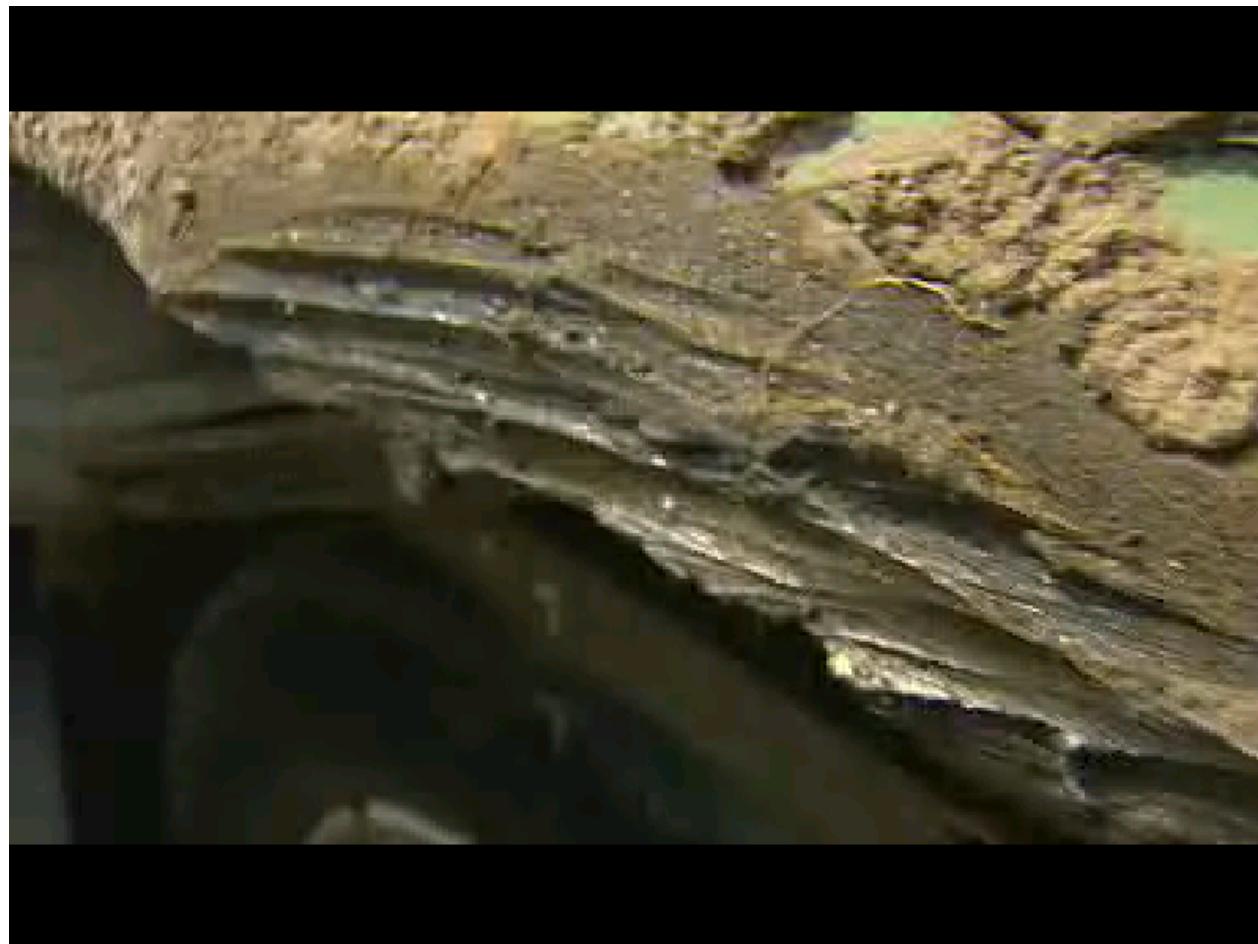
Pipeline damage

- Pipeline wall thickness 13.6mm (with no under-tolerance)
- Multiple cuts and gouges (parallel and regularly spaced) on the pipe in the area of the failure point. Similar damage present on adjacent pipe sections.
