Managing vibration related fatigue failures in process pipework

Case Study: NGT's Pressure Reduction Stations

Dr Mike Wastling - Advantica

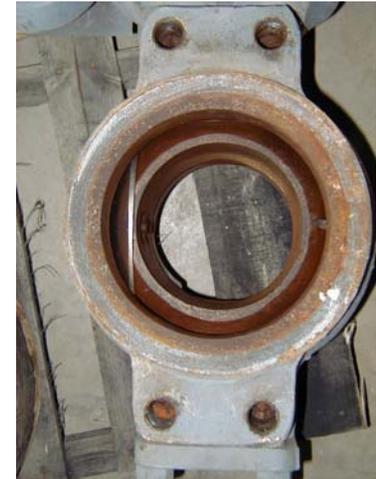
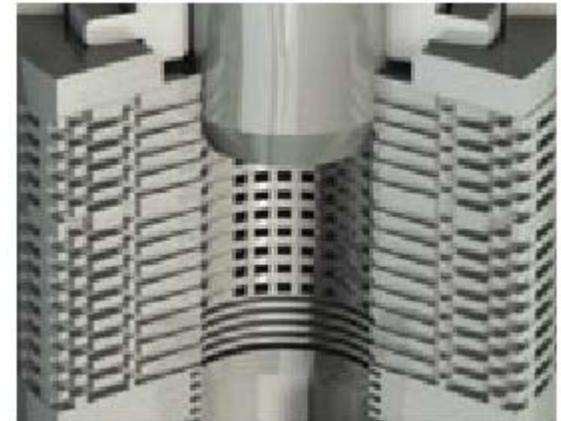
Pressure regulator

- Pressure reduction achieved by giving the gas kinetic energy
 - Source of turbulence that can cause dynamic loads on pipe
 - Broad range of frequencies including high frequencies
 - Possible source of periodic loading from vortex shedding – see later
- Some specific design features / types of regulators are particularly likely to cause vibration in the pipework.
- Severity of vibration is sensitive to flow rates / pressure reduction

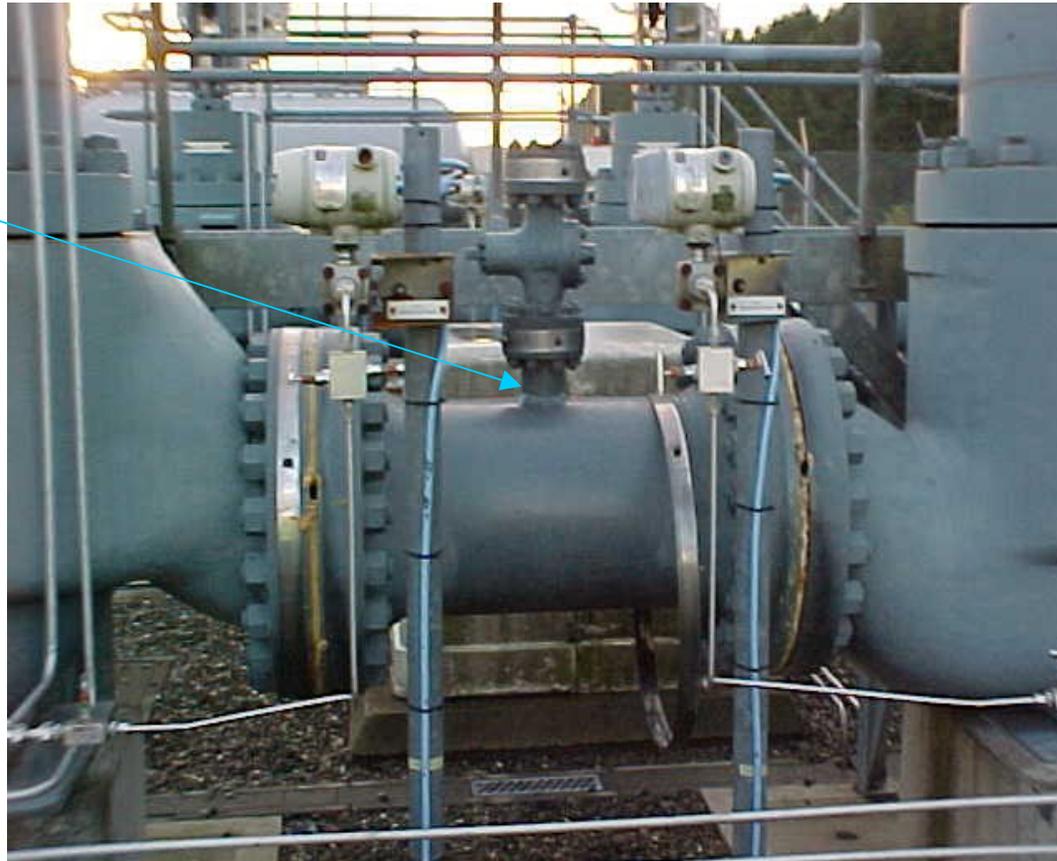
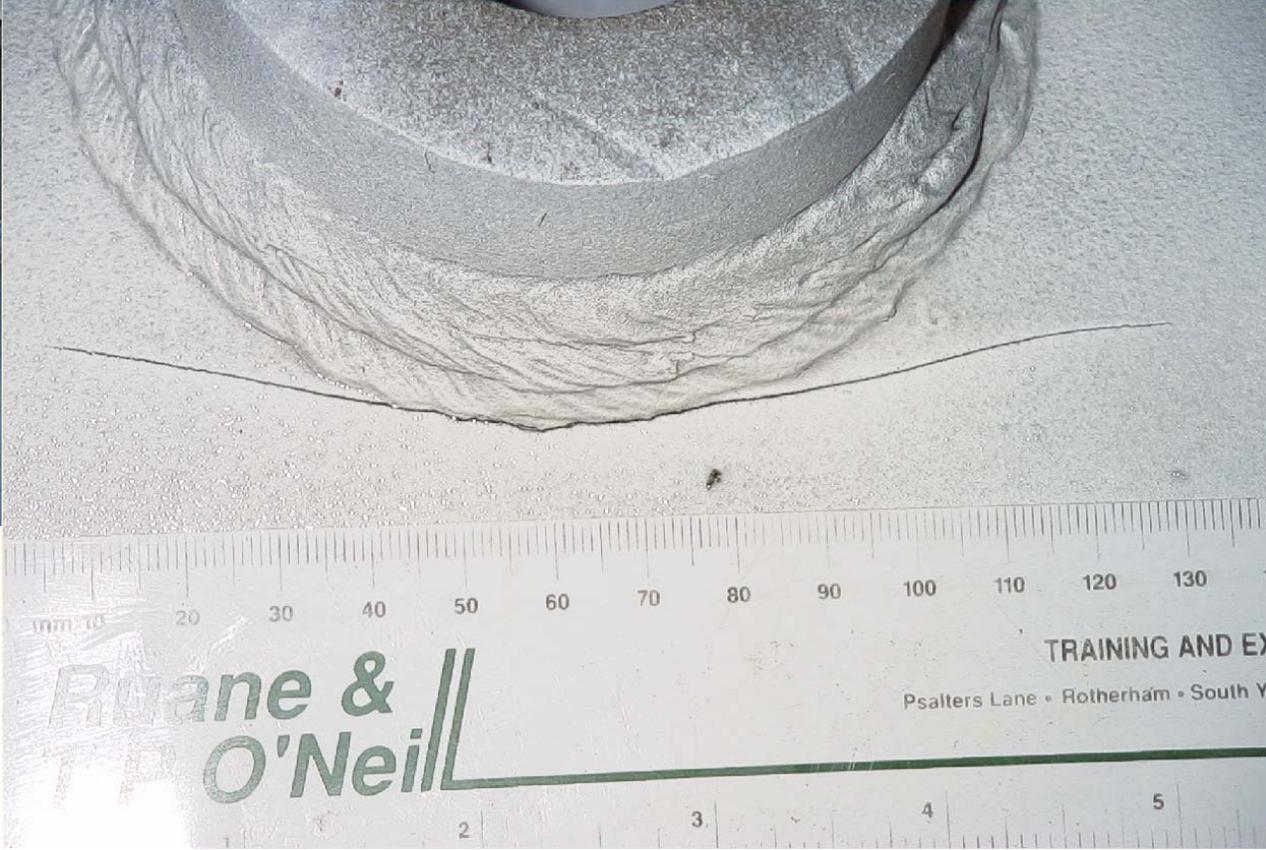
Example 2

Problem: Two separate failures experienced at weld toe of a 2" welded outlet branch connection between two regulators.

2" stabbing

Cause: Severe vibration from the regulators when operating nearly closed that became worse over time. Cantilevered valve was the weakest connection.

- Overhaul of regulators.
- One of the branch connections removed by replacing spool piece
- Solution was effective, but high vibration eventually returned. A further failure occurred on an adjacent stream.
- Ongoing discussions with manufacturer.

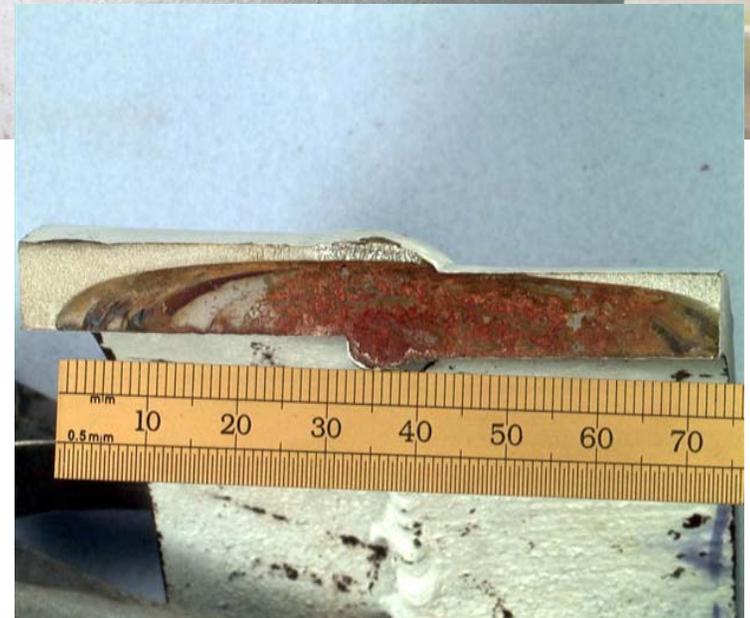
Example 4 - Recycle line failure

- Longitudinal crack detected in girth weld on compressor station recycle line

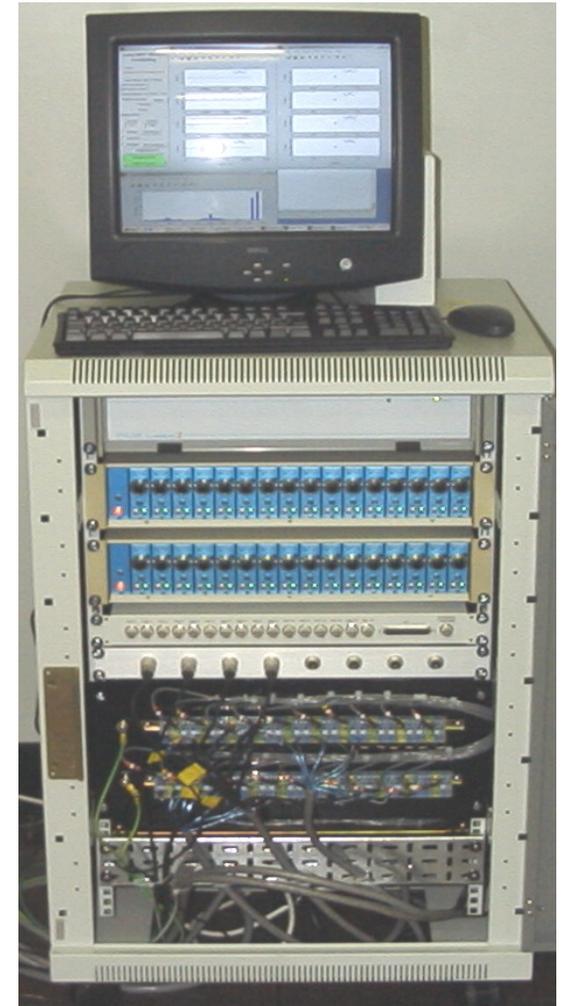
Can range from:

- Visual inspection / basic measurements
- to:
- Detailed investigation using long-term continuous vibration monitoring to capture operating conditions that arise only occasionally.
 - Has involved the development of assessment techniques/criteria that have been subjected to external review.
 - Final outcome: Solution / verification
