UK ONSHORE PIPELINE OPERATORS' ASSOCIATION - INDUSTRY GOOD PRACTICE GUIDE

**Near Neutral pH and High pH
Stress Corrosion Cracking**

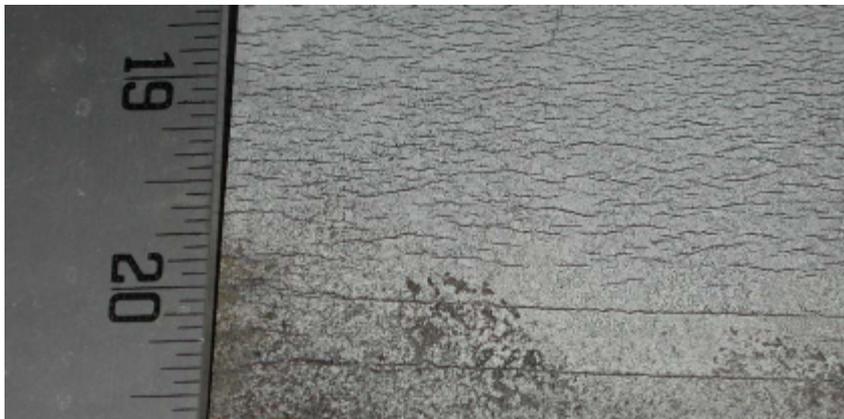
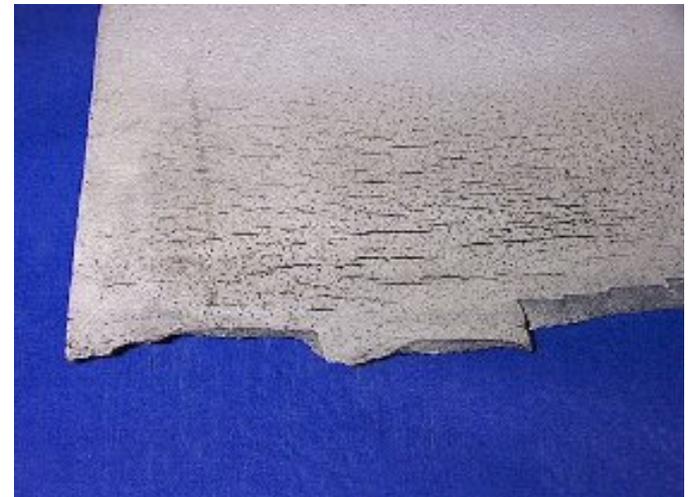
Section 3: Understanding SCC – SCC types

- SCC in pipelines is characterised as “High pH SCC” or “Near neutral pH SCC (NNSCC)”. The ‘pH’ relating to the environment at the crack location.
- The most obvious characteristic of SCC in pipelines, irrespective of type, is the presence of colonies of parallel cracks on the external surface.
- The cracks are closely spaced, are of varying length and depth and are perpendicular to the direction of the highest stress (generally the hoop stress) on the external surface.

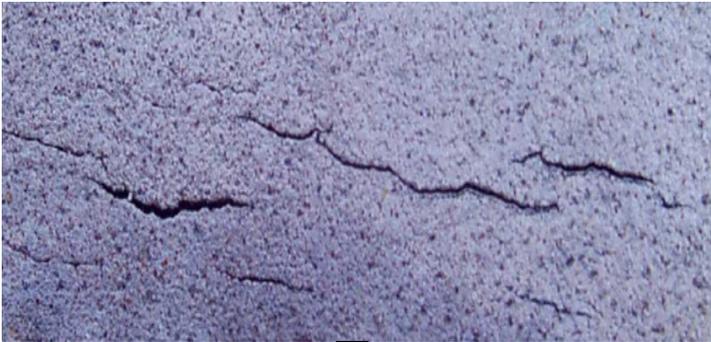
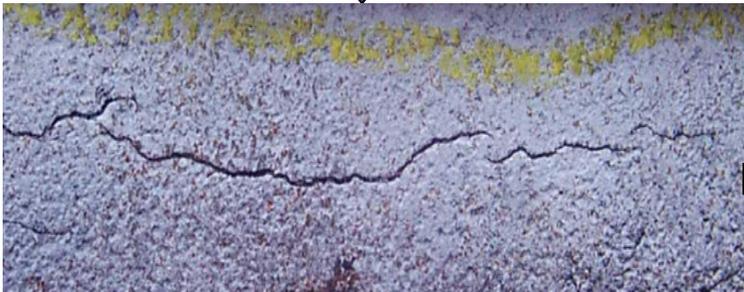
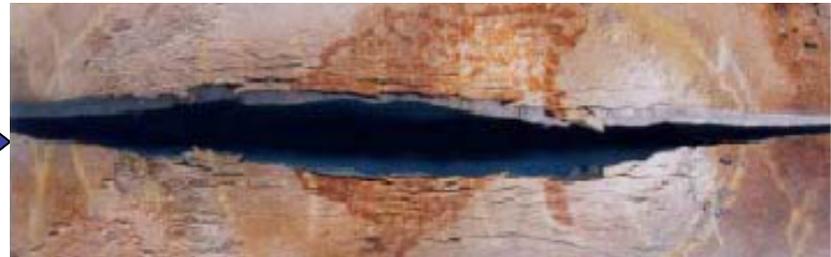
Section 3: Understanding SCC – Crack growth

Smaller cracks tend to coalesce to form longer and deeper cracks, which in some cases can lead to a rupture. Cracks do not need to fully penetrate the wall for a rupture to occur.

If cracks are sparsely spaced they might grow through wall and leak before they reach a length that is sufficient to cause a rupture.

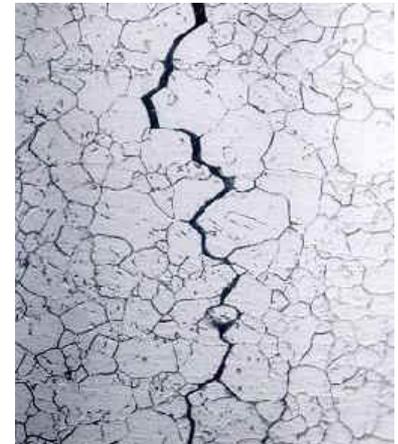
Section 3.1: Understanding SCC - High pH SCC

- First found in the USA in the 1960's under field applied CTE, Asphalt and Tape.
- Occurs under a disbonded coating which is still receiving CP current
- Carbonate/bicarbonate environment at pH >9
- High pH SCC cracking is caused by the dissolution of grain boundaries in a stressed metal which is in contact with ground water.
- It is most frequently observed as intergranular cracking.

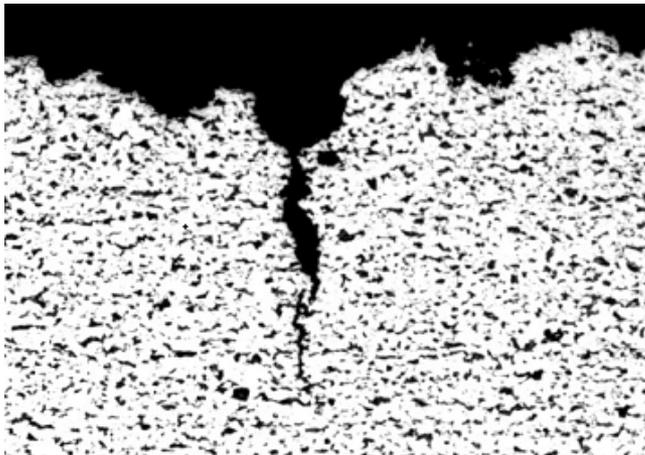
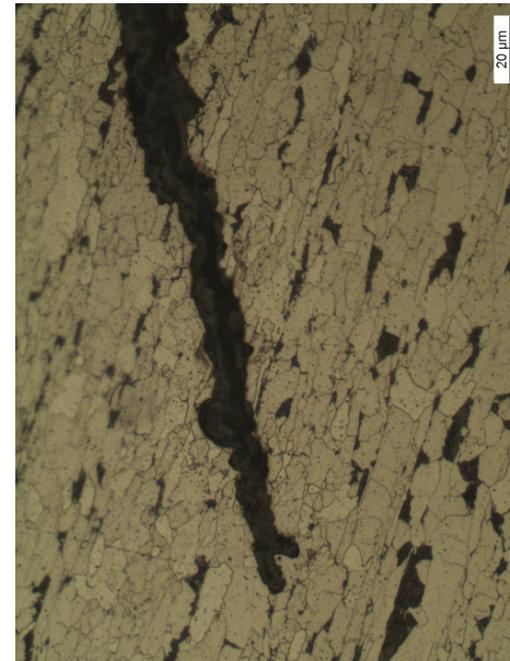
Section 3.2: Understanding SCC - Near Neutral pH SCC (longitudinal)

- First experienced in Canada in 1985 on Tape, CTE and Asphalt coated pipe
- Occurs under a disbonded coating which is shielding the pipe from CP
- Associated with underfilm corrosion and near neutral cracking tends to initiate from corrosion pits
- Cracking occurs in a transgranular manner under near neutral conditions (pH 5 – 7.5).

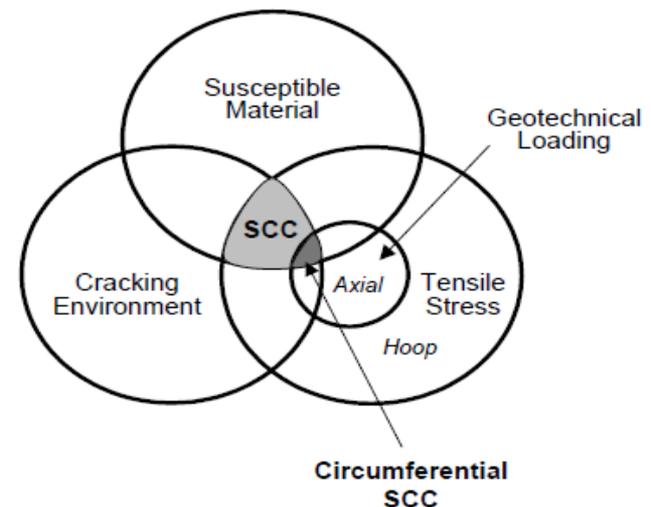
Section 3.2.3: Understanding SCC - Circumferential Near-neutral pH SCC

- Circumferential SCC is a subset of NNSCC in which the principle stress acting on the pipe is a bending stress
 - Soil creep
 - Slope movement
 - External loading (residual stresses at tie in welds)

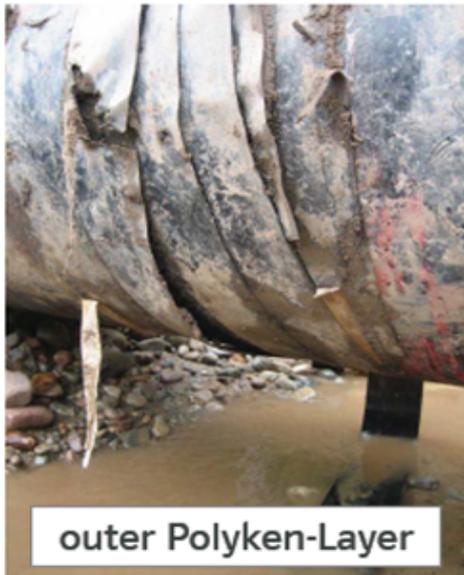
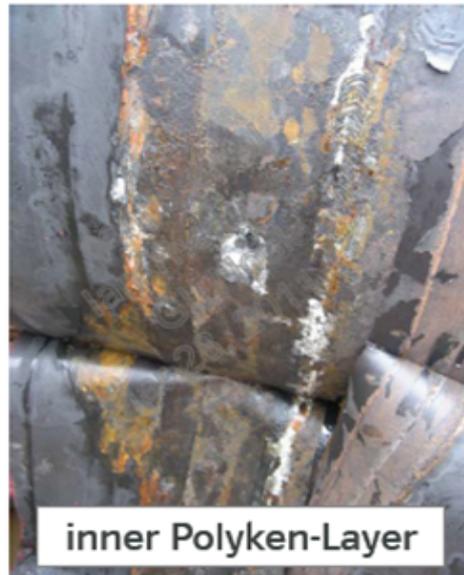
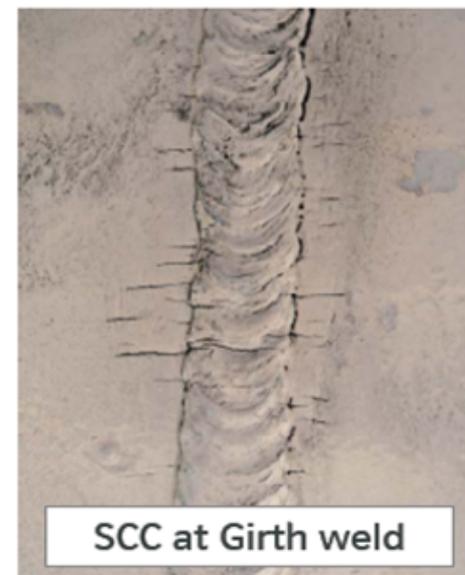
The EGIG gas pipeline incident report last published in 2015, indicates that 8% of external corrosion incidents (13 incidents) were due to SCC.

Diameter (mm)	WT (mm)	Strength	SMYS (Mpa)	UTS (Mpa)	Coating Mainline	Field Joint Coating	Pressure MOP (bar)	Commisioned
954	12.6	X60	415	550	Asphalt	Tape	67.5	1974

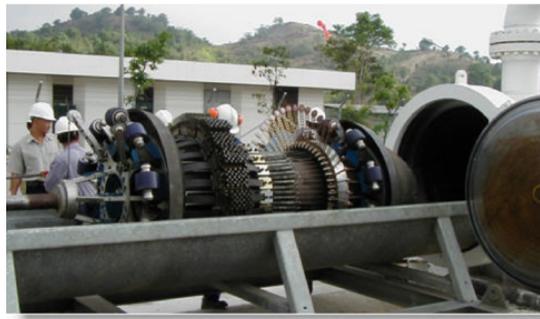
- In-Line Inspection

- EMAT (cracking/disbonding)
- Ultrasonics

- ILI conducted using MFL tool during which metal loss was located under disbonded tape coating at field joint.
- On excavation, cracking was detected.
- ILI conducted using EMAT tool to locate cracking:
 - Unsuccessful at crack location.
 - Successful at locating coating disbonds at field joints.
- ILI repeated using UT tool to locate cracking.

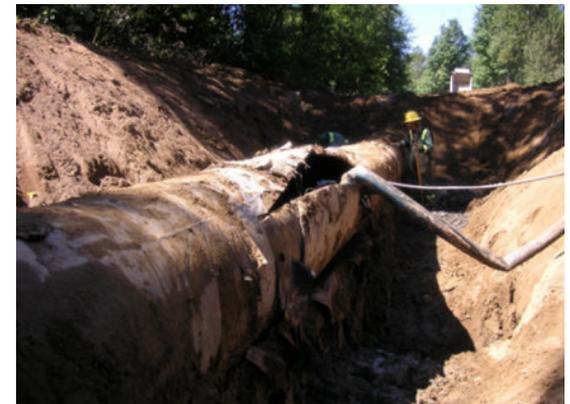
Section 5.1.3: Prevention and Mitigation – Hydrostatic Testing

Repeat hydro-testing is the most reliable way of demonstrating pipeline integrity and mitigating the effects of SCC

- It provides a margin of safety against in-service failures
 - removes near-critical cracks
 - blunts non-critical cracks
- Need to have a good knowledge of crack growth rates to schedule subsequent tests
- Only applicable to longitudinal cracking

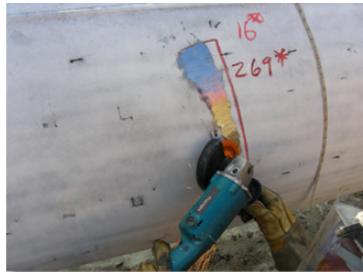
(i) Grinding

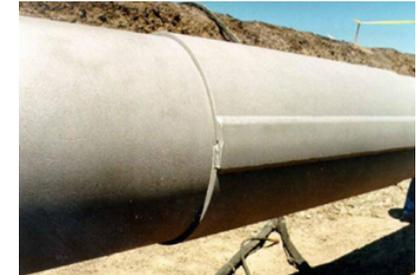
(ii) Pressure containment using repair sleeves (steel or composite)

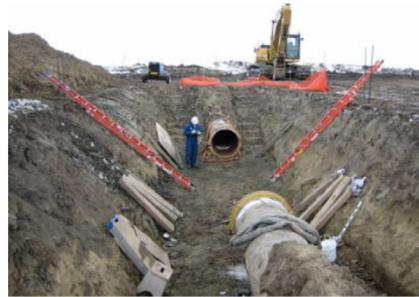
(iii) Pipe removal and replacement
