What happened?

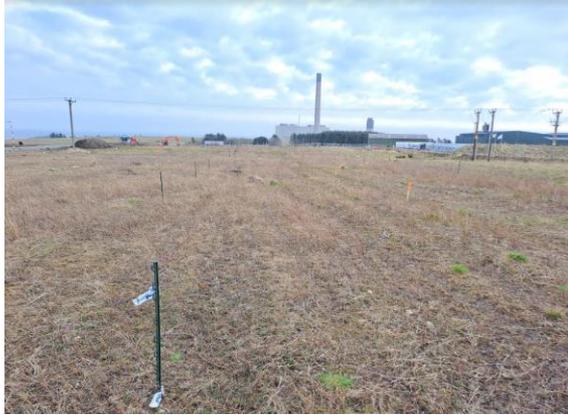
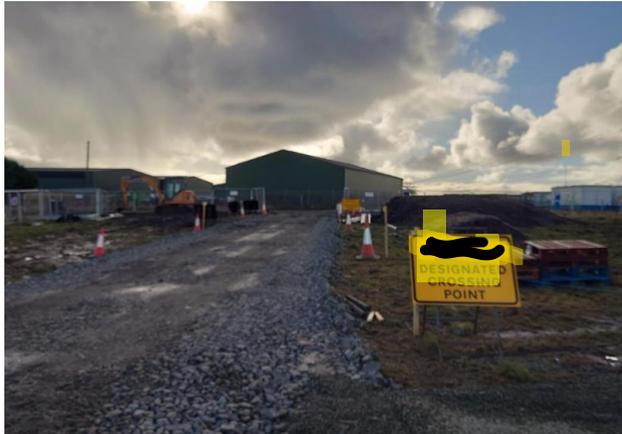
- A utility company installed a temporary road over a gas pipeline without the pipeline operator's authorisation or supervision
- The location of the pipeline was known to the utility company as were the procedures that they were required to follow

- A utility company required to install a power cable duct under several pipelines
- The utility company were in possession of all pipeline information and had prepared an approved design for the duct and both temporary and permanent road crossings. They were also aware of the pipeline operators required procedures
- However, the utility company's principal contractor proceeded to strip 250 – 300 mm of top-soil from above the pipelines without permission
- The utility company held an internal investigation resulting in several actions: removal of certain personnel, daily tool-box talks & safety meetings, tightening of the blanket no-dig zone, clearly designated crossing points

- Operators should be aware that despite contractors having all the necessary information and procedures, rules may not be adhered to
- Operators may need to consider increasing their representation at work sites
