What happened?

Findings and key learning points

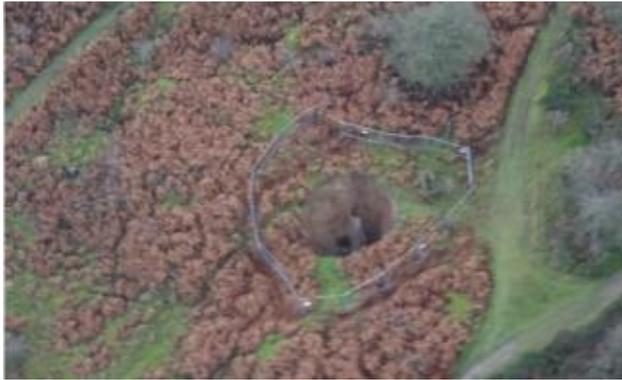
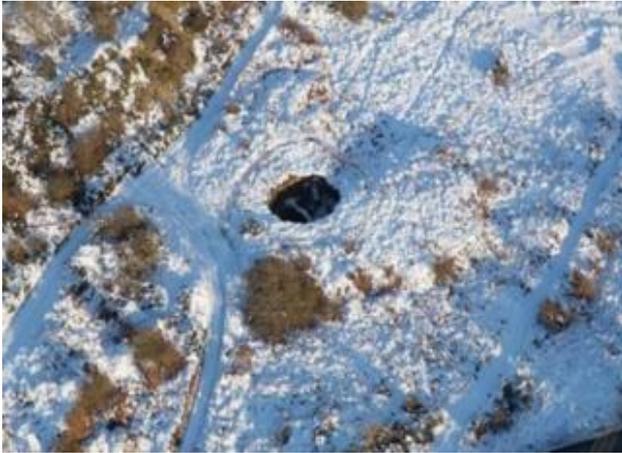
- During a weekly vantage point survey, a sinkhole was noted
- The sinkhole was formed due to an abandoned mine shaft re-opening
- An adjacent gas pipeline was unaffected

- A pipeline operative noted the appearance of a sinkhole during a routine weekly vantage point survey
- The pipeline operator carried out investigations and established that a capped disused mine shaft had collapsed and re-opened. The appropriate agencies and landowner were informed. A fence was erected around the hole.
- An aerial survey was undertaken to confirm the exact location. An adjacent gas pipeline 33 metres away was unaffected.
- The presence of the mineshaft was known when the pipeline was constructed so the route was selected accordingly
- The operator carried out a geophysical survey of the pipeline to ensure that there had been no subsidence or settlement caused by ground movement or underground water

- Operators should be aware that capped abandoned mine shafts may re-open and should consider including these on surveillance lists
