Wytch Farm Oilfield: Pipe-in-pipe Remediation Project

Presentation to UKOPA Members
24th February 2015

Richard Sellen – Pipeline Integrity Engineer

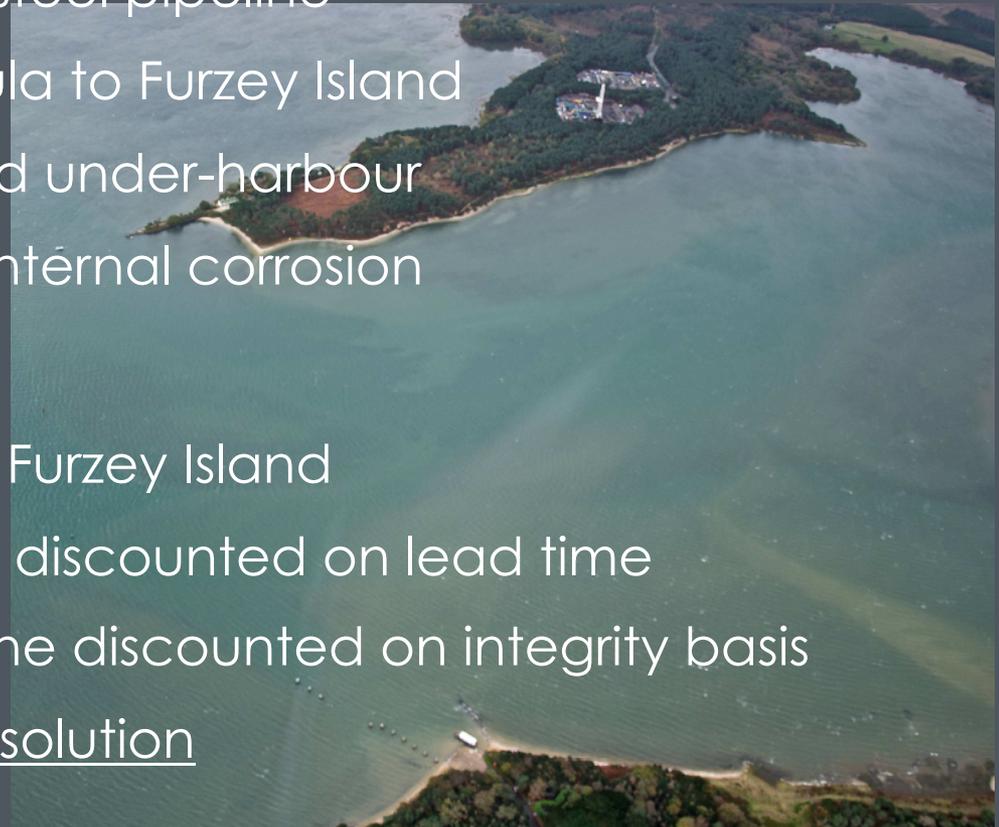
Water Injection Pipeline

- Existing Pipeline:
 - 90bar water injection
 - 6,4km 10"/8" X52 carbon steel pipeline
 - 80kbpd Goathorn Peninsula to Furzey Island
 - 1,3km 8" horizontally drilled under-harbour
 - Inline inspection Nov'14- Internal corrosion
- Project Scope:
 - Restore water injection to Furzey Island
 - HDD of a new pipeline discounted on lead time
 - Lining of existing pipeline discounted on integrity basis
 - Pipe-in-pipe preferred solution

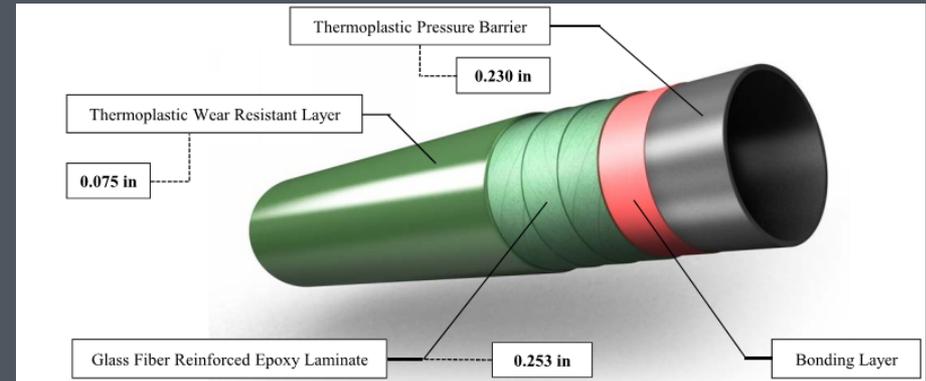
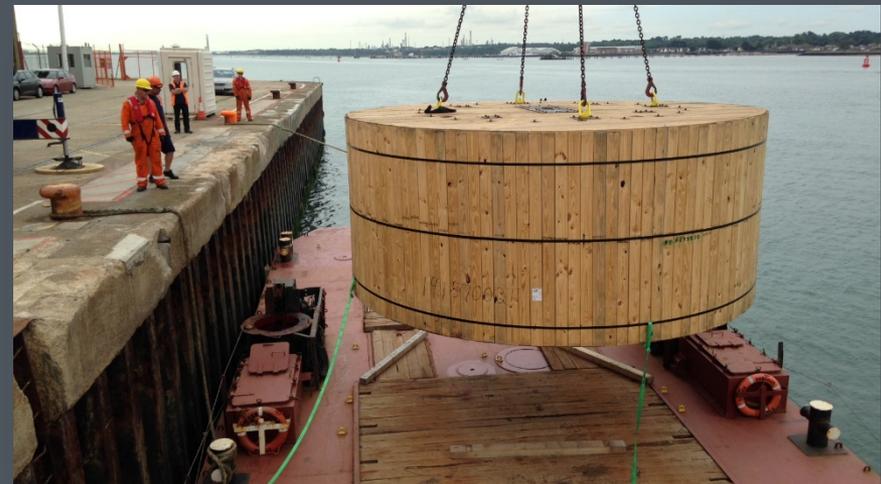
- GRE lined with HDPE core and jacket
- Continuous spoolable pipe
- Compatibility
 - Full pressure/temperature rating
 - Corrosion free
 - Permeability checks
 - Chemical checks
- Flow Rate Matching
 - Two off 5", One off 4"
 - Three parallel out of use pipelines selected as carrier pipes under harbour

2 x 5" Lines being loaded at Southampton docks having arrived from the USA

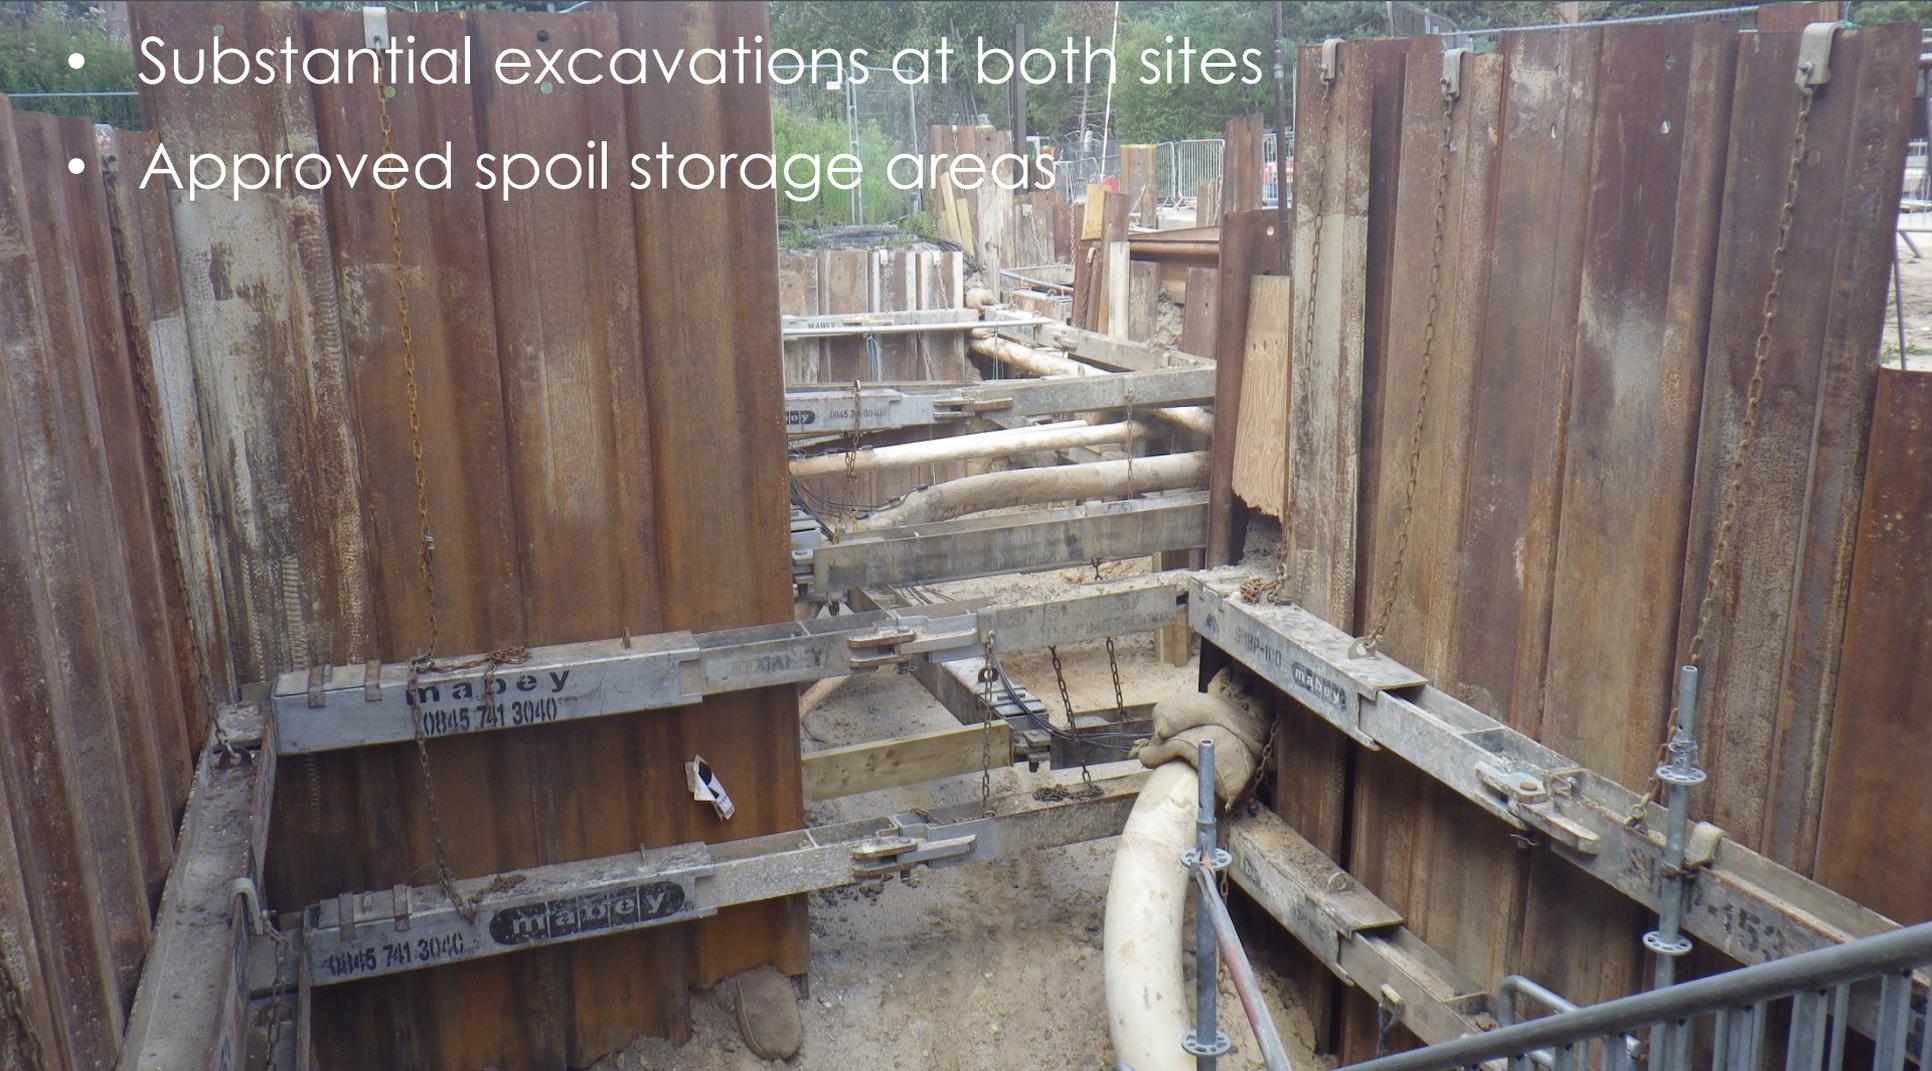
Installation (1/4)

- Substantial excavations at both sites
- Approved spoil storage areas

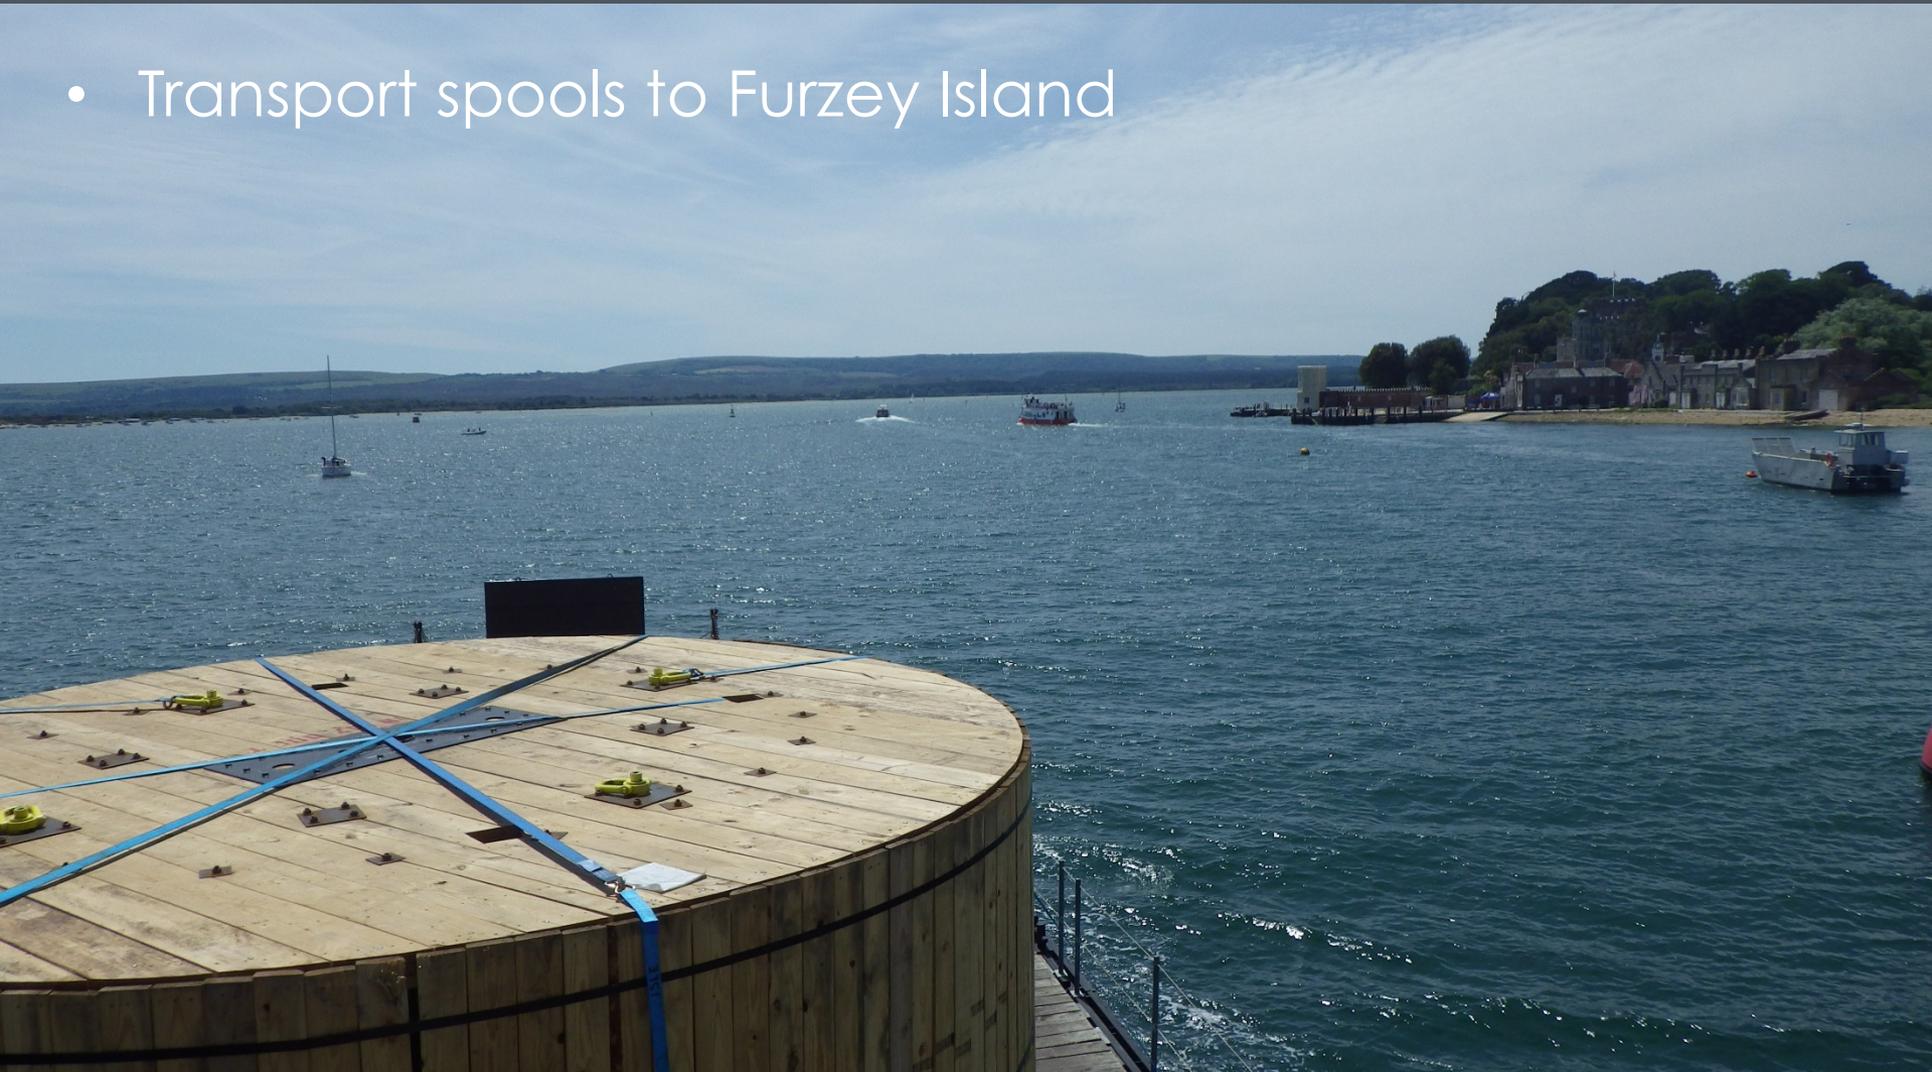
Installation (2/4)

- Transport spools to Furzey Island

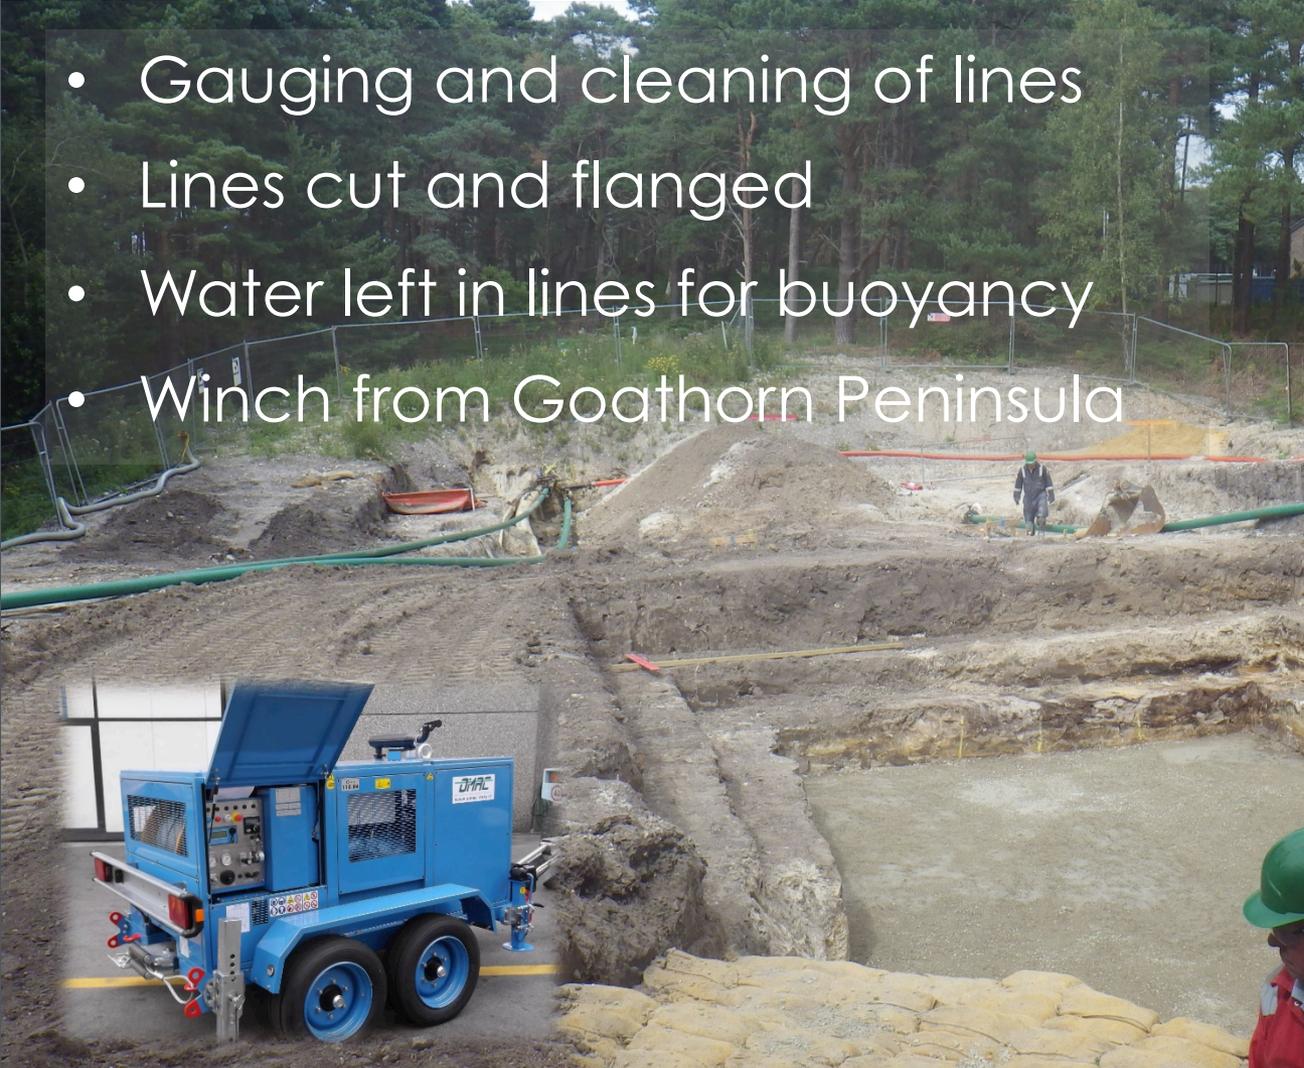
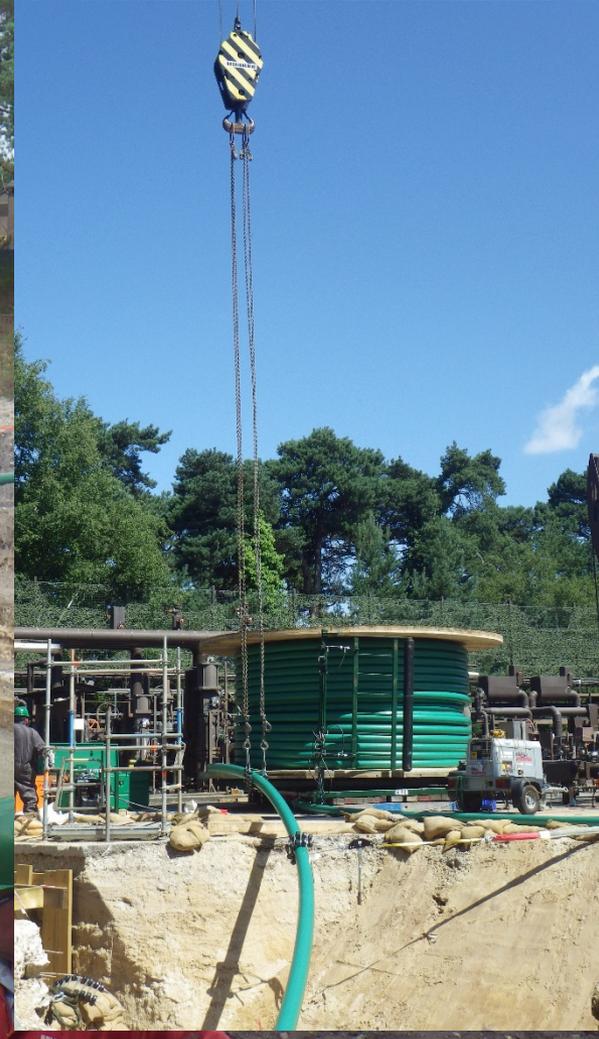
Installation (3/4)

- Gauging and cleaning of lines
- Lines cut and flanged
- Water left in lines for buoyancy
- Winch from Goathorn Peninsula

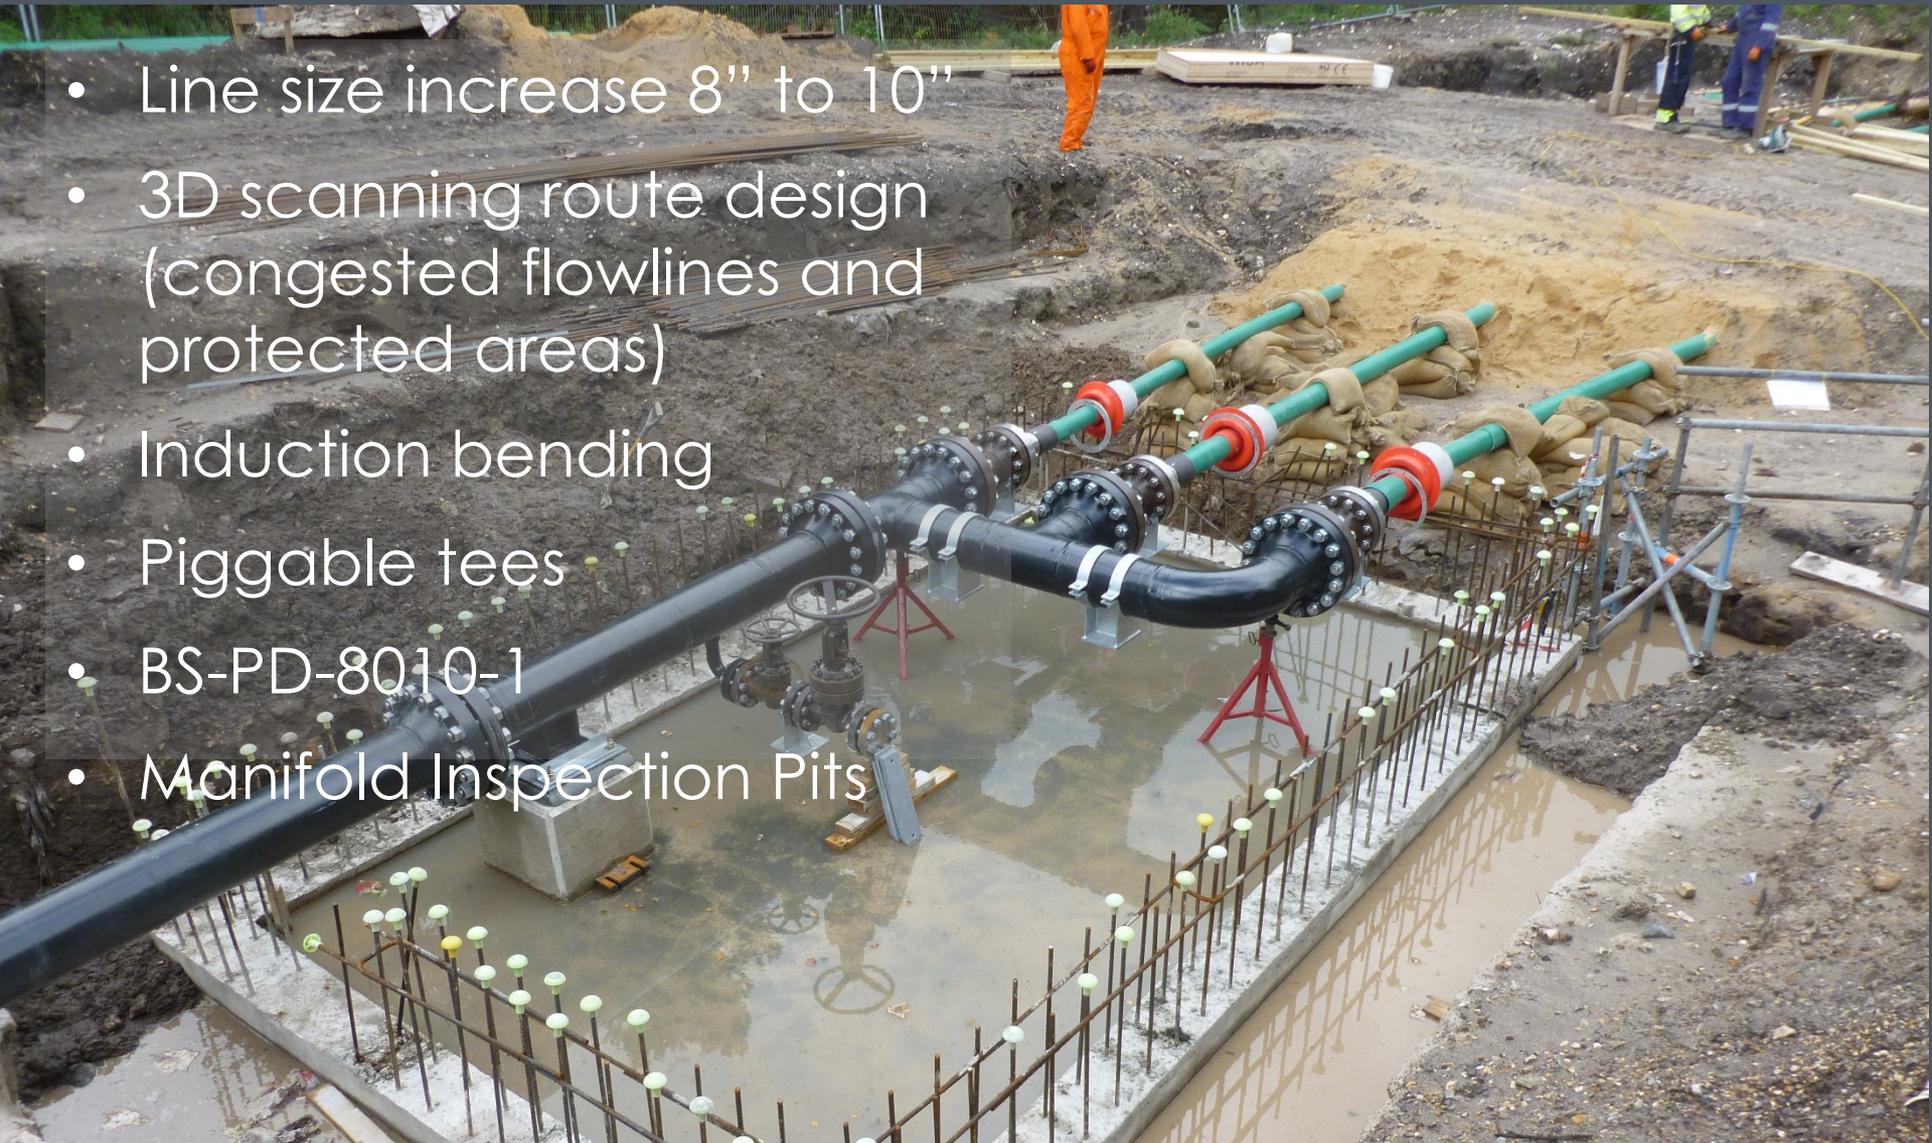
Carbon steel tie in manifolds

- Line size increase 8" to 10"
- 3D scanning route design (congested flowlines and protected areas)
- Induction bending
- Piggable tees
- BS-PD-8010-1
- Manifold Inspection Pits
