# Condensate Pipeline Humber Crossing Free-Span Remediation

UKOPA Meeting Dublin – 27-02-2018

Presented by Paul Hardy  
Centrica Storage Asset Integrity TA

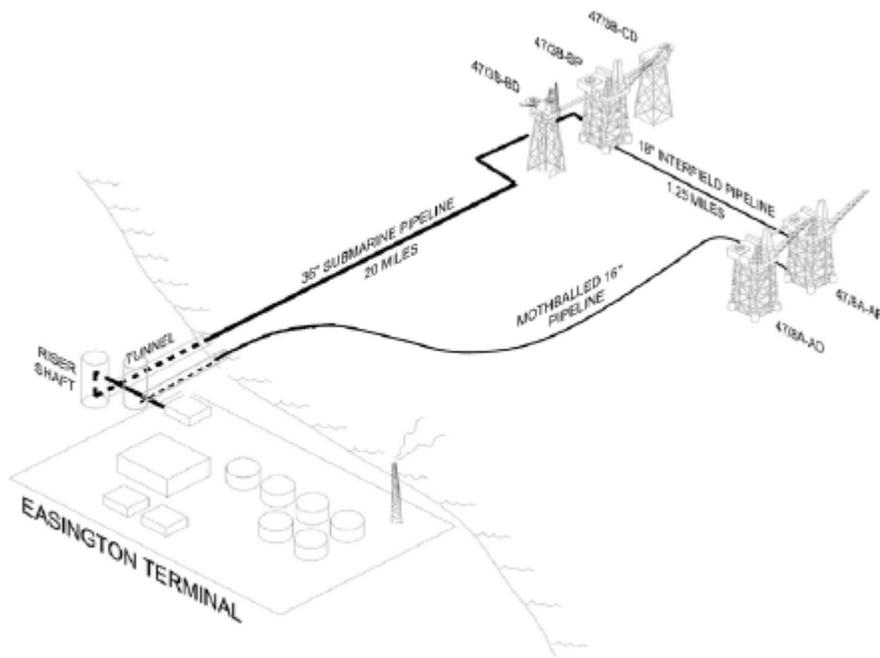
Figure 1-1: Schematic of the Rough Field layout

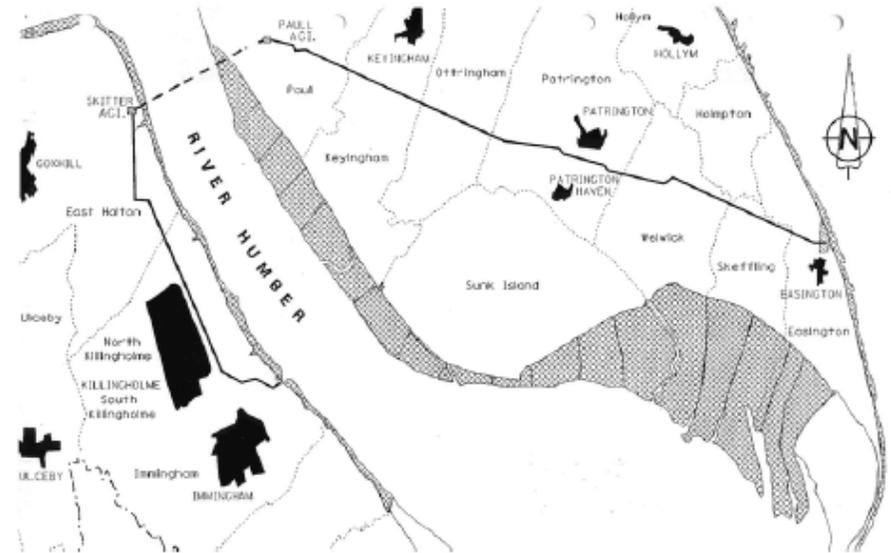
Figure 1-2: 8" Condensate pipeline route

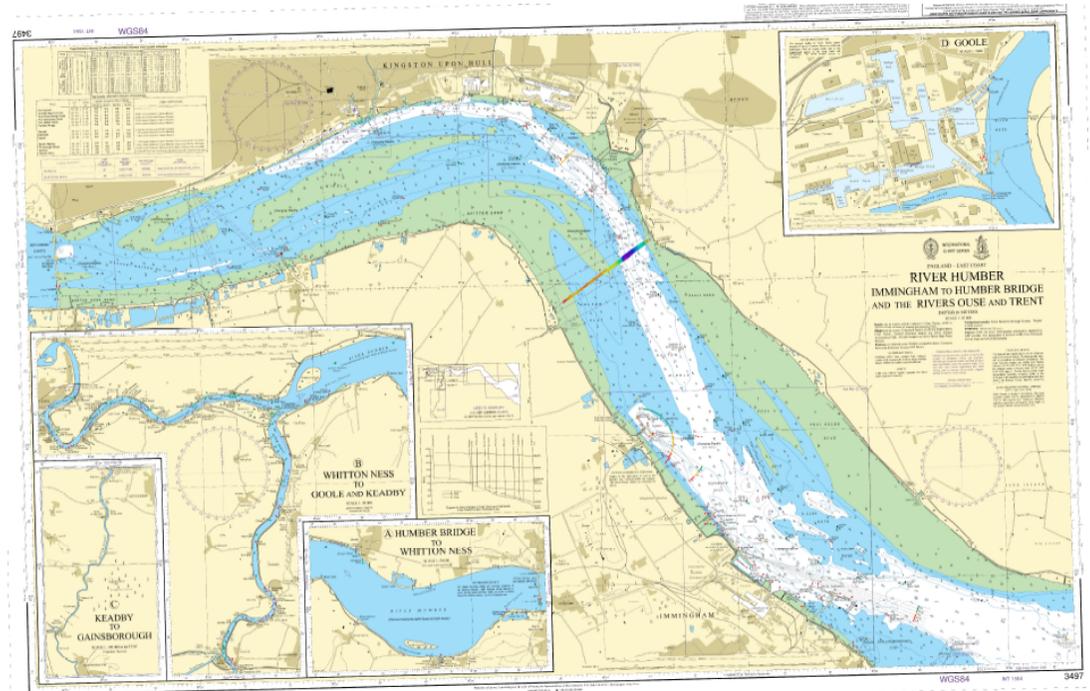
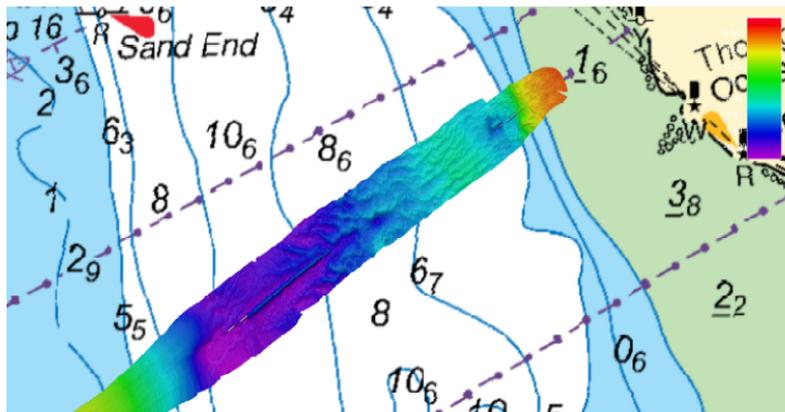
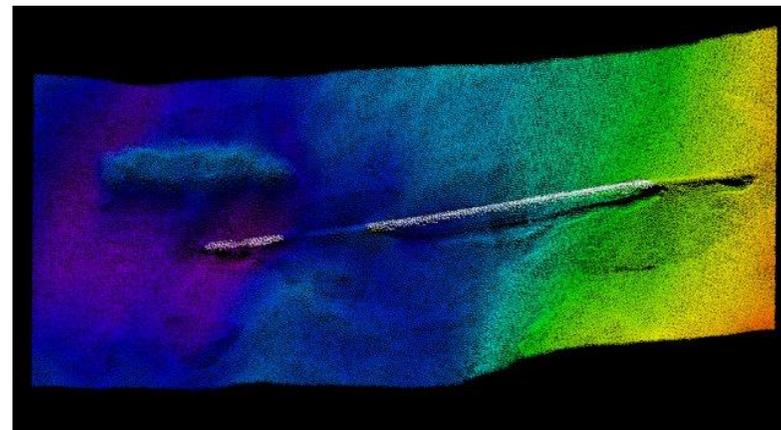
- Paul to Skitter
- UK's busiest estuary
- Work can affect shipping
- Notice to mariners
- Need to minimise duration
- Very fast flowing
- Neap tides best

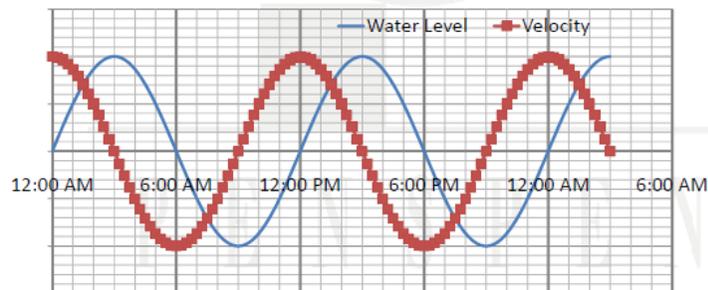
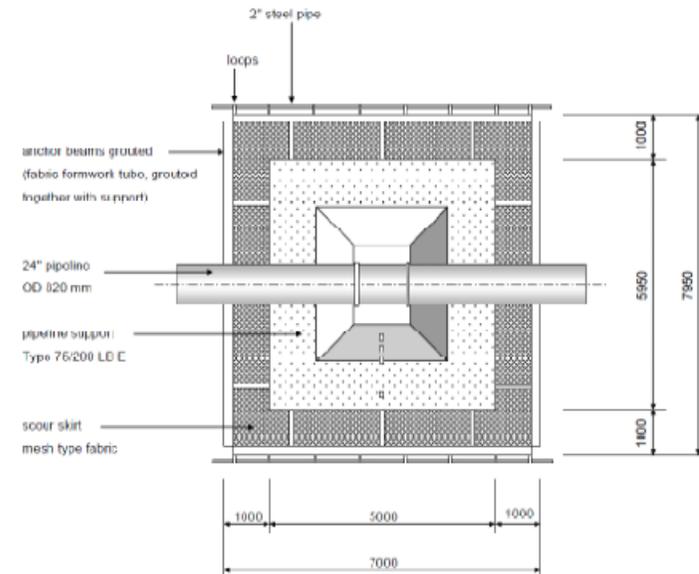
- Pipeline runs in old feeder 1 – 24 inch carrier
- Centraliser clamps at 14 metre centres
- Carrier pipe nitrogen filled
- Carrier pressure monitored via DCS and weekly checks
- Monthly MBES by ABP
- River bed very mobile
- Free-spans and exposures appear and fill back in
- Difficult to project when they will reach acceptance limits for VIV
- VIV limits set via analysis to DNV-RP-F105
- VIV limit probably conservative – pipe within a pipe hard to model
- Latest free-span developed over a few months
- Concern it was in danger of growth via convergence

Acceptance Criteria	Allowable Span Length (m)
Static Stress	50
Onset of In-Line VIV	13
Onset of Cross-Flow VIV	23

Table 3-1: Span acceptance limits

- Initial 2013 design suggestion from Penspen was grout bag
- 28 tonne of cement to fill
- 4.5 hours to pump in – not practical due to currents
- Northern Divers suggested alternative of 4 tonne rock bags – used before

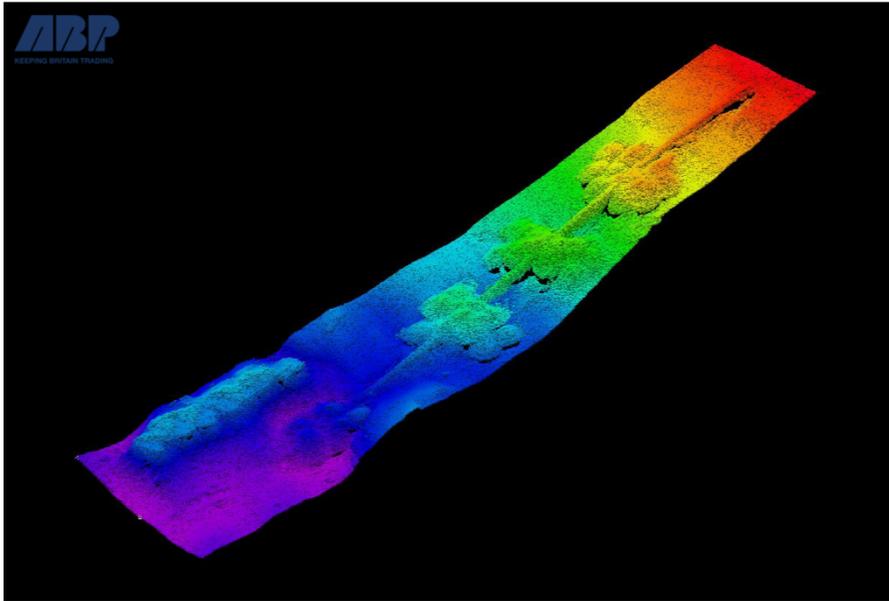
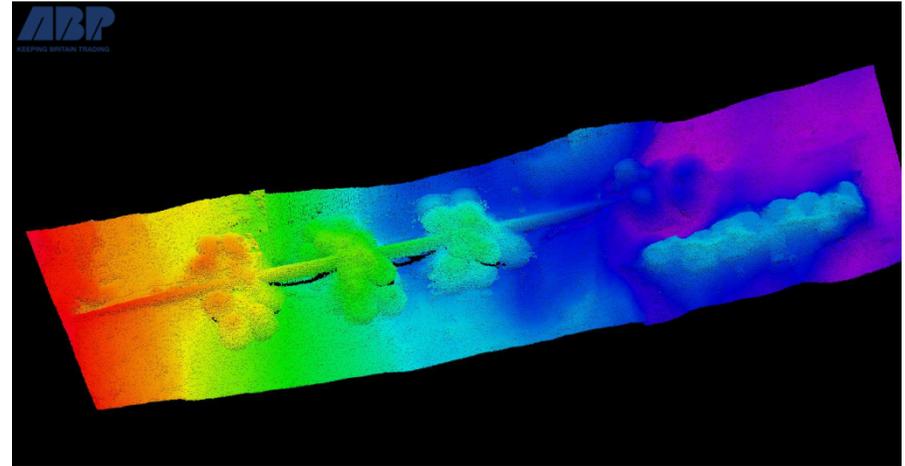
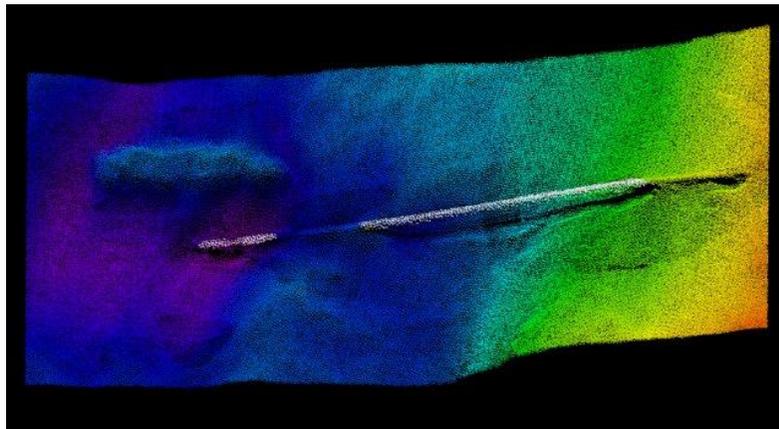
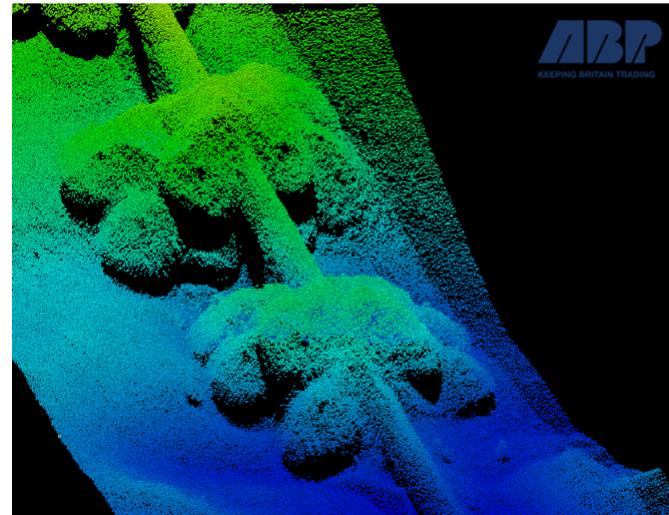
## 2018 Free-Span Remediation – Post Remediation ABP MBES
