# Case Study: In-line Inspection of Buried Large Bore Pipework at Dalmeny Tank Farm

Cameron Millar  
Mechanical Engineer

# Problem Opportunity- Inspection of Tank 801/2 & 807/8 Fill Lines

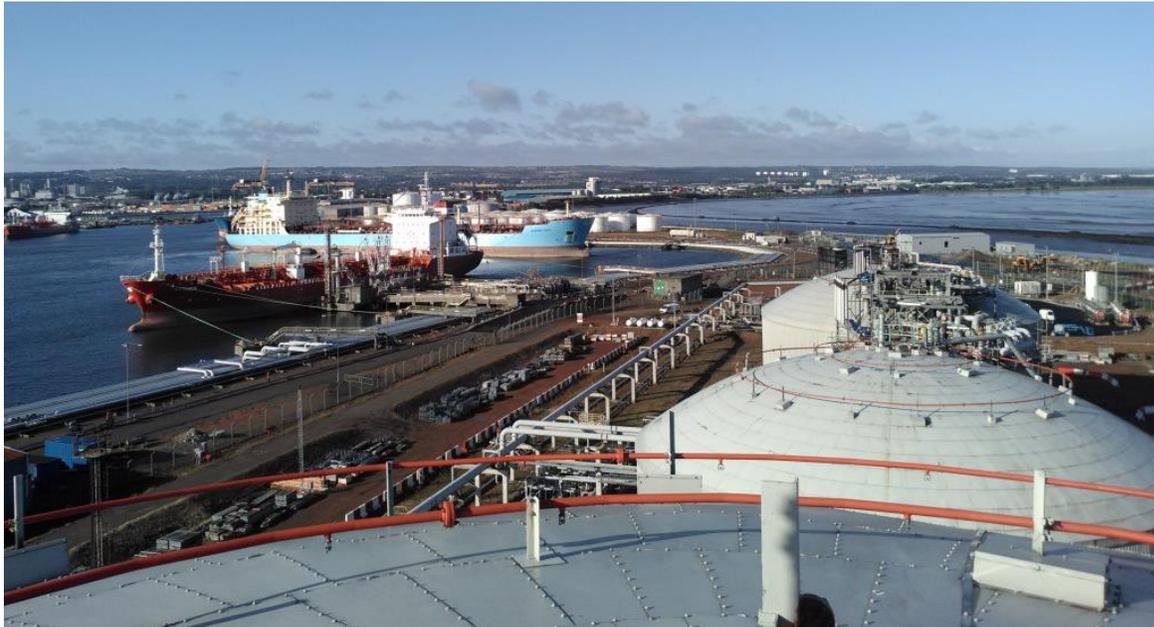
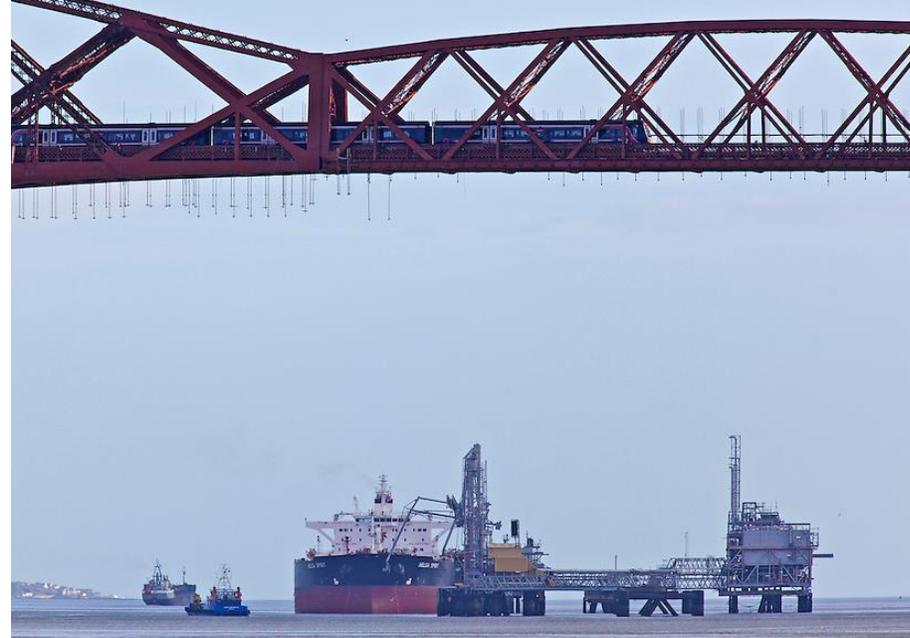
## Dalmeny/ Hound Point (DHP)

- Stores 2.4 Million barrels of stabilised crude oil across four tanks.
- Crude is exported to ships via Hound Point Loading Platform.

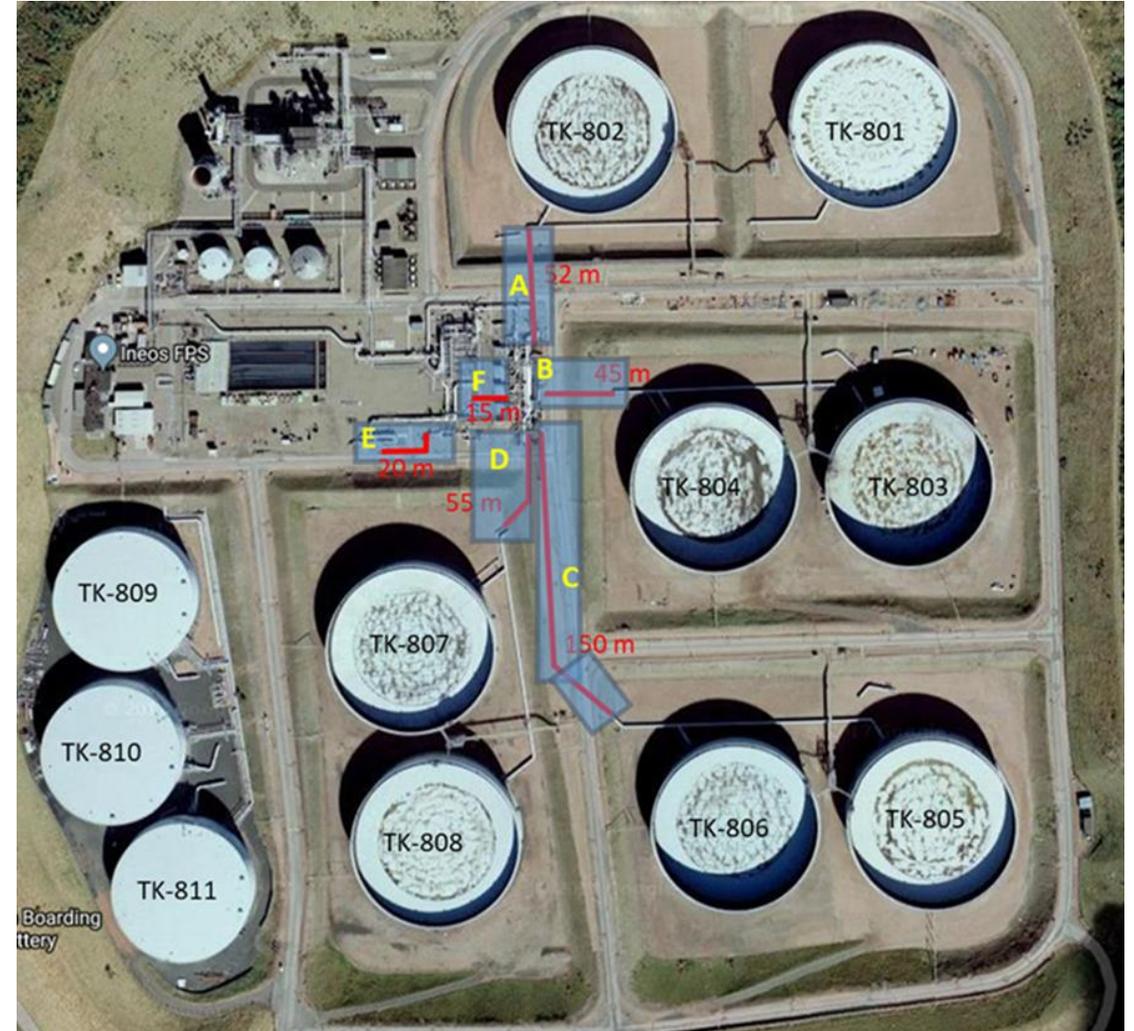
- As part of Dalmeny 2040 tankage strategy, 48" fill lines to tanks 801/802 and 807/808 required inspection for endorsement.
- These lines are buried under critical site roads.
- To inspect lines externally would require excavation at a significant cost and disruption to site.
- Total cost for excavating approx. £1.5m per line.
- To instate new pipework above ground from tanks to MOL sump would require cost of approx. £10m per line.
- Opportunity to inspect pipework internally via in-line inspection tool at a reduced cost.

Tank 802 & 808 fill lines labelled A & D respectively

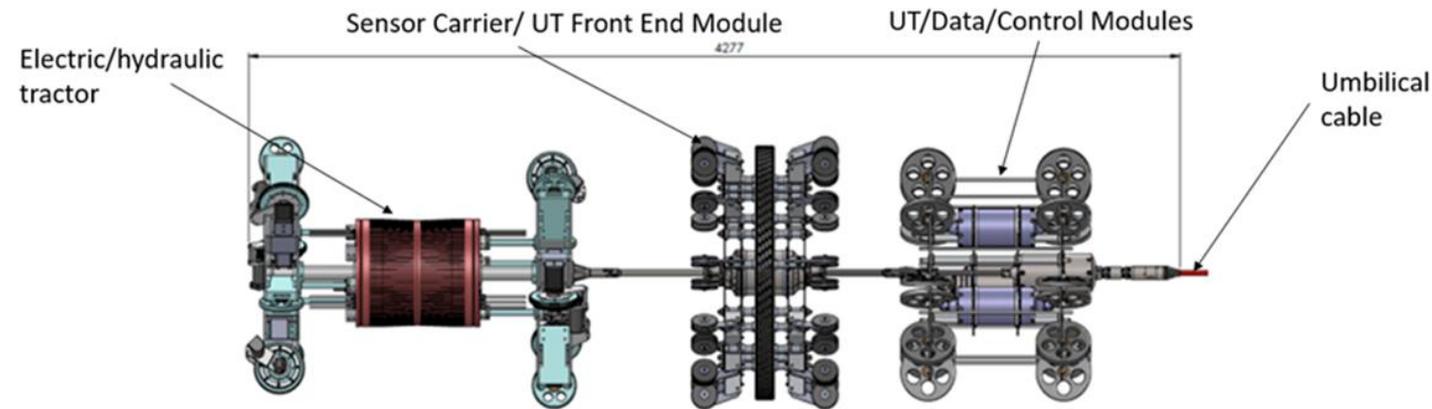
# Rosen Norway 48" Tethered Crawler Inspection Tool

- Vendor selection process undertaken in 2020 to select suitable ILI tool with contract being awarded to KTN.
- Self propelled tool consisting of three modules.
- Captures full circumferential data of pipe via UT sensors.
- Powered via umbilical cable connected to motorised winch.

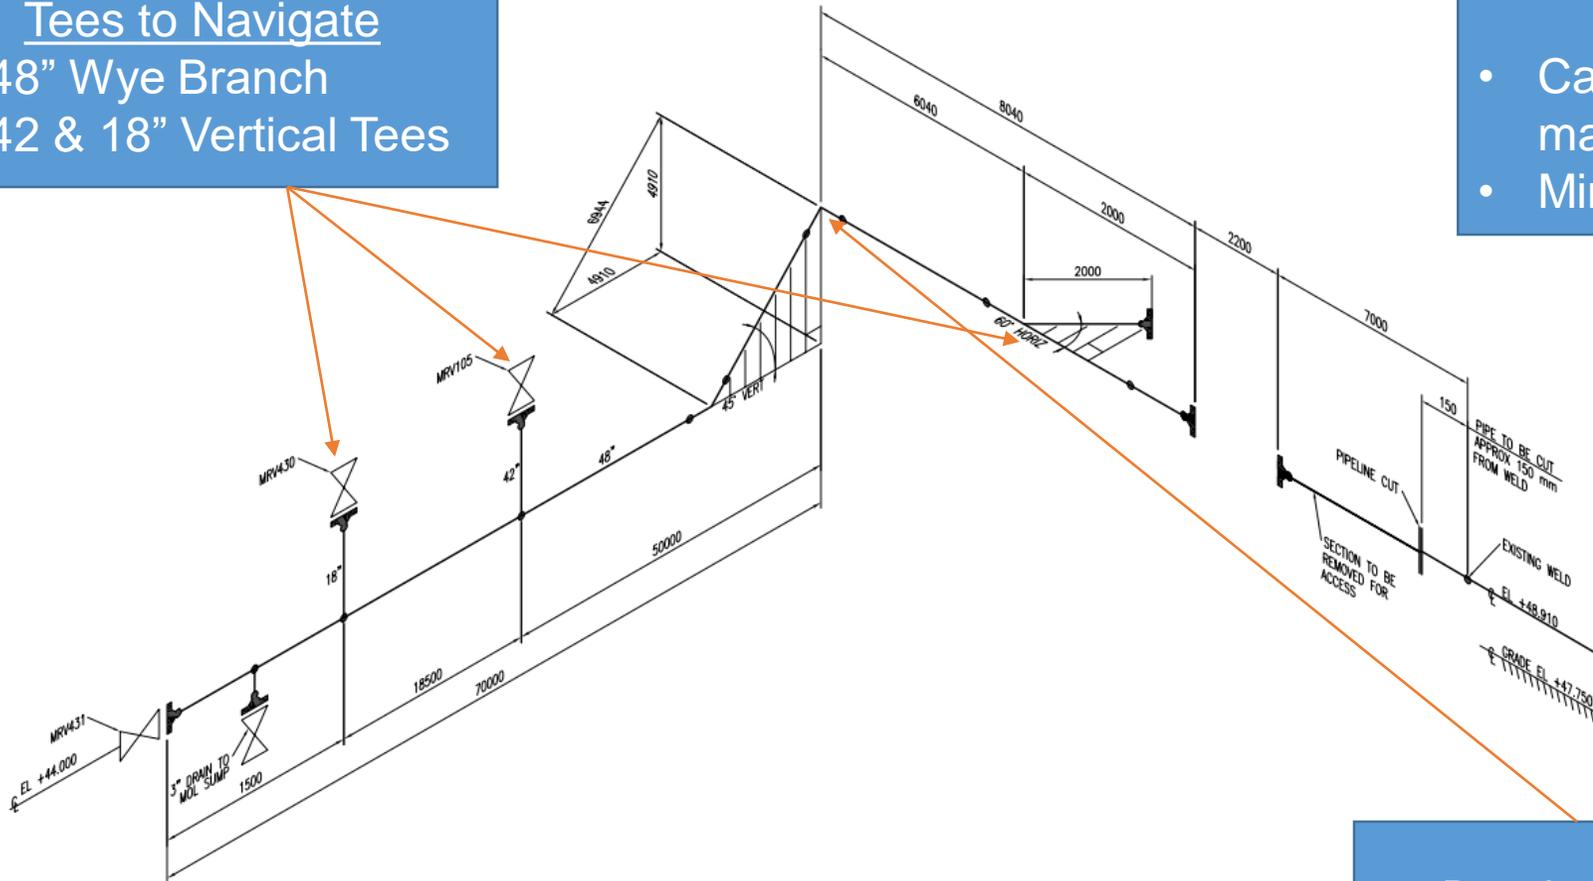
## Tees to Navigate

- 48" Wye Branch
- 42 & 18" Vertical Tees

## Minimum ID

- Calculated from pipe material specification
- Min ID = 1166mm

## Bend to Navigate

- 1.5D min radius

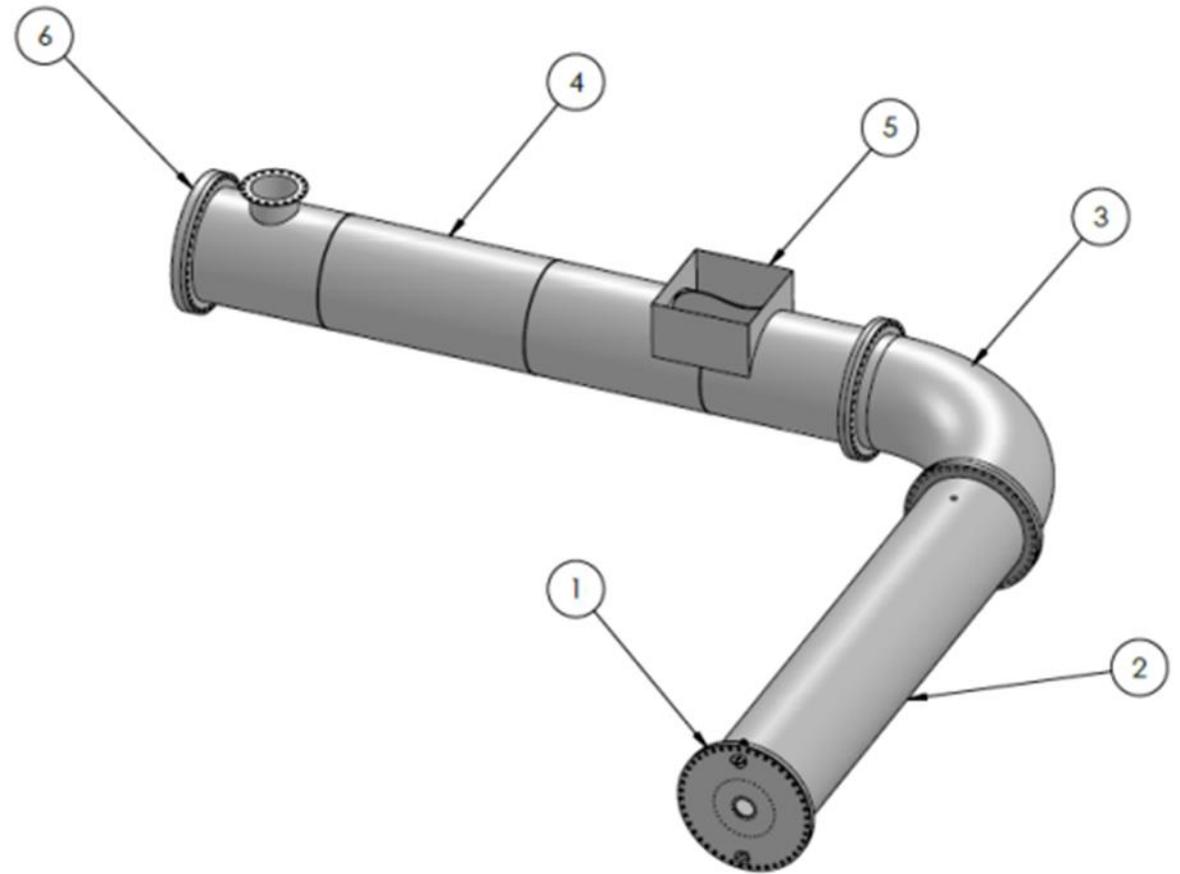
- Conducted at KTN's facility in Norway.
- Detailed testing procedure agreed between KTN & INEOS to verify tool can navigate relevant features.
- Results recorded and sent to INEOS remotely (Covid-19).

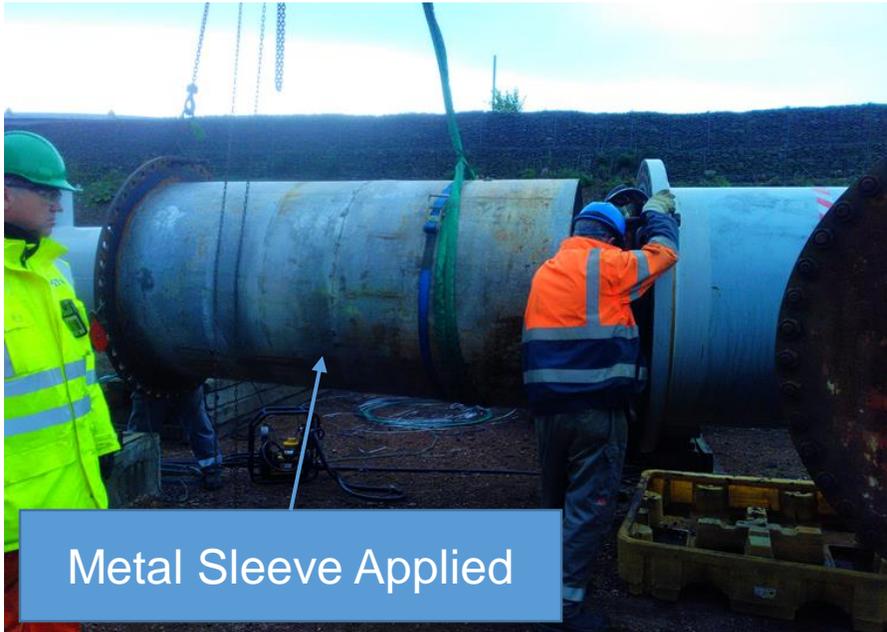
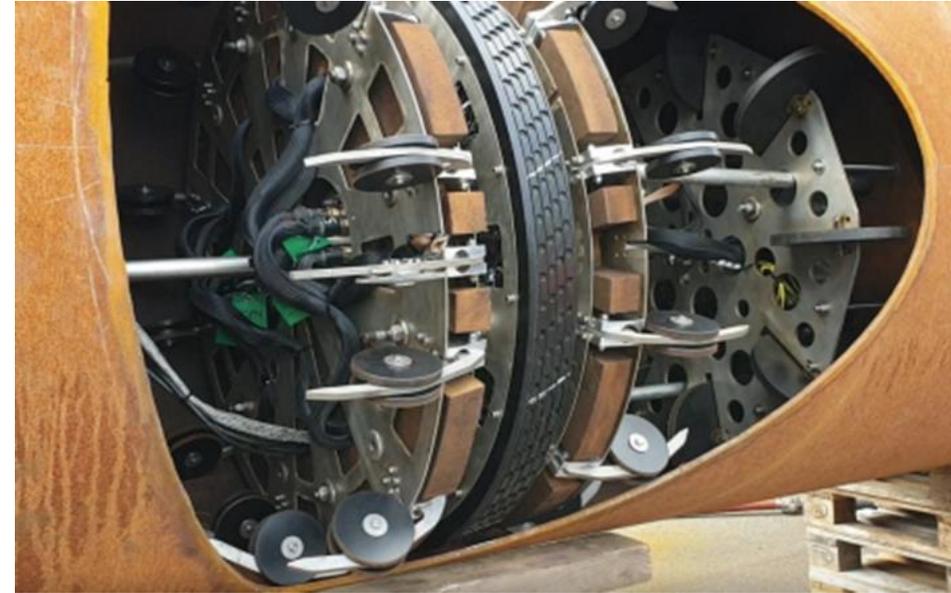
- Tool could not navigate wye branch during FAT for T802 line.
- Spring loaded wheels caught at offtake.

- Last minute engineered solution required for project to commence.

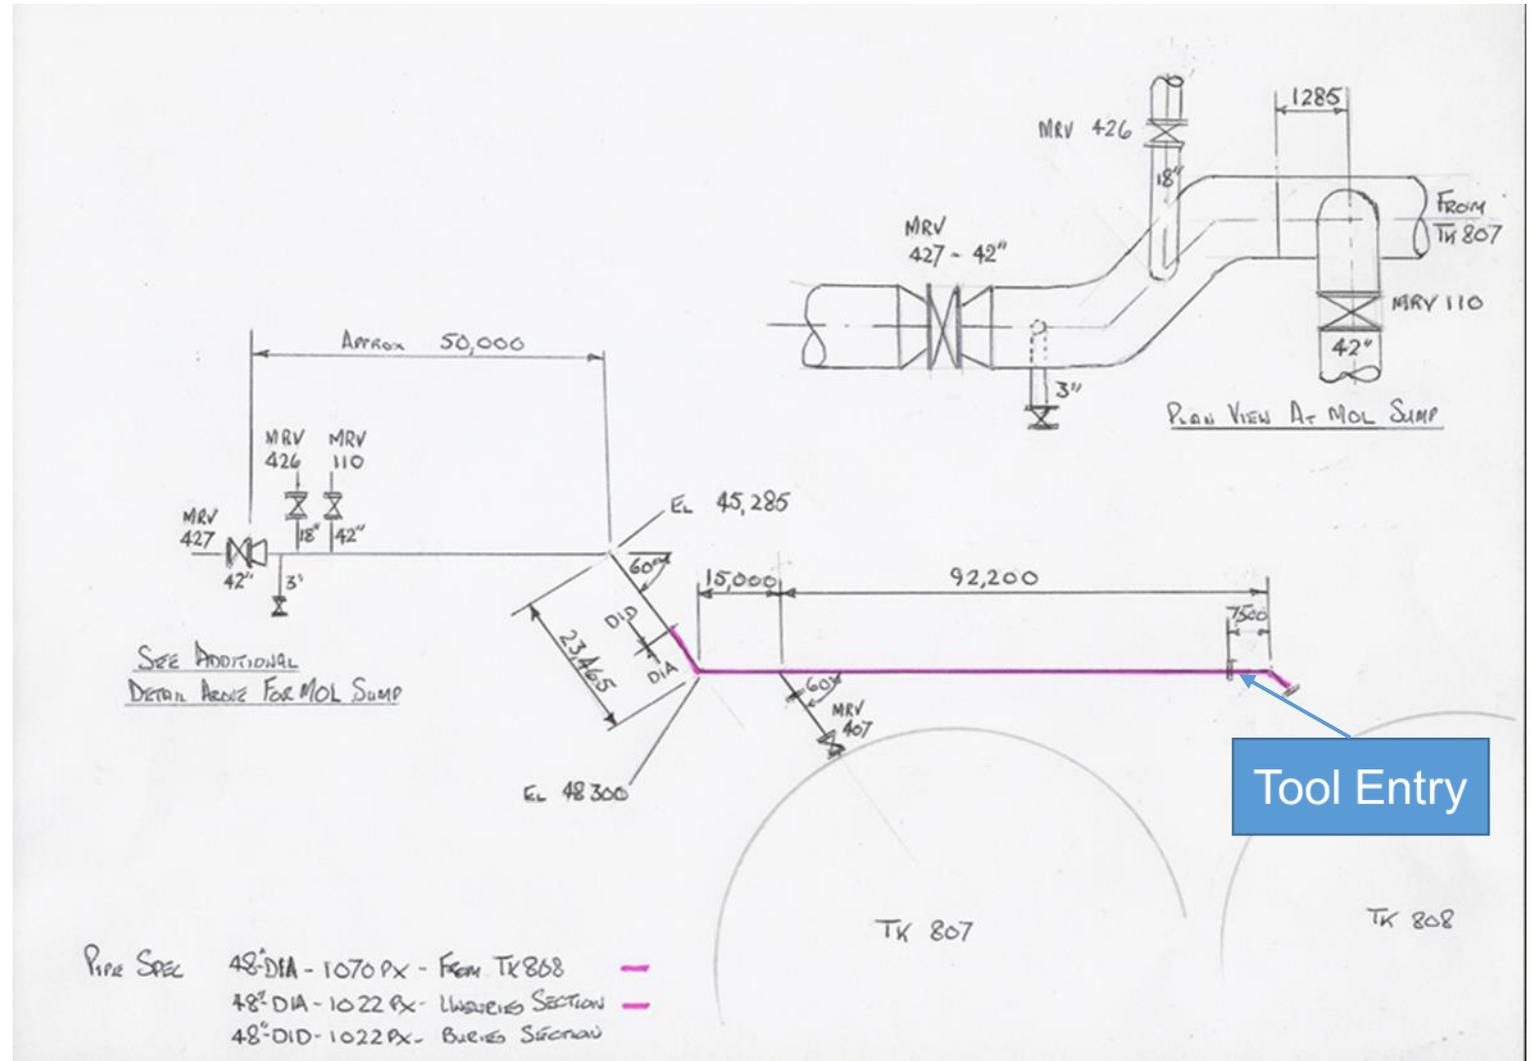
- Tool launch for T807/808 fill line was approx. 90m from wye branch.
- Metal sleeve therefore could not be implemented to bypass branch.
- Requirement stated to KTN and FAT carried out three months before site execution to provide contingency.
- Tool engineered to differentially lock wheels when passing wye branch. Increased torque applied to wheels contacting wall.
- Tool length increased from 4m to 6m.

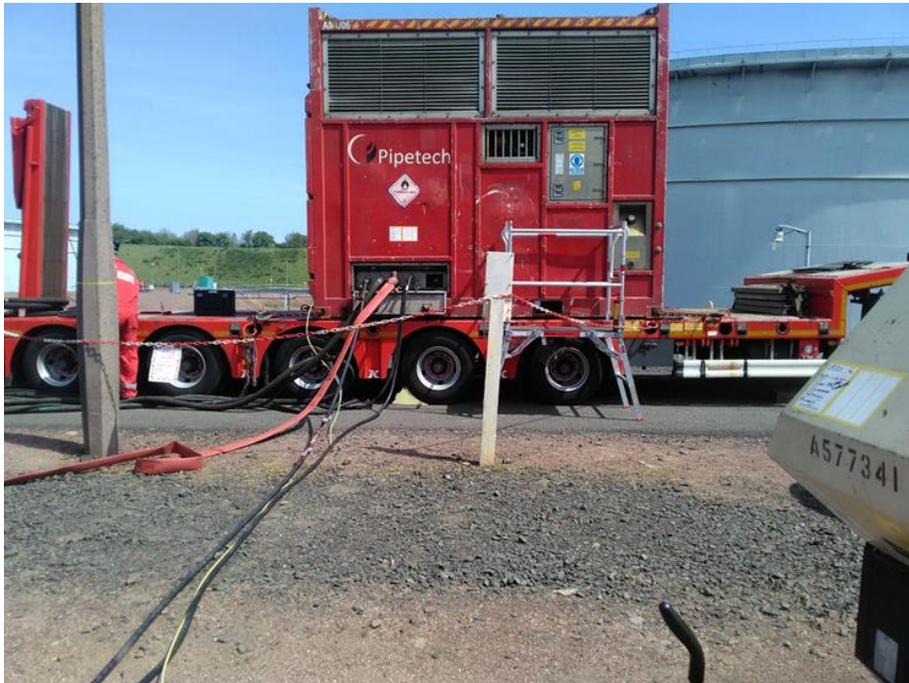
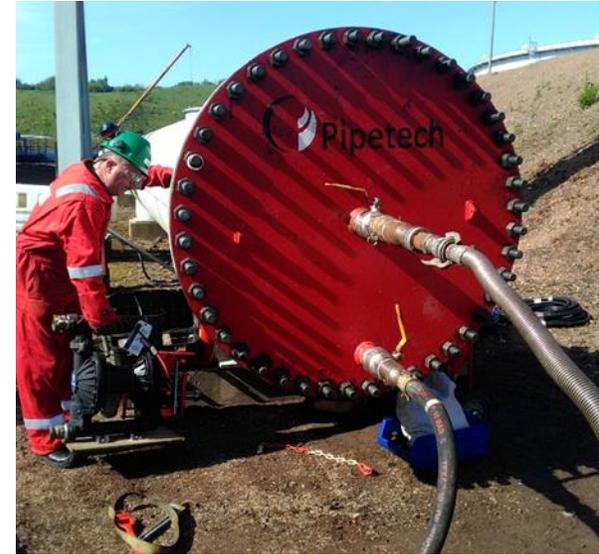
- Utilised Pipetech's Aquamilling System to internally clean the pipework.
- Removed debris and residue from the pipe wall which would impede the tool sensors.

- Relevant permits and controls in place regarding high pressure application.
- Hoses fed into pipe via Entry Point Alignment Tool (EPAT) and discharge water monitored for cleanliness.

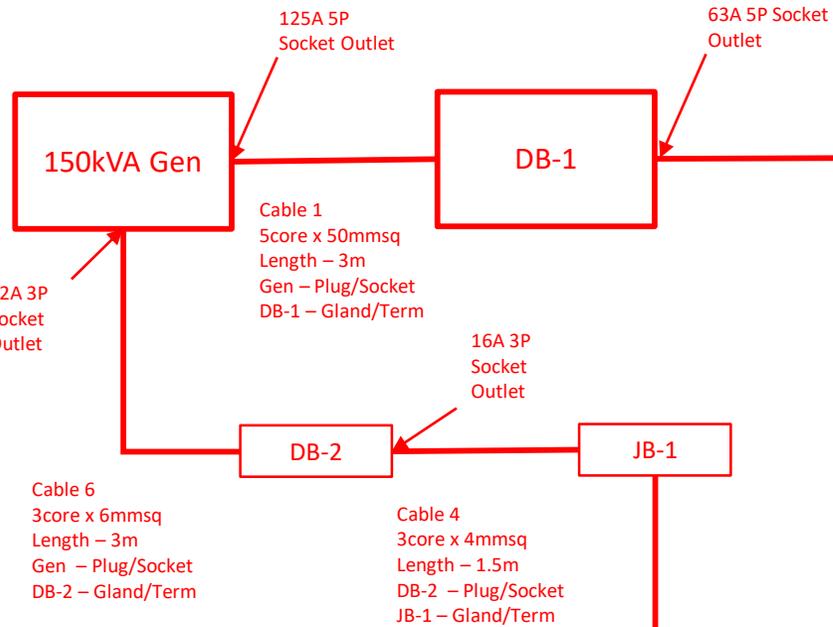
## Perimeter Road (Non Haz Area)

- Voltage - 415V  
Frequency - 50Hz  
MCCB (Schneider Electric NSX250F)
- Long Time Protection Pick Up  
I<sub>o</sub> - 100A
  - Long Time Protection Fine Adjustment  
I<sub>r</sub> - 0.9
  - Short Time Protection Pick Up  
I<sub>sd</sub> - 3

- I<sub>Δn</sub> - 1A
- Delay - 0.06s

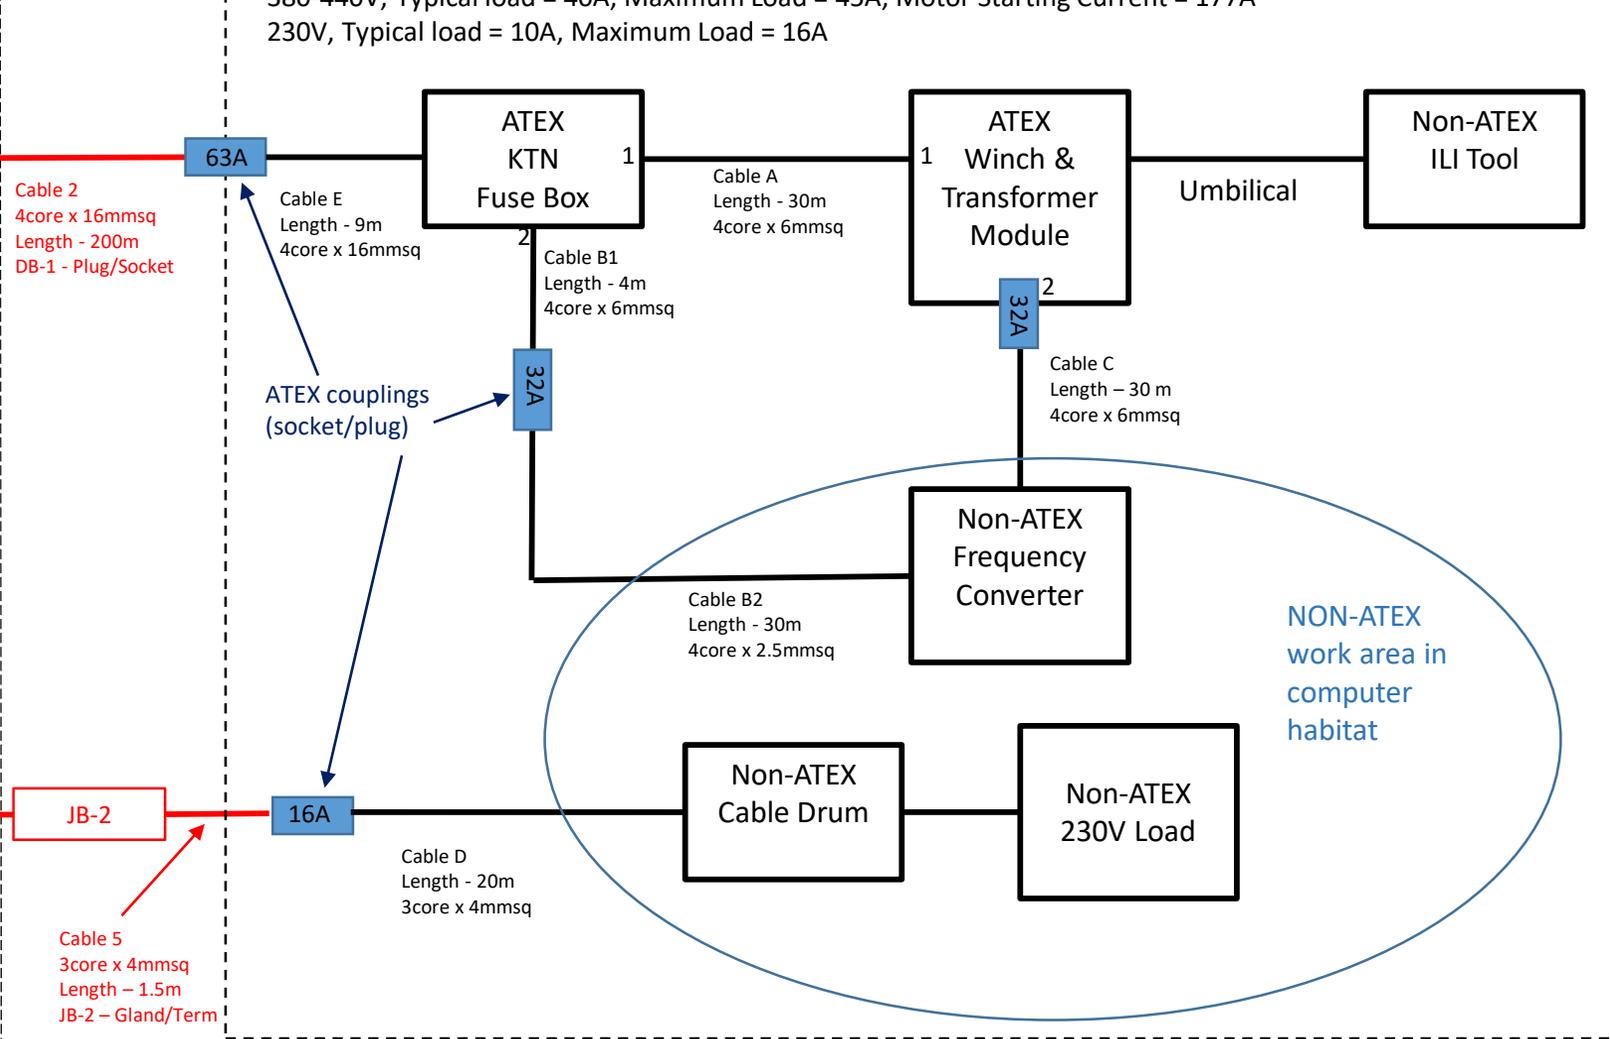
## Tank Bund (Zone 2 Area)

KTN Supplied Equipment  
380-440V, Typical load = 40A, Maximum Load = 45A, Motor Starting Current = 177A  
230V, Typical load = 10A, Maximum Load = 16A

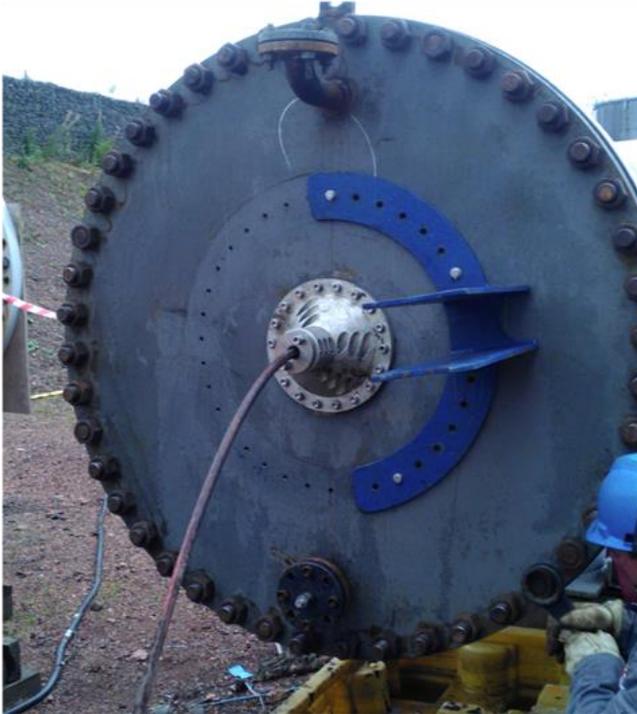
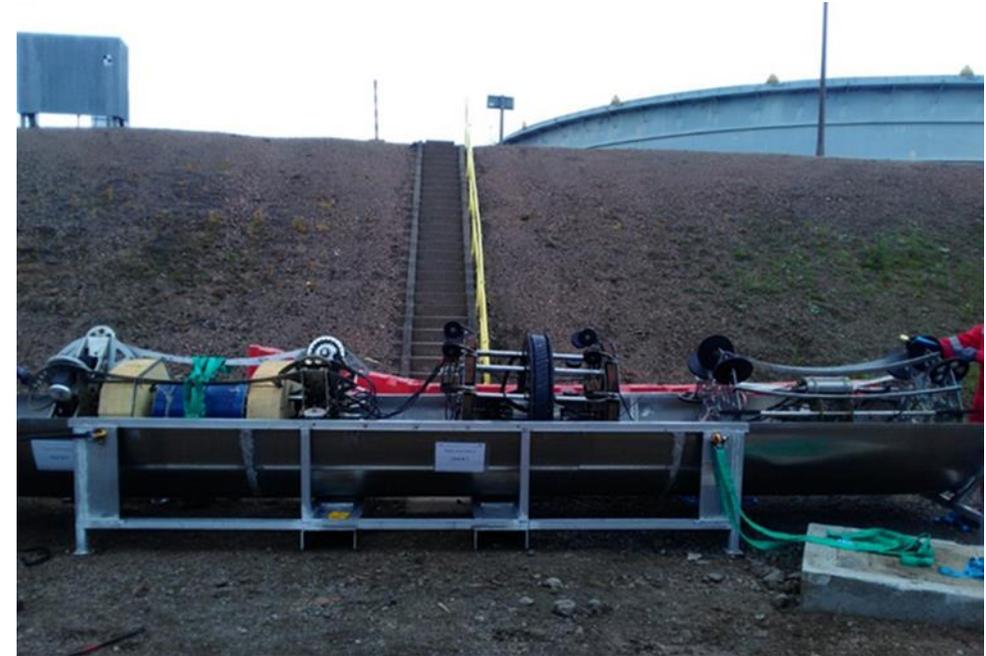
- Mobilised equipment to site.
- Performed relevant checks and certification.

- Tool inserted into pipe and stuffing box flange fitted.
- Pipework water filled; ATEX & UT couplant.

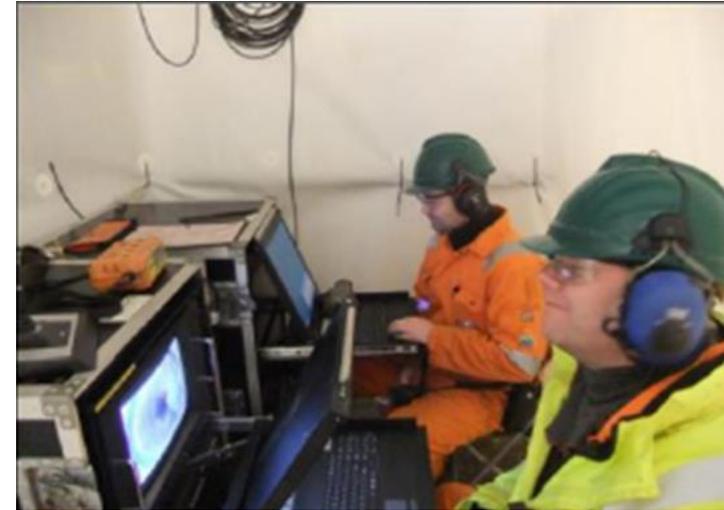
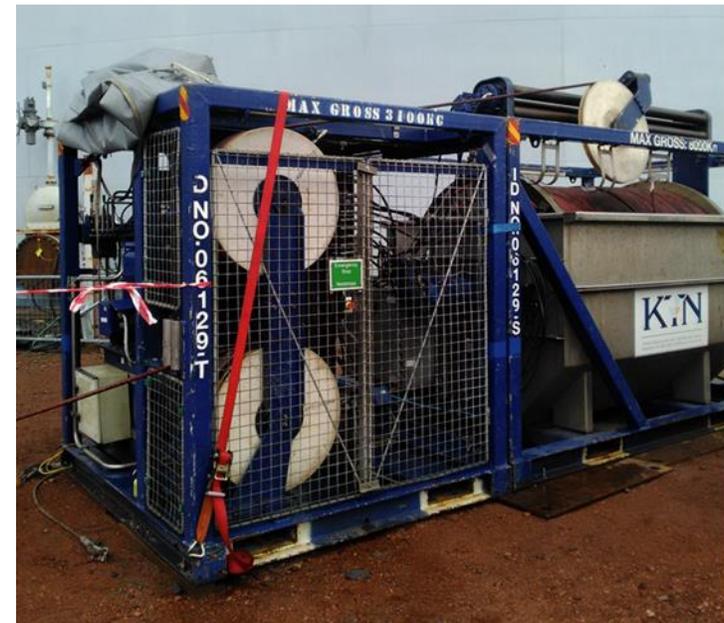
- Tool authorised for use and powered-up.
- Constant data stream to computer habitat. Monitor for tool location.
- Applied communication skills to work alongside non-native English speaking technicians.

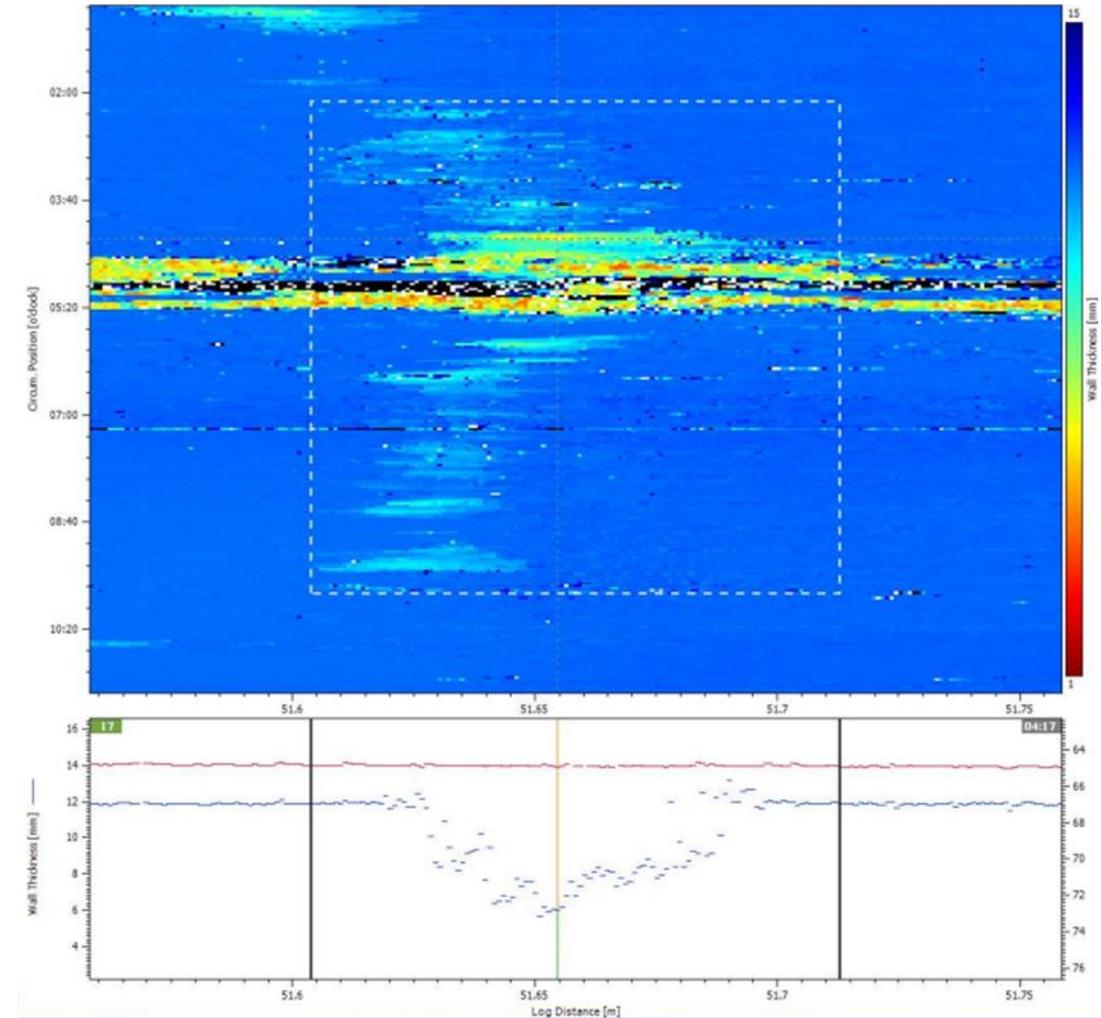
- Tank 802's fill line inspected in October 2020 and tank 808's in June 2021 during full system outage.
- Applied learnings from tank 802 inspection to tank 808. Project delivered ahead of schedule.
- IIs successfully captured 98% of pipework requiring inspection and retrieved required data to assess lines.
- One area of significant corrosion detected on 802 fill line.

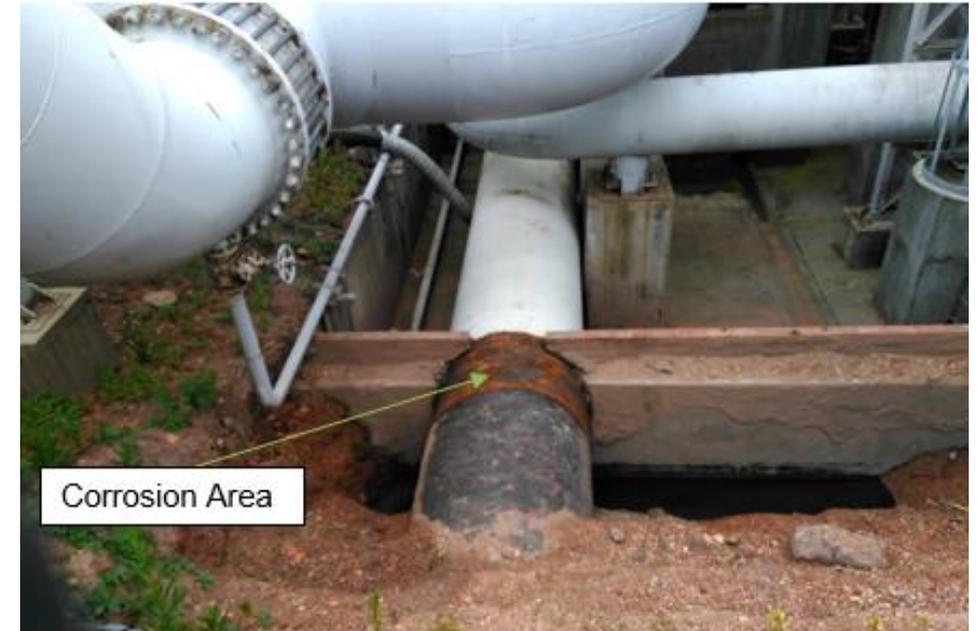
- Area of external corrosion detected on 12 o'clock position of 802 line.
- Corrosion occurred at interface between buried/unburied section.
- Min wall thickness: 5.4mm
- ASME B31.3, Eq 304.1.2 utilised for assessment.

$$t = \frac{0.91 * 1219.2}{2(138 * 1 * 1) + 2(0.91 * 0.4)} = 4mm$$

Existing wt 5.4mm > 4mm so pipework is safe to operate. Consider composite wrap repair to mitigate further external corrosion.
