United Kingdom Onshore Pipeline Operators' Association

Mechanical Properties and Weld Quality of Vintage Seam-Welded Pipe

MSc Student: Carrie Tagg

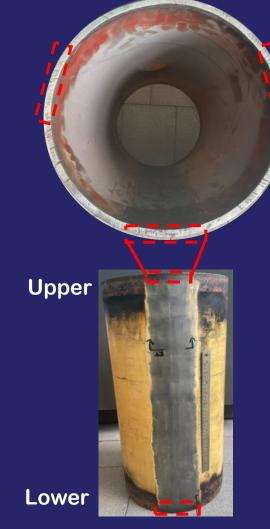
- Extraction of samples from 5, 7, 12'o'clock
 - Upper 10mm x 15mm x 100mm
 - Lower 10mm x 30mm x 155mm

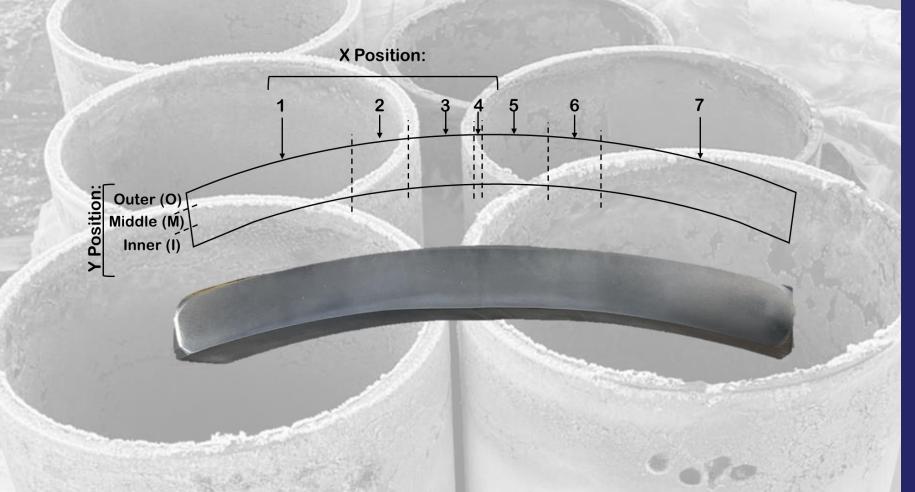
What do the labels mean?

1&7
2&6
3&5
should have similar
microstructures

e.g. W-XPos1-YPosI = Welded Sample in X-axis Position 1 and Y Position Inner

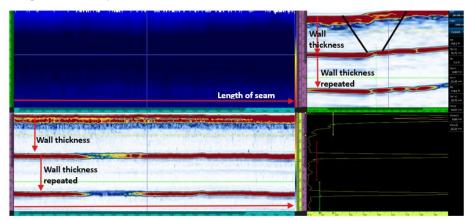
0 Degree Phased Array Data

Phased array ultrasonic testing PAUT (Oceaneering, Swansea)

No notable defects found using PAUT

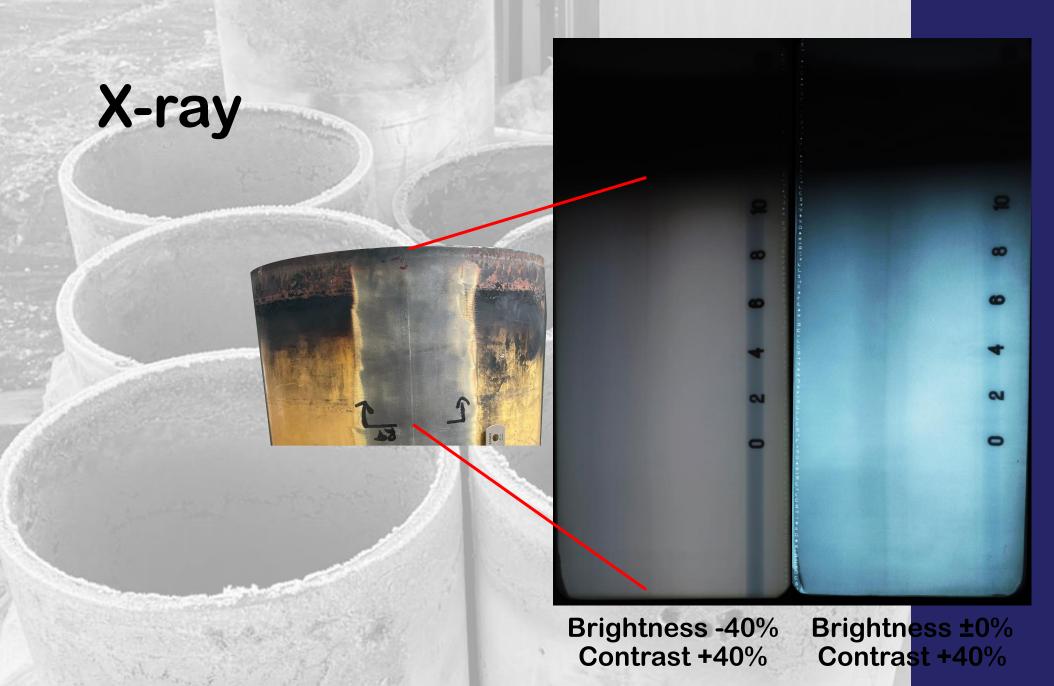
No notable defects found using X-ray radiography

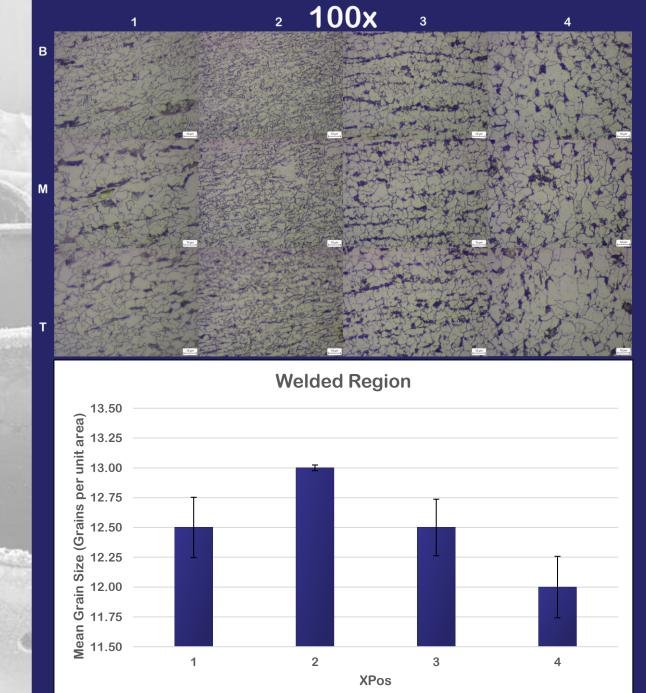
Grain size was calculated using MLI with standard ASTM E 112-13 on Zeiss ZENcore software

- 1. Parent metal
- 2. Fine grain HAZ
- 3. Coarse grain HAZ
- 4. Weld

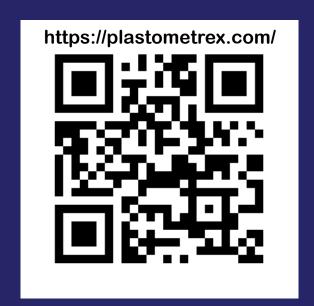
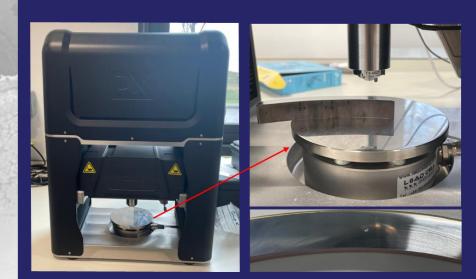
PIP

"Profilometry-based indentation plastometry" Capabilities:

- Test diagnostics e.g. surface roughness, tilt, target and measured load
- Work hardening detection
- Residual Indent
- Load-displacement
- Stress-Strain (including YS, UTS, Elongation)
- Anisotropy check
- Profilometer Alignment Check
- Brinell Hardness
- Generate reports

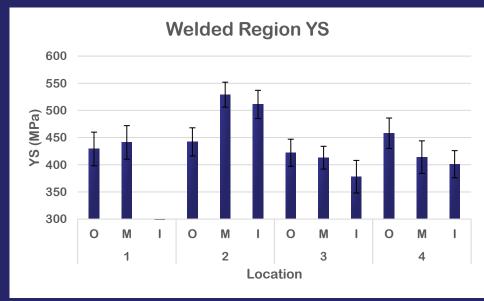
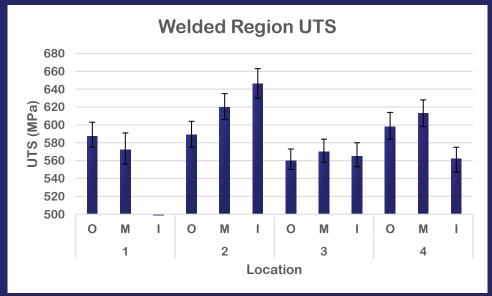
Test diagnostics indicate intermediate and severe anisotropy.

When severe anisotropy is detected, stressstrain data is not given for that data point.

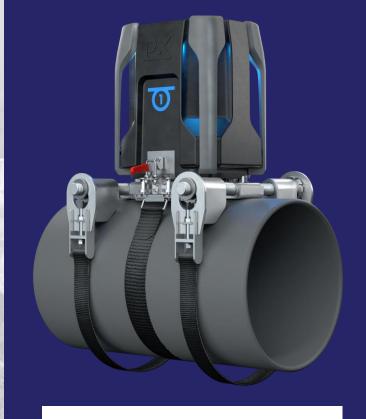
Plastometrex have developed a portable tester.

"[...] PLX-Portable delivers reliable stress-strain results quickly, non-destructively, and in-situ, with report-ready pipeline material verification data available immediately[...]"(3)

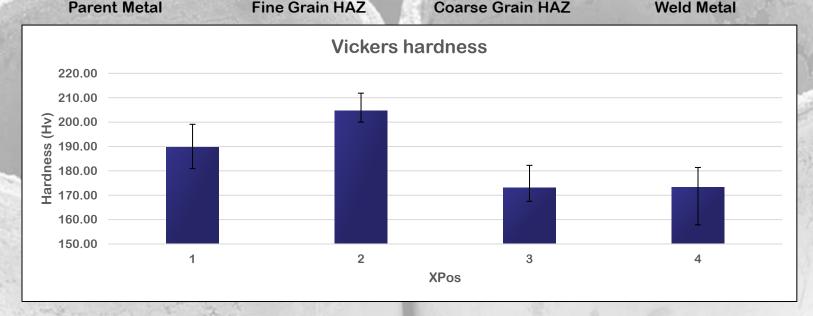
Each zone was tested in a 5x5 array with 1mm separation

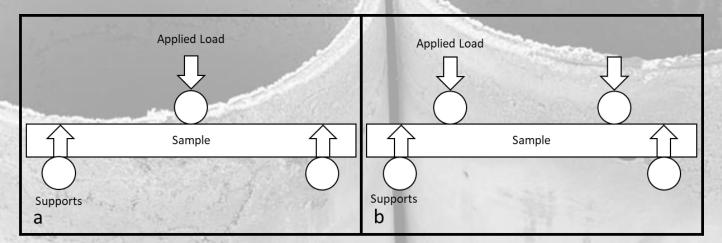
- SolidWorks model
 - Estimation of roller spacing
 - Behaviour prediction
- 4-point bend test
 - Test curved sample
 - Stress distribution similar to hoop stress

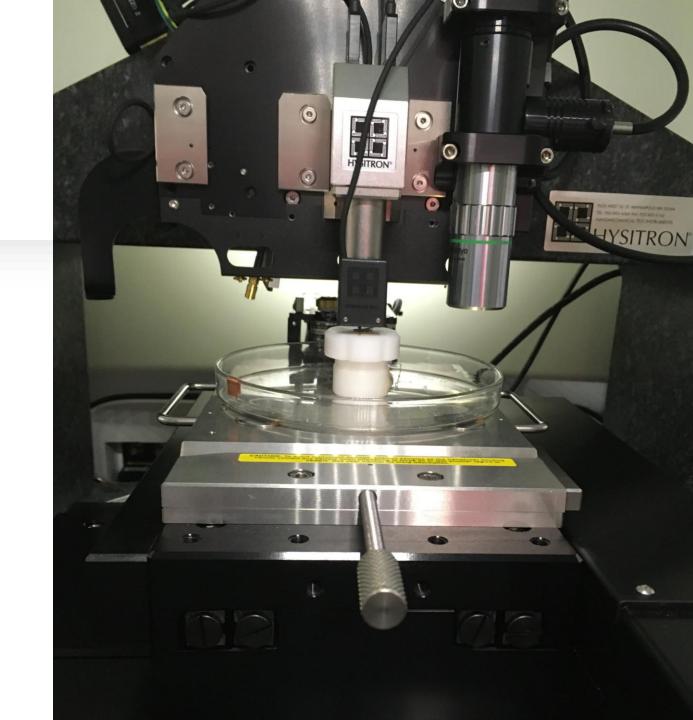
- Modified charging cell
 - ElectroChemically charge samples in-situ
 - Issues with compliance
- Correct trends observed in comparison to tensile data
- Pre-charged samples also investigated
 - Good correlation to tensile data

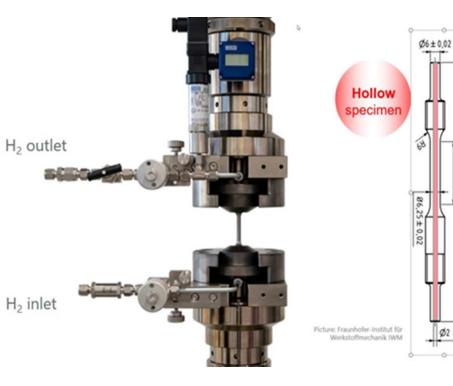
Electrochemical Hydrogen Cell

High temperature capability via induction heating

Gaseous hydrogen environments including high pressure (150 bar hollow samples),
