AGI Inspection

UKOPA Technical Seminar

February 2025

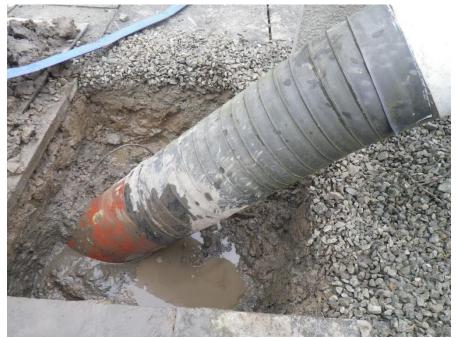
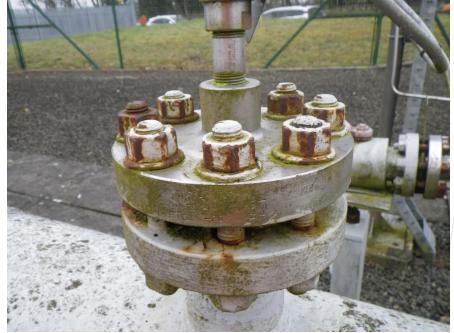
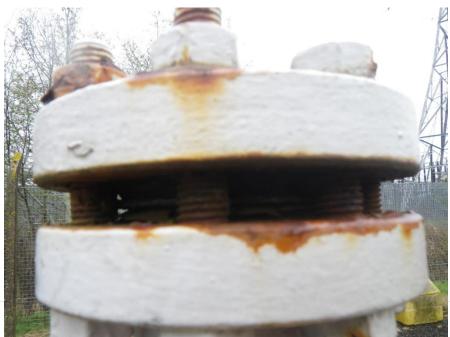
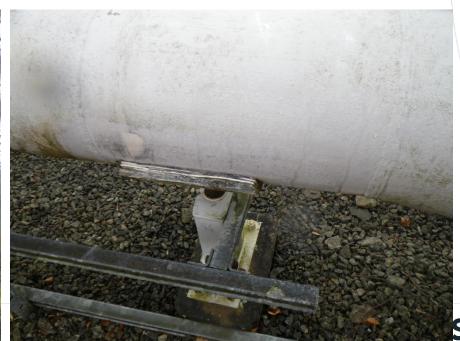
- Internal Corrosion
 - Deadlegs / Low Flow
 - Sour service
- External Corrosion Mechanisms
 - External corrosion paint breakdown from general weathering
 - Soil-to-air interface corrosion
 - Flange face crevice corrosion
 - Galvanic corrosion SS instruments to CS pipework
 - Corrosion under pipe supports
 - ...plus many others, your responsibility to define and ensure inspection coverage

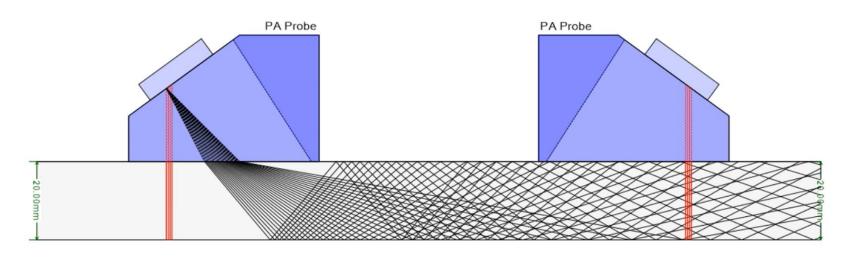
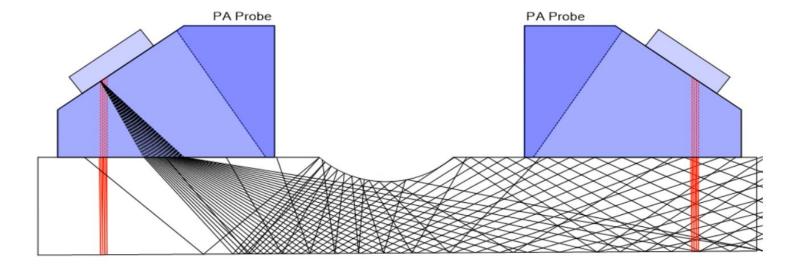
PA-CAT = Phased Array Composite Angle Technique

- Phased array ultrasonic technique
- Based on signal attenuation between two probes
- Good material minimal sound attenuation
- Corroded material amount of attenuation recoded based upon severity of wall loss
- Data quality of great importance
- Algorithmically analysed by online subscription modelling software

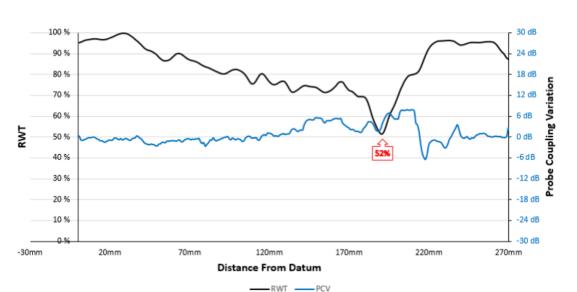
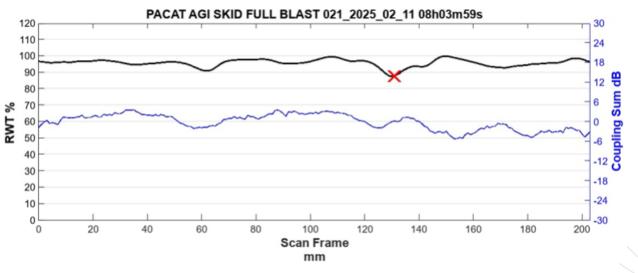
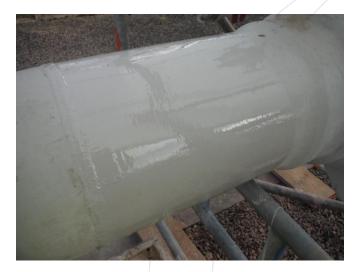
Issues we faced

- Uneven paint surfaces
- FBE coatings (transition from FBE to painted)
- 4mm loss under one support
 - Followed up and found to be attenuation issues from the silicone giving losses
