SAFETY ALERT

'EYE didn't check the spindle speed'

Visor was no guard against "bullet" force of flying disc

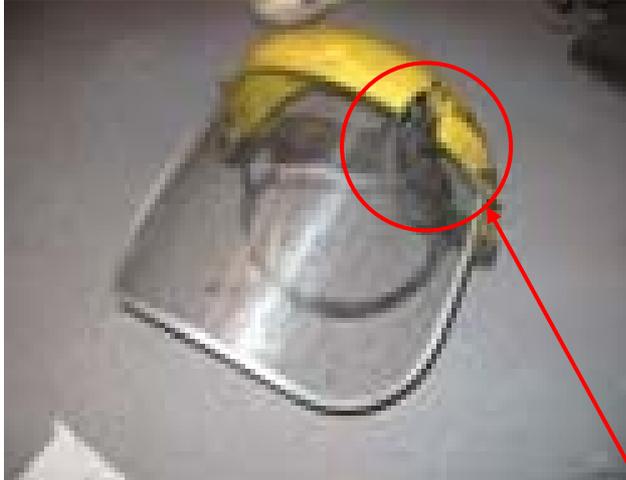
Instead, Weldex gave him a home-made adaptor that allowed him to attach a four-and-a-half-inch disc to the grinder. Although the maximum speed for the disc was supposed to be 10,000 rpm, the grinder was operating at 28,000 rpm, making it far more likely to rupture.

HSE inspector Martin Baillie, who investigated the incident and prosecuted it in court, told SHP that as soon as Mr Fielding started work, part of the disc shattered, flew up into his helmet, penetrated the visor and entered his left eye, in which he is now blind. "Any disc of that size should be guarded, and you can't expect a visor to offer protection, as the centrifugal forces engendered by the over-sized disc are far too great," the inspector remarked. "It was like firing a bullet into the visor."

- **Always ensure you have the correct tool for the job. The spindle speed on the abrasive wheel must never be exceeded above the maximum RPM**
- **Operatives must be trained to use grinders with additional training required to mount abrasive wheels**
- **Always ensure you have the correct PPE. Check your MS/RA**
