Damage and failure of a propylene pipeline offsite caused by a 3rd party

CH/2010/AW/03

FIM #455254

Feb 2010

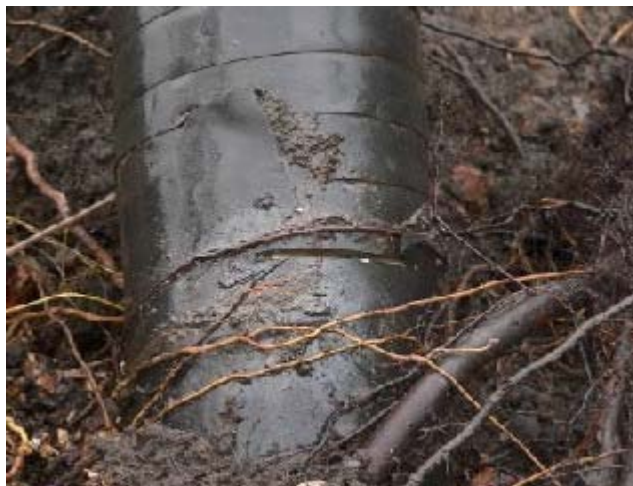
On the 2nd December 2009 a pipeline used for the transportation of propylene from a jetty to a storage site, routed through privately owned land, was cut through by a 3rd party contractor using a petrol driven disc cutter (see photograph below). The work being undertaken was site clearance involving extensive excavations and the removal of redundant underground pipes and cables within a former tank farm site owned by a 3rd party. At the time of the incident the line contained propylene at approximately 9 bar pressure. There was a release of an amount of propylene but no one was hurt, nor was there any fire. The only damage was to the pipeline. The contractor recognised what had occurred and notified the operator and the pipeline was isolated immediately and made safe. A few months before this incident the contractor had inadvertently cut through the water supply line and the 415 V and telecoms connections to the jetty on two separate occasions.

- The contractor failed to employ an adequate risk management process to ensure the pipeline was not damaged. The Risk Assessment had not been communicated to the workforce and there was no hot work permit in place.
- The original developer (who had engaged the contractor) had been provided with drawings of the pipeline and was aware that it was planned to divert this pipeline to allow the final development to proceed. The contractor, though aware of the pipelines, had no site drawings available on site indicating the underground pipelines or cables.
- The contractor had not formally advised the pipeline operator of any work that they were planning to do in proximity to the pipelines where the incident took place.
- The route of the propylene line had been

identified and physically marked above ground before any land clearance had started. However the markers were short wooden pegs painted yellow at the top with no signs attached. An exclusion zone around the pipeline had not been definitively established.

- Raise the contractors awareness of the risks of underground pipelines. The following web link provides a useful awareness DVD 'Utilities and Contractors' produced by the UK onshore pipeline association.
<http://www.ukopa.co.uk/pipeline-safety-excavation.html#G>

- Maintain a single register of all pipeline records handed over to site developers or contractors working in proximity to underground pipelines.
- Visit the pipeline route within any development site and verify awareness in the contractors organisation of the pipelines and the potential risks.

- In the area of live pipelines on a development site establish a fenced off area within which additional levels of risk control are employed
- All temporary marker pegs or fencing indicating the location of buried pipelines in the vicinity of any new construction works should have a specific pipeline warning notice attached to them. Be aware of any redundant markers on a site, which are no longer applicable and request their removal.
