UKOPA SAFETY ALERT

HSEQS FEEDBACK NOTICE Return of Experience

Potential for electrocution – Pipeline Transformer Rectifier

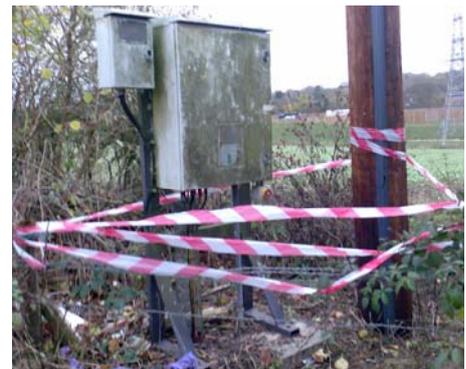
- In 2007, EDF Energy had carried out modifications as part of a Motorway widening project. During the reconnection of the low voltage single phase service connection to the overhead line, the neutral and live phase were reversed by EDF Energy. It appears that this situation remained until it was identified by a CP contractor in November 2009. The electrical connection used is called PME (Protective Multiple Earthing). This is where the earth connection for the system is derived from the incoming neutral from EDF. The metal cabinet containing the system is bonded to earth. If the neutral connection is mis-connected to a live

- conductor, the outer metal cabinet will become live.
- It should be noted that there was a real and potential danger that either technicians or members of the public could have come into contact with the faulty equipment. The equipment is within a fenced field, and is a good distance from casual public access. However, there was a potential for electrocution as the metal box was in fact live.

- Review reports, produced following internal or external inspection, for relevant maintenance recommendations.
- Consider replacement of cabinets with plastic cabinets on any change of cabinet.
- Ensure contact details are clearly displayed for any remote installations to allow contact to be made before any work (including inspection) is carried out on such installations.
