UKOPA SAFETY ALERT

Crude Oil pipeline Easement incident July 2010

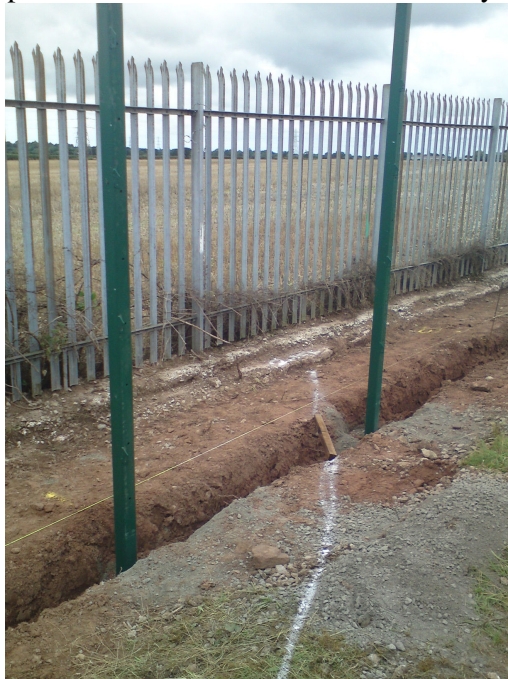
It was discovered that several excavations for fencing posts had been made within the pipeline easement. The nearest excavation was found to be within 300mm of the pipeline.

Pipeline markers were in the close vicinity to the excavations.

The contravention was raised with the site subcontractor and the site operator and work was stopped until an agreed work method was in place.

1. Ensure landowners have adequate records of services. The Operator of the site did not have correct records of all buried services that were not their own, despite being made aware annually of these services.
2. If pipelines are expected do not assume the ones found are necessarily the ones expected to be found.
3. Take note of pipeline markers and information contained within them. Don't make assumptions
4. Ensure aerial and ground vantage point surveillance procedures are adequate to identify this type of work. Take particular note of sudden changes in directions of pipelines and where only a short route of the pipeline is within a section of 3rd party land
