Issuing Manager/Department: - Tony Stonehewer - Gas Engineering Policy Manager (Transmission)
Approved: - 10/01/2011

Product Alert – BIFFI ELGA & WGR Models of Electric Actuator

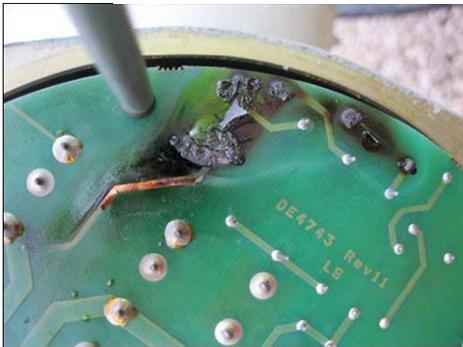
Although the units are still operational, evidence of short circuiting or power surge on the power card has been experienced. The damage has caused the PCB track to come off with severe blackening around the area on the card and inner wall of the control group housing.

Fig.1 – Damaged track on the PCB card

BIFFI's engineering department have advised that there have only been a few occurrences of overheating of these three resistors on the power card. The resistors act as suppressors on the high voltage circuit and are there to eliminate interference when the electric motor is running. In extreme circumstance on high voltage units (>500 v) that are subject to repeated use over short periods of time, overheating of the resistors can occur damaging the resistors and connecting track on the PCB card.

It should be noted that the problem ONLY effects units manufactured in 2006, BIFFI identified the potential problem and have revised the resistor values on all units from 2007 onwards.

1. Visually inspect the actuator nameplate to check date of manufacture, its location on the nameplate has been circled in Fig.3.
2. If found to be manufactured during 2006,
 - a. Remove control group housing to inspect for signs of short circuiting or overheating, as shown in Fig.1 & 2. **Note : All electrical supplies must be isolated prior to removal of covers.**
 - b. Contact Steve Johnstone (07867-905922) or Steve Law (07767-382862) for further guidance.

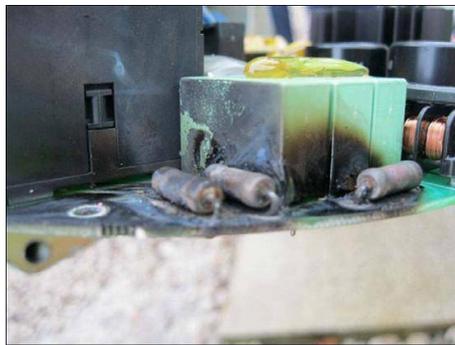
Fig.2 – Signs of overheating on resistors

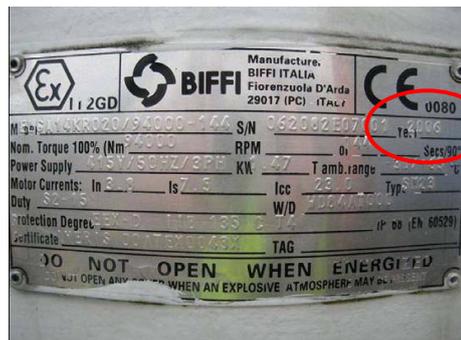
Fig.3 – Actuator Nameplate
