Engineering Bulletin

Removal of plugs from small bore valves

An incident has occurred on the National Grid area of the NGN / NGT Offtake site at Elton, Teesside, and resulted in serious injury to a National Grid Employee. The circumstances and actions are relevant to NGN and the following instructions should be followed by NGN Staff.

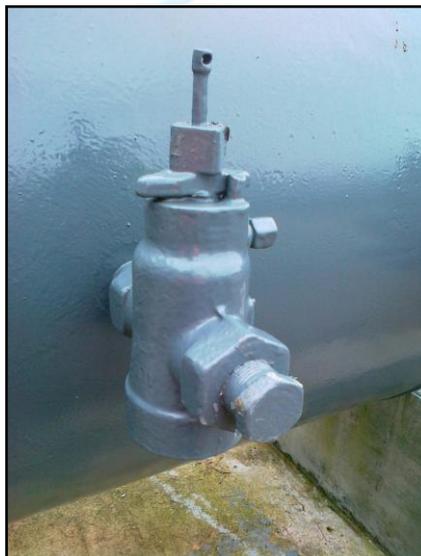
A solid 1" plug was ejected under full NTS line pressure from a 1" Audco valve (as shown below) resulting in injury to the operator and a significant release of gas from the NTS system.

Initial investigations have shown that the valve was indicating fully closed but was in fact fully open.

The following precautions always apply when removing solid plugs from small bore valves.

- Prior to starting plug removal operation via documented risk assessment apply appropriate precautions to reduce the impact should the plug eject from the valve. Considerations should include location of other personnel and nearby plant / equipment.

- Never stand in line with the possible direction of projection of the plug, always stand to the side.
- Prior to plug removal operate the valve; this will give an indication as to the integrity of the spindle. Feel for lack of resistance which could be a sign that the spindle has sheared. Be aware that paint and / or corrosion will provide some resistance. If the spindle has failed then the valve indicator may not give the true position of the valve. **If there is any doubt as to the actual valve position, do not remove the plug and seek further advice from your line manager.**

- Apply leak detection fluid prior to slowly removing the plug at 1/6th of a turn increments whilst listening / looking for any gas passing the threads. **If gas is continually passing the threads do not remove the plug further and seek further advice from your line manager.**
