**Subject:** Scaffold Board Fire  
**Date:** 02/07/2013

**Incident location:** Killingholme Power Station  
**Incident date:** 01/07/2013

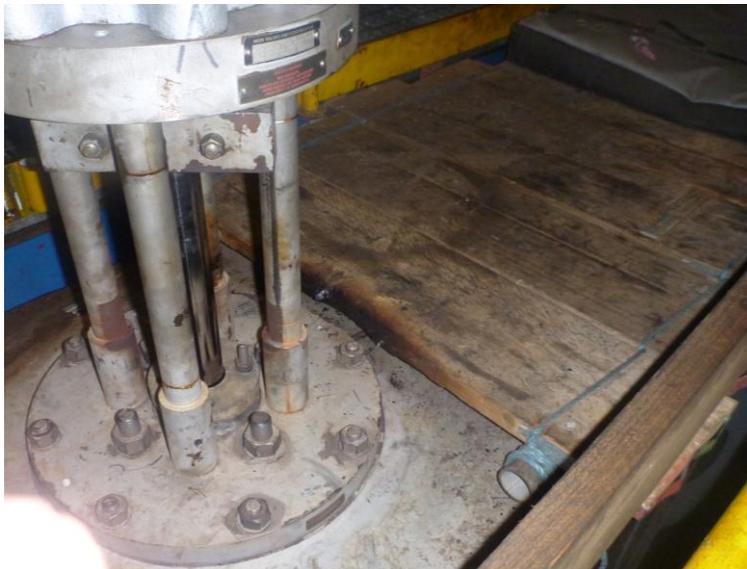
### Attachments/Photographs

Scaffolding boards erected around HRSG HP Steam Stop valve was found charred/burned. The scaffold was erected during the recent PSSR outage.

The incident occurred on returning the plant to normal operation. The live HP steam temperature within the system elevated the surface temperature up to 500°C. The scaffold board started to smoulder over a period of three hours where it was discovered and removed.

- Carry out a review of all current scaffolds on site in close proximity to hot surfaces to prevent a reoccurrence of this event.
- Review Back Out procedures during completion of outage and major works to ensure that all scaffolds in close proximity to hot surfaces are removed and a safe distance from a potential ignition source.
- Carry out a review of this event with your local scaffold partner to determine best industry practice.
