<b>Date</b>	13 March 2014	<b>Ref</b>	HSEQB080314-2
-------------	---------------	------------	---------------

## Youngman BoSS X3 Pop-Ups

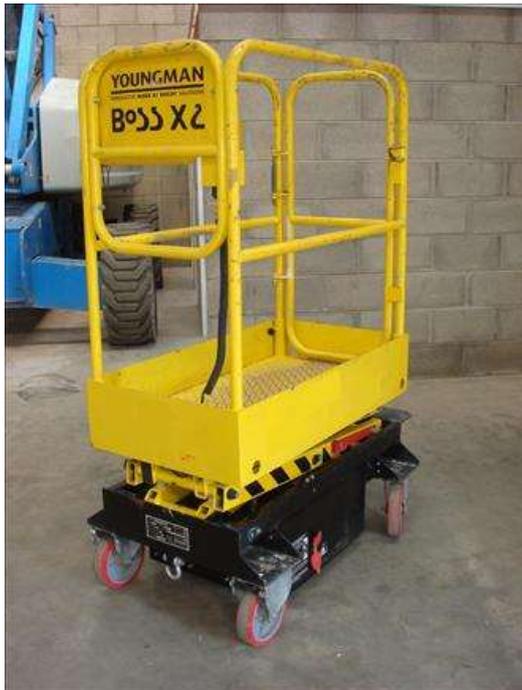
There has been a recent industry incident where a Pop-Up platform failed to stop elevating even after the operator released the controls and pressed the emergency stop button. The platform continued to rise through a ceiling causing part of the ceiling to collapse which injured a colleague.

The operator had been trained and was experienced in the use of the equipment. The operator had also carried out a full daily pre-use check that included testing of the emergency stops.

Youngman have issued a product advice notice regarding this type of machine and believe that the most probable cause is excess heat at the contactor points, possibly attributed to excess current being drawn as a result of a drop in battery charge.

Quarantine any Youngman BoSS X3 Pop-Ups, note the serial number and contact the supplier to establish if the unit requires remedial action.

If similar types of unit are in use produced by another manufacturer sites should contact the supplier to confirm that the supplied equipment cannot suffer the same type of failure.

Complete a full Pre-Use Inspection which should include the Emergency Stop buttons  
Maintain the battery charge above 20% to prevent a potential voltage drop.
