The ejection of a plug from a body vent valve

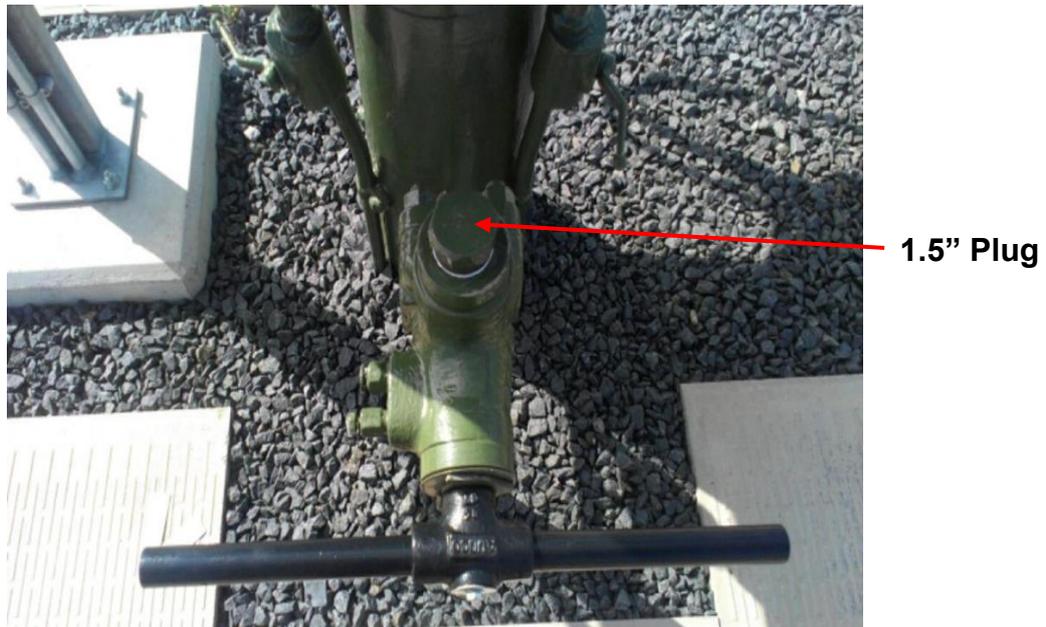
Whilst attempting to remove a 1.5 inch plug from a body vent the plug blew out at high velocity.

Despite applying a soapy leak solution no gas was seen to vent from the plug as it was being loosened and it was noted that the plug was extremely tight to undo. The amount of gas passing the valve below the plug was negligible.

The plug that was ejected was examined and it was found that a liquid threadlock substance had been applied to the plug when it was last removed. The investigation found that due to the amount of this liquid threadlock substance that had been applied it would restrict the flow of gas past the threads while the plug was being removed.

Please note the National Grid policy is that no liquid threadlock type substance should be used on any threaded joints. PTFE tape is the preferred jointing material when making threaded joints.
