Learning from others:-

**SERIOUS INJURY FROM LIFTING CUSHION USED ON PIPELINE**

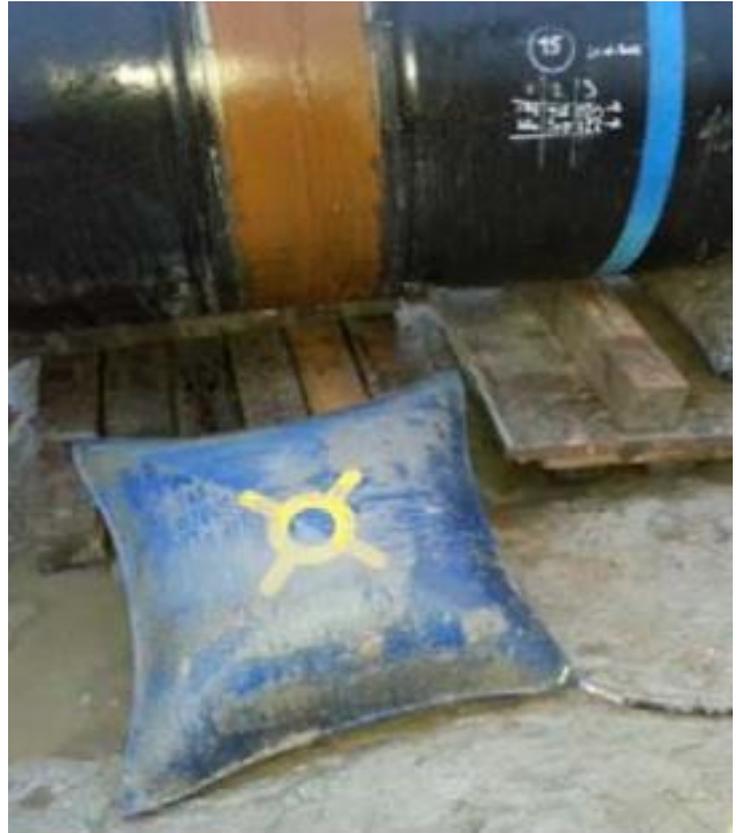
- A welder working for Gasunie, in the Netherlands, on a 48" gas pipeline broke his hip during a lifting operation using air lifting cushions
- The welder was with a pipe fitter in a safe area with the air compressor adjacent to the cushions
- Two cushions (one on top of another) were inflated to lift the pipe.
- Once inflated, the welder left the safe area to inspect to confirm correct height had been achieved. At that moment, one of the air cushions ejected from underneath the pipeline, hitting the welder and pushing him against the barrier behind him and breaking his hip.

The ejected air cushion besides the pipe section it was supporting

- There was a lack of restraints for the air cushions to prevent them moving sideways.
- No clear working instructions were available for the use of air lifting cushions.
- The incident was compounded by adverse weather and ground conditions which caused a temporary support to subside into the soil.

- Project managers shall share the learning of this incident to all staff and contractors who use air cushion lifts.
- Where air cushions are used, risk assessments and method statements should be reviewed to ensure safe use of air cushions and suitable supports are included.
