An LPB toolbox talk

Improving process safety by sharing experience

Bunding – should be simple and reliable

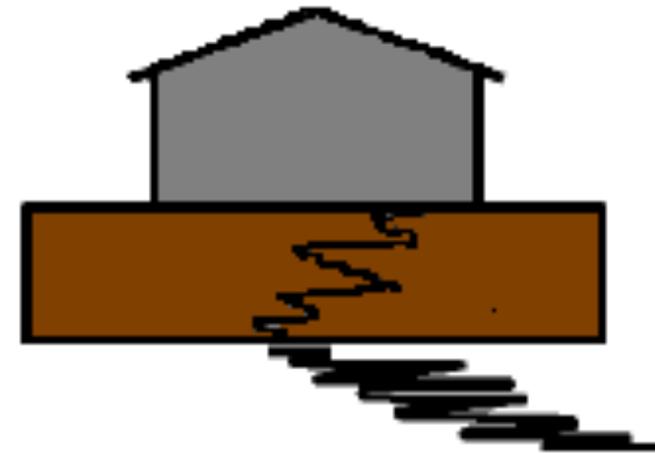
Cracks in the base or wall of the bund

- Cracks may develop in the concrete base or wall of a bund.
- Small cracks can be a concern if ground water contamination is to be avoided.
- Expansion joint materials may be missing or unsuitable for the liquid being stored.

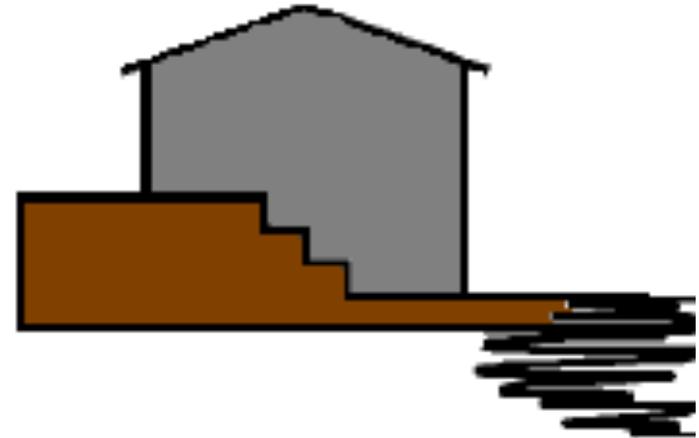
Bund not designed for hydrostatic pressure

- If the material being stored in a tank is changed to one with a higher density, it will be important to ensure that the bunds will still be able to contain the hydrostatic head.

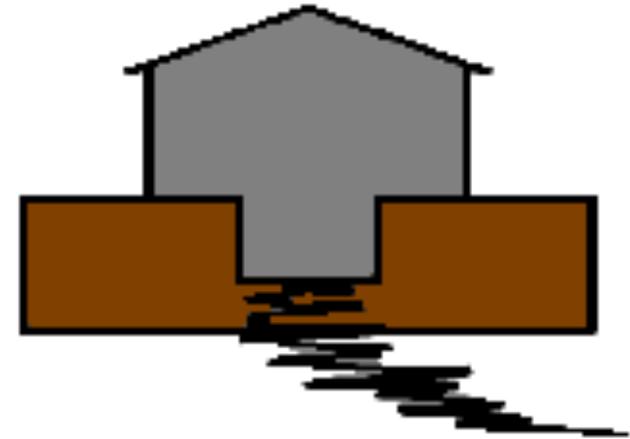
Bund not designed to contain tank capacity

- Bunds should be designed according to local rules but with a capacity of at least 110% of the capacity of the largest tank within the bund.

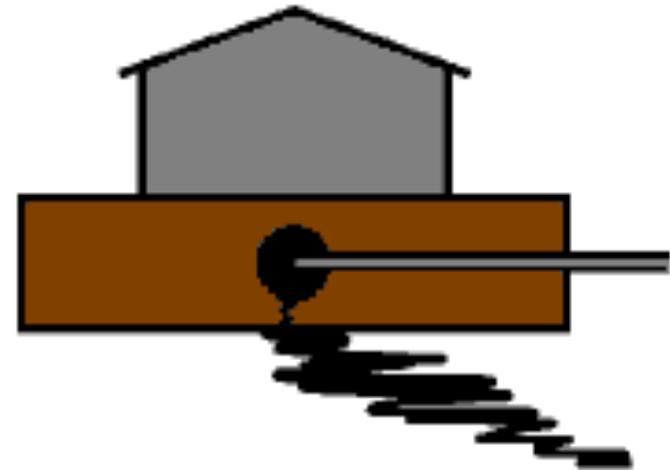
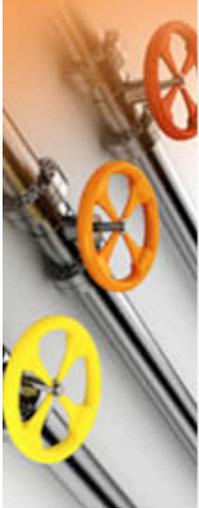
Bund not sealed after new pipe installed

- This is one of the most common errors and has contributed to a number of serious fires.
- It is important that all modifications are completed to the original specification.

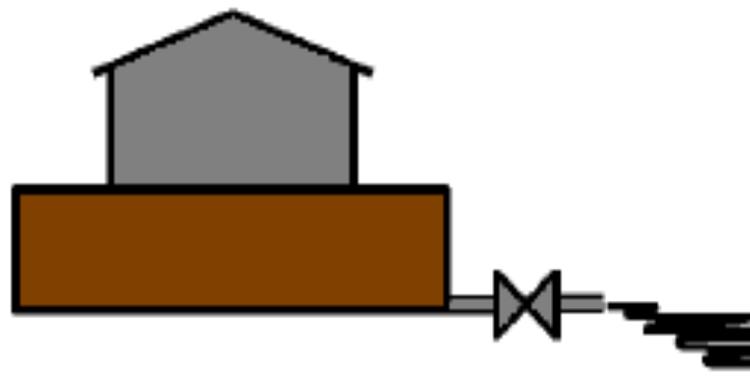
Bund drain left open

- The collection of rainwater within the bunded area can be a problem and drains are necessary.
- However, the common error of leaving the drain open completely negates the value of the bund.

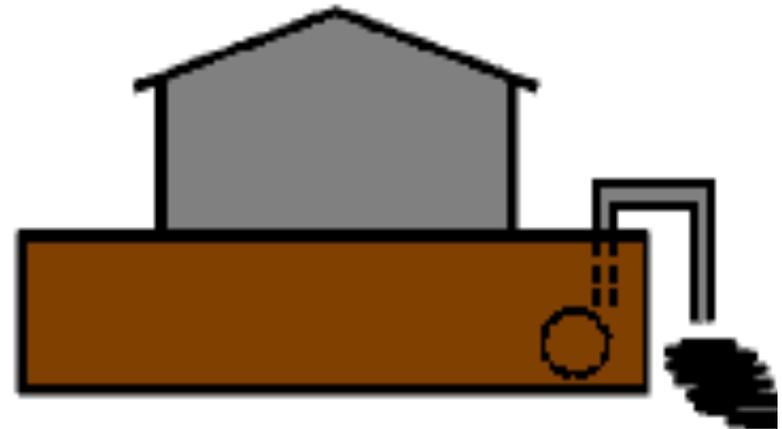
Pump installed to empty bund

- Due to the problem with rainwater build-up, pumps can be installed to empty the rainwater.
- In one case, this was found to be equipped with an autostart facility, negating the purpose of the bund.

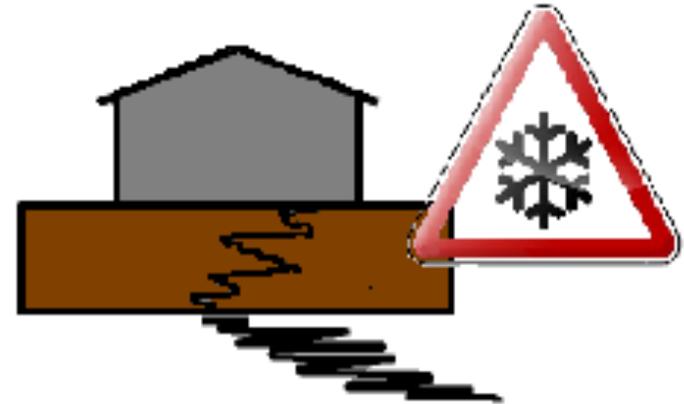
Bund damaged by freezing conditions

- Bunds, particularly those made of brick or cement overlain by a concrete coating, can be damaged if water penetrates the coating and freezes.
- Repeated freezing and thawing can damage the bund to such an extent that it loses its integrity.
- Regular draining or pumping is required, together with a regular and thorough survey of the wall, both inside and out.

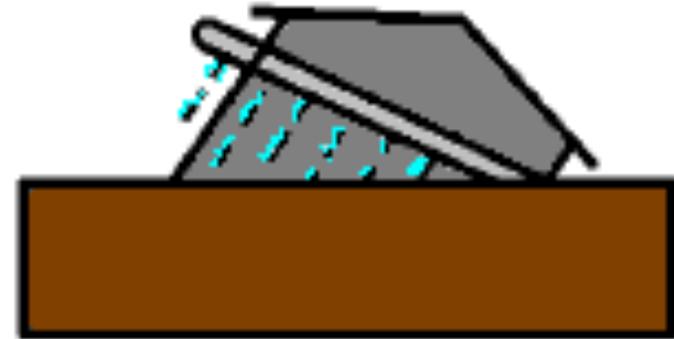
Firewater spray fills bund

- When firewater sprays are activated, they can cause water build-up within the bund.
- If the stock tank is at a very low level, the buoyancy forces on the tank can be very high.
- There have been cases where the tank has started to float, leading to pipework damage and leakage.

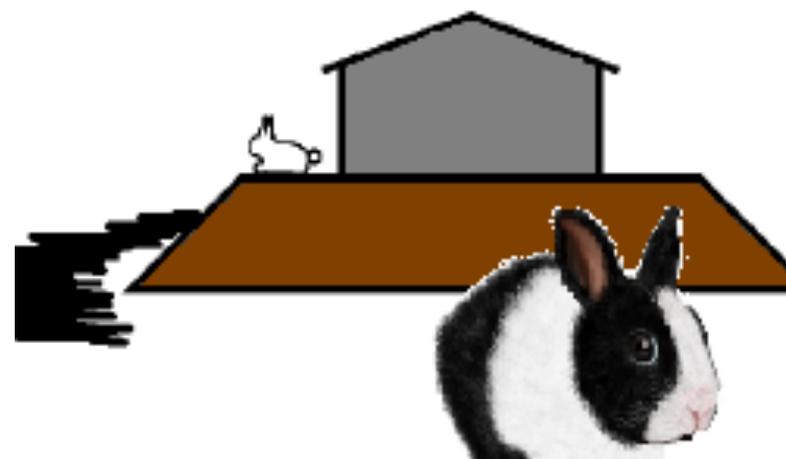
Attack by rabbits!

- In one example, rabbits were found to have burrowed into earth bunds causing them to lose integrity!
