Balfour Beatty should have waited for right plant

29 January 2016

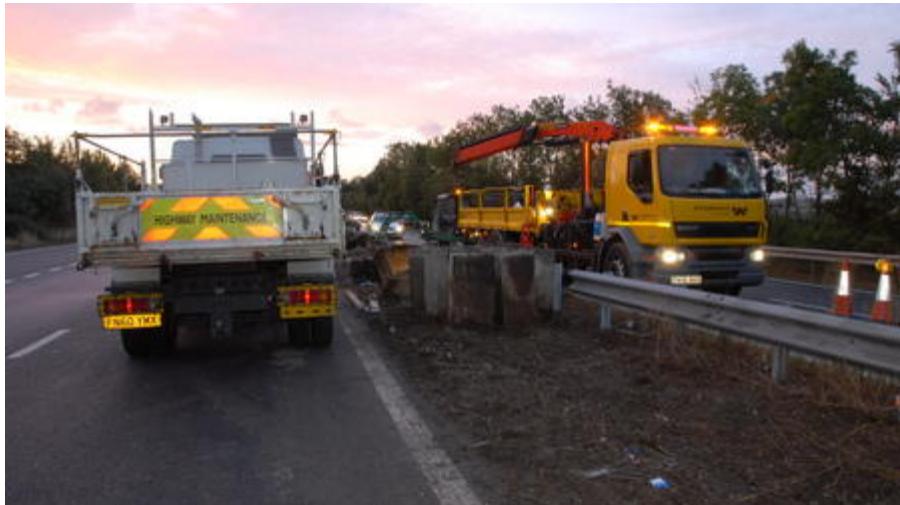
The Balfour Beatty worker was crushed to death by a lorry-mounted crane while repairing a central reservation barrier | Image credit: HSE

The team then decided a Palfinger PK 15500 lorry-mounted hydraulic crane might be able to remove the footing. The crane operator used the crane's jib to push and pull the concrete block and loosen it from the ground before chains could be wrapped around to lift it free. "That operation is inherently

dangerous," said Cousins. "It was an articulated crane and not intended to be used as a device for pushing and pulling things."

The crane slipped while it was forcing the concrete block back and forth and swung around at full speed. Larry Newman, who was standing in the danger zone ready to fit the chains, was crushed between the jib and an outrigger and died instantly.

"We were not convinced by that, the judge was not convinced by that and the evidence didn't say that. This unsafe action had been going on for many months ... both employees and nonemployees were being exposed to danger," Cousins explained. Severe damage to the lorry-mounted crane indicates it was being used incorrectly for a period of time.
