Safety Observation

8" Pipeline Nitrogen Displacement

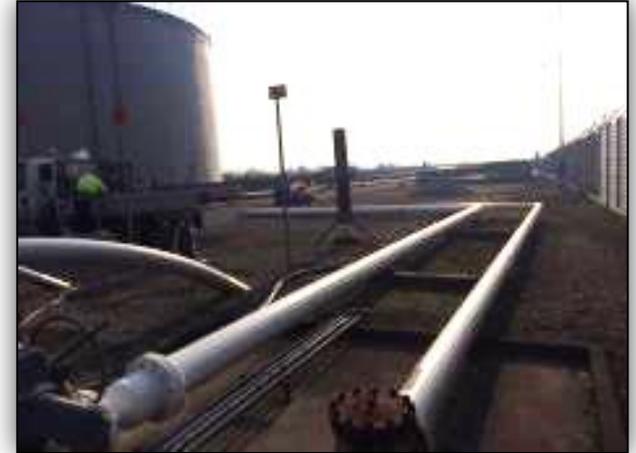
- Two Contractors were executing a displacement of Diesel on an 8" pipeline for maintenance activity, using a pig pushed by N2 Interface product (mix of N2 / ADO) was directed from pig trap to a drum using a hose.
 - After few minutes suddenly the hose disconnected and started to whip.
- One Contractor tried to catch the hose while the other correctly closed the valve to shut off the flow and stop the hose movement. No spill occurred (only N2 at this time)

- Hose disconnected because was not properly tightened.
 - RCAF: In the past did not follow acceptable practices and no incident occurred
- Contractor failed to identify the risk because he perceived low risk, simple & quick operation.
- When asked why he tried to stop the hose by hand, the Contractor mentioned that the size of hose was small and not high pressure...
 - RCAF; Doing the job according to procedures or acceptable practice takes too much time or effort.
 - RCAF; Lack of skill or knowledge

- Coaching of involved personnel on potential consequences of temporary connections
- Refresher on Risk Tolerance to avoid similar events
- Incident sharing during monthly terminal Safety Meeting

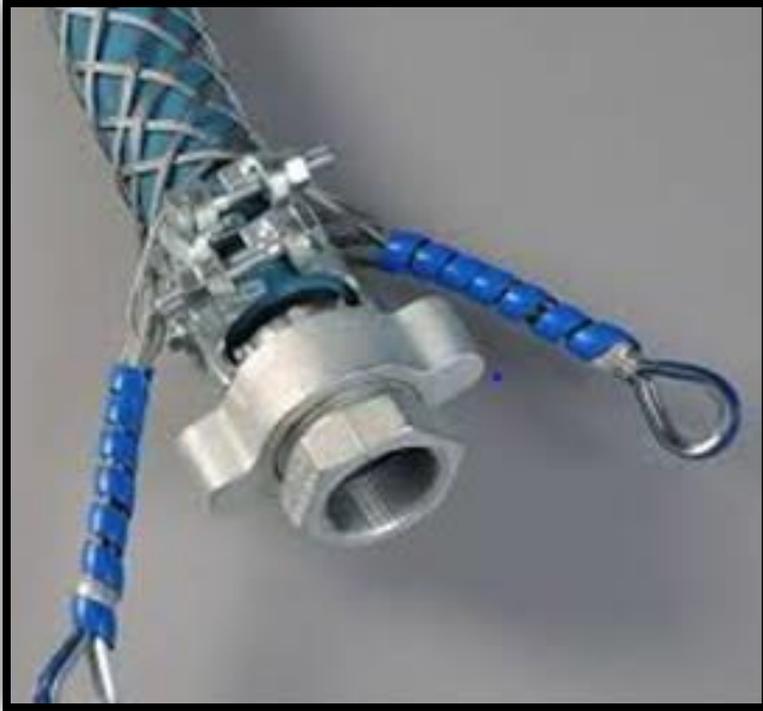
Hose “anti-whip” devices are available.
