## IMCA Safety Flash 27/16

### Focus: Falling into Open Hatches

#### 1 Near Miss: Open Hatches Left Without Barriers

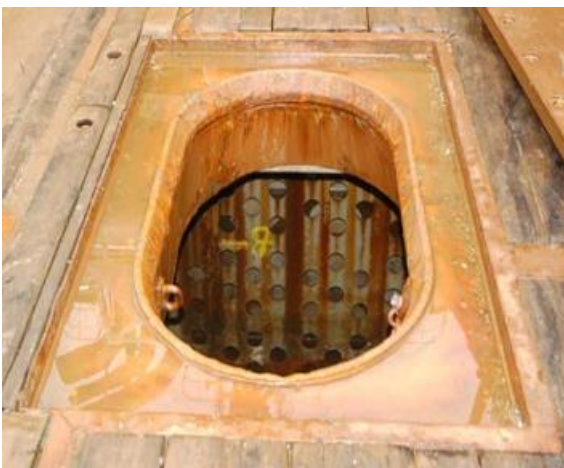
The Marine Safety Forum (MSF) has published the following safety alert regarding a near miss during preparation to load anchor chain into a moon pool chain locker. One person almost fell into the chain locker. The hatch cover had been temporarily removed before the installation of the chain guide. The hatch had an opening of 155cm x 85cm. The depth of the locker was approximately 10m and there was 1–1.5m of water at the bottom.

*A similar hatch*

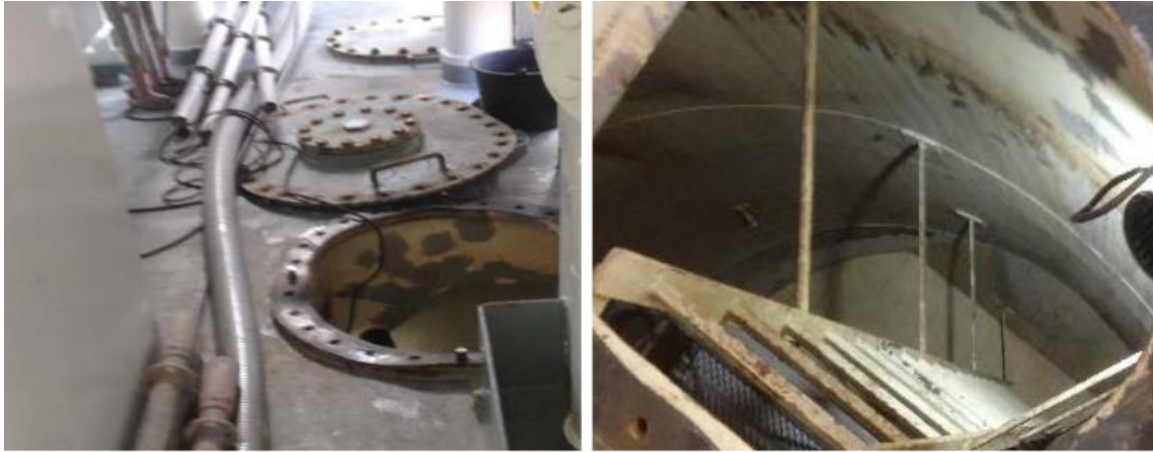
The MSF has published safety alert number 16-17 regarding an incident in which a shore-side foreman walked into the "safe haven" area of a supply vessel and stepped into an open manhole. Whilst he managed to catch himself and prevent a free fall of 5m into the tank, he nonetheless suffered a laceration on his shin requiring 3 stitches and bruising to the forearm.

- ♦ Lack of barriers to open manholes;
- ♦ Several different activities all occurring at once;
- ♦ Lack of coordination of those simultaneous activities.

- ♦ Covering of manholes with gratings during work;
- ♦ Ensuring that ongoing work is coordinated between the work parties in the same area, through toolbox talks.

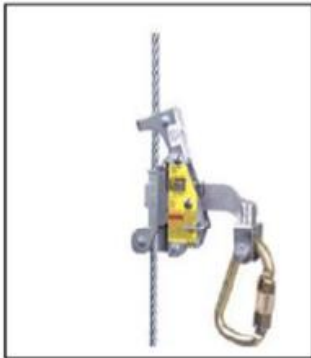
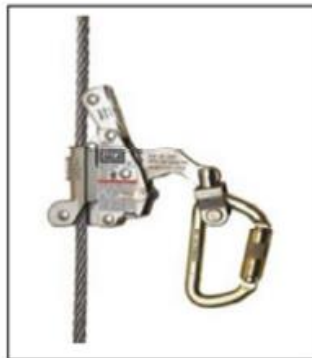
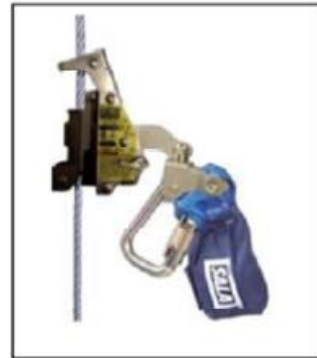
**DBI-SALA Lad-Saf™ Sleeve**

A member has drawn IMCA's attention to problems with certain safety equipment used in work at heights. The equipment is the DBI-SALA® Lad-Saf™ Sleeve. The manufacturer of this equipment reiterates that customer safety and confidence are their highest priorities, and confirms that in light of reported incidents and potential misuse scenarios involving the equipment, its sale has been discontinued.

6100016, 6116500, 6116501, 6116502, 6116503, 6116504, 6116505, 6116506, 6116507, 6116509, 6116512, 6116535, 6116540, 6116541, 6116542, 6116500C, 6116500SM, 6116507/A, 6116540b, 6160031, KC36116502, KC36116506 = 6116506, KC3PL3330, KC3L3330/O, KC3L3330ED, KC3SC2020

*"immediately stop using and quarantine all original Lad-Saf sleeves. Affected part numbers are:*

Contact 3M Customer Services at +33 4 97 10 00 10 or email us at [LADSAFEMEA@mmm.com](mailto:LADSAFEMEA@mmm.com), to discuss the replacement of your returned units with an X2 sleeve, depending on your needs, at no cost to you."
