UKOPA Weld Quality Project

Technical Seminar May 2017

Overview

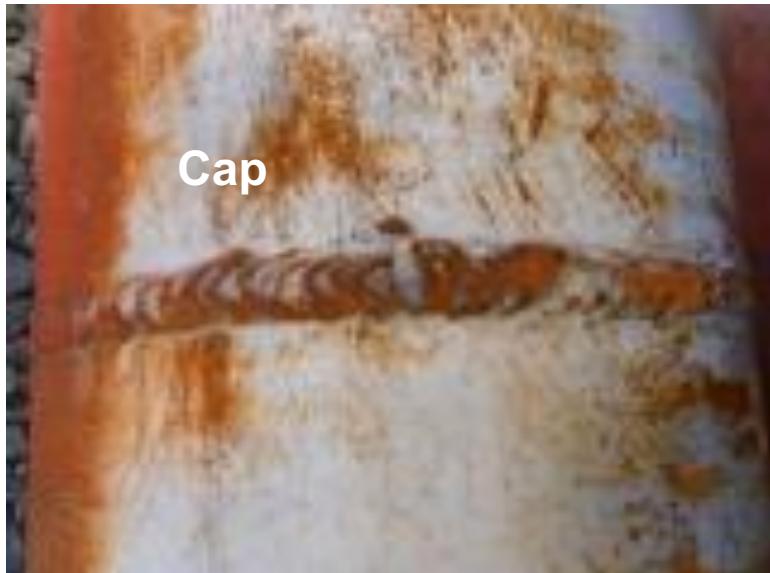
SABIC 8"

1968

Nothing to note

Meets T/SP/P2 (1980)

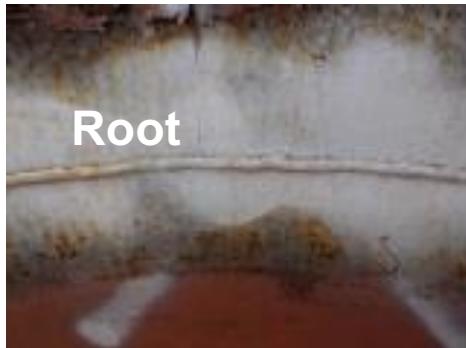
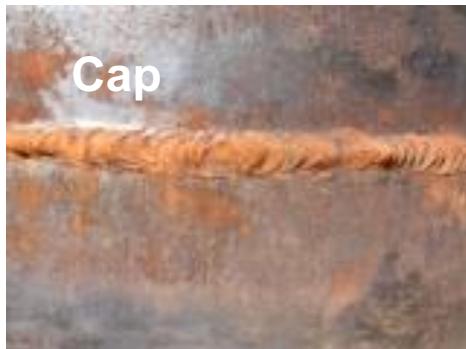
UKT Tirley 24"

Pre 1972

Nothing to note

Meets P2 (1980)

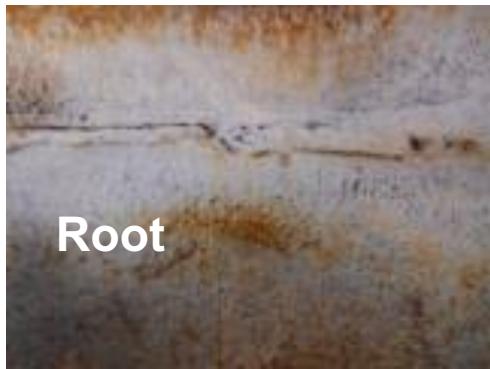
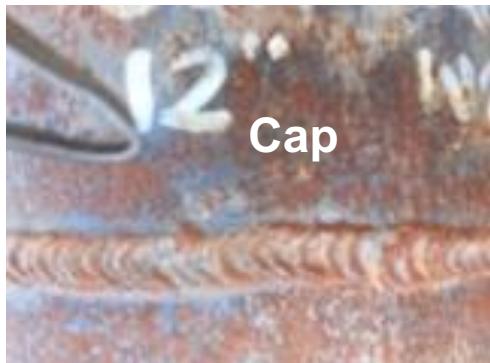
12"

1960s

Lack of root
fusion
Repaired burn
through

Meets P2
(1980)

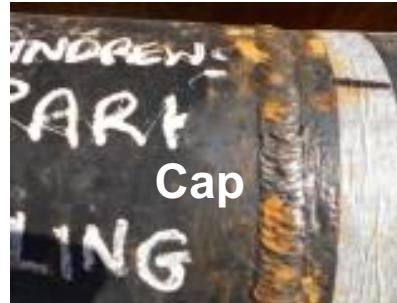
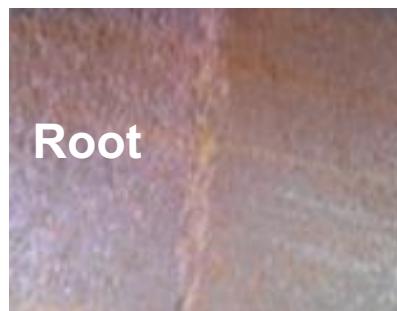
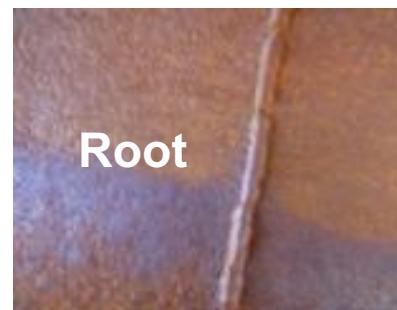
8"

1960s

Cap undercut
noted

Meets P2
(1980)

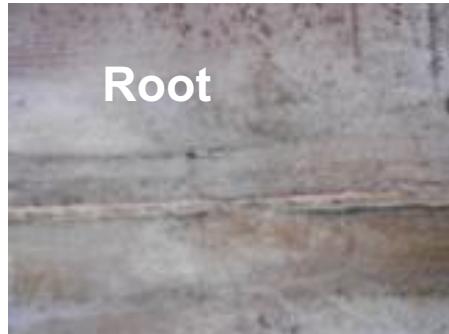
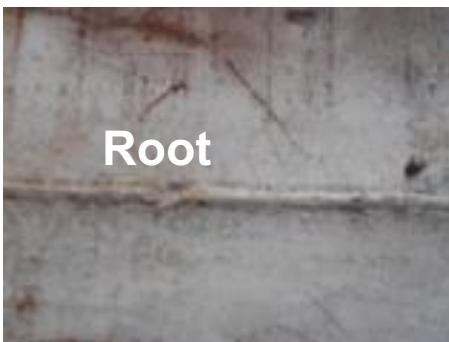
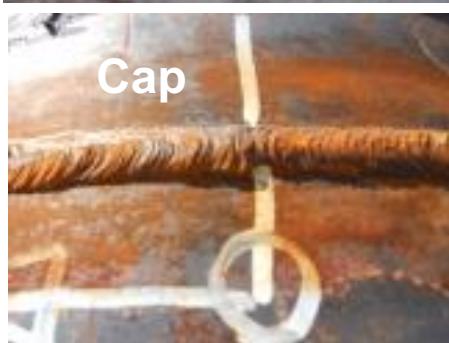
UKT 36"

1968

Nothing to note

Meets P2 (1980)

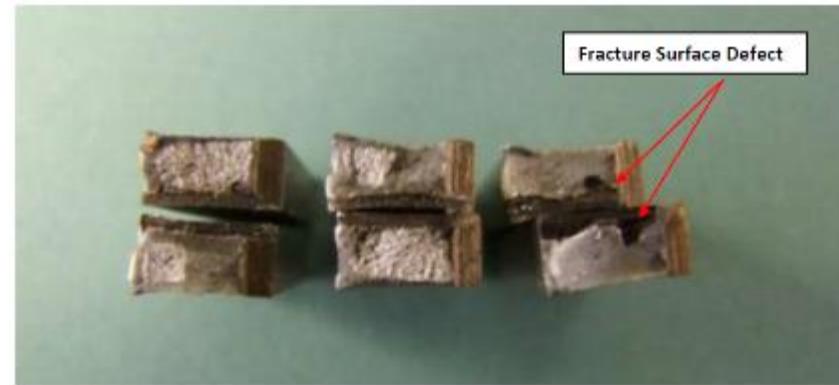
Results – Impact testing

- 17 Sets of samples had impact testing.
 - All 17 samples passed the 'average' impact value (>27J).
 - One sample failed on an individual test (>20J) but this was due to the presence of a large defect in the sample.
 - A local defect such as this would not cause the impact toughness of the entire joint to be unsatisfactory.
- Conclusion – impact toughness of historical welds acceptable.
