Scaffold Tower Incidents Dec 2013

NYU Incident details

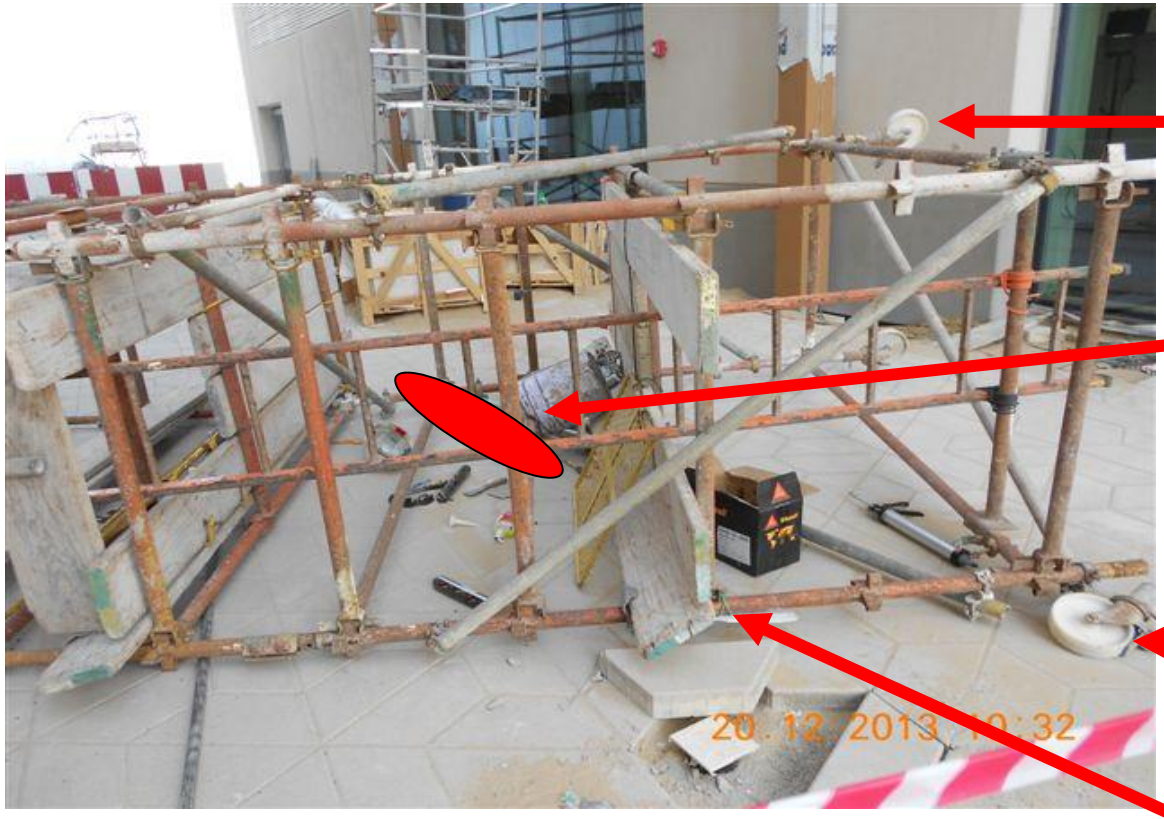
The IP was helping his workmates move a tube and fitting mobile scaffold, as they moved the scaffold along one wheel slipped off the paving and sank into the sand. As that side sank the opposite side lifted and the wheel fell out of its fitting. When they brought the scaffold back on the level one side tipped causing the scaffold to topple over landing on the IP.

Area where the wheel sank into the sand

location of IP after the incident

Wheel 1

Area IP was trapped below scaffold tower

Wheel 2

Scaff-Tag on Scaffold

Immediate Cause: The Ip was part of a team attempting to move a large Tube and fitting mobile tower when it over turned and landed on the IP.

Underlying Cause: Workers were unaware of the risks of moving heavy equipment and had not ensured the route was adequate.

Root Cause: Lack of understanding and training within the workforce regarding the safe system for moving large mobile access towers.

Safety stand down for whole site.

All workers involved in the use and movement of towers provided with training and a toolbox talk regarding safe movement of all types of scaffolding.

Guidance for safe movement of towers to be drafted and circulated.
