UKOPA – CATS INCIDENT

Tuesday 9th June 2009

Mark Kelso
NSI Pipelines
Engineering & Maintenance T/L

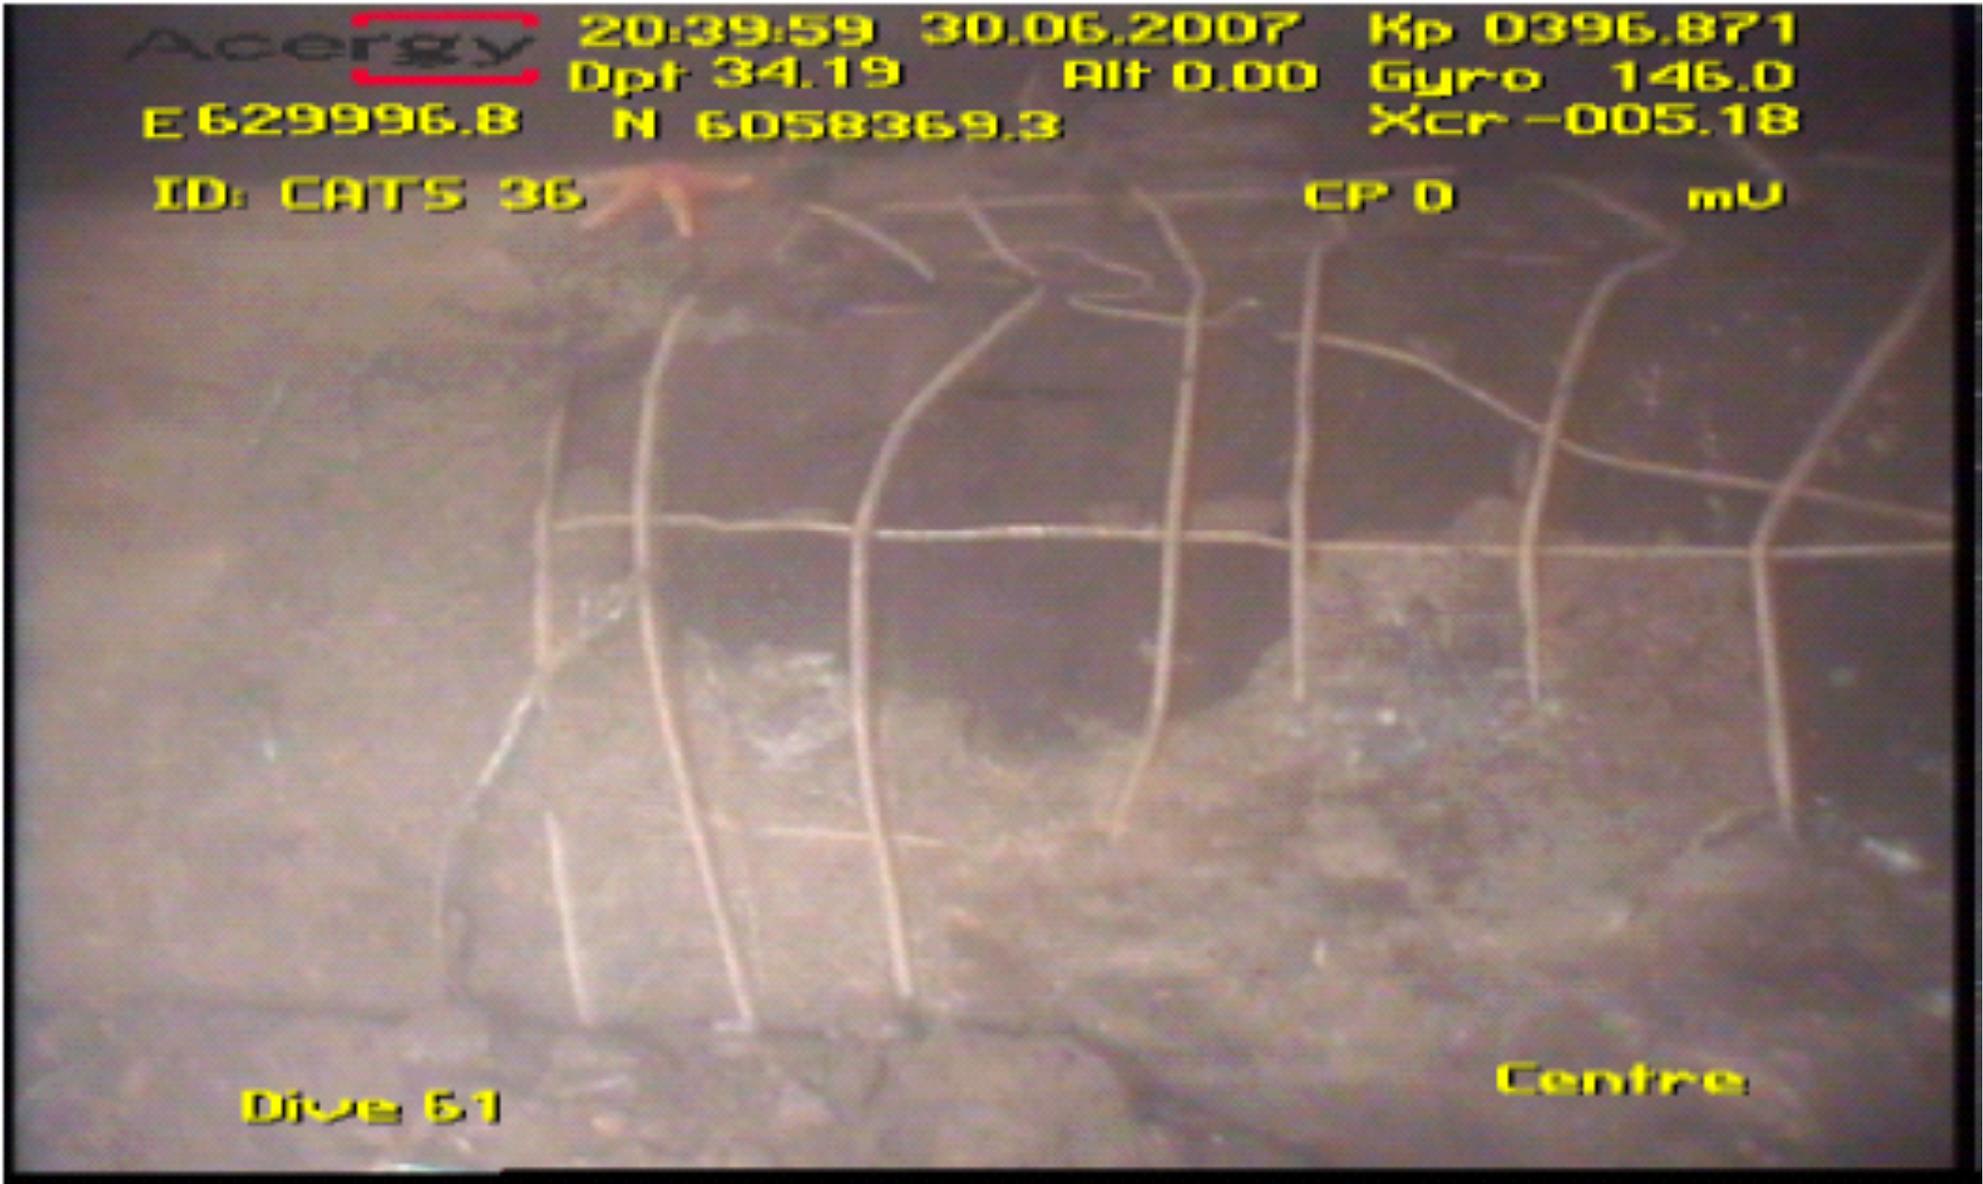
Initial ROV Inspection (3)

- Vessel anchor snagged on pipeline
- Notified to Port Authority by vessel then de-snagged and sailed away
- ROV inspection carried out – found pipeline had been removed from trench with extensive concrete and coating damage

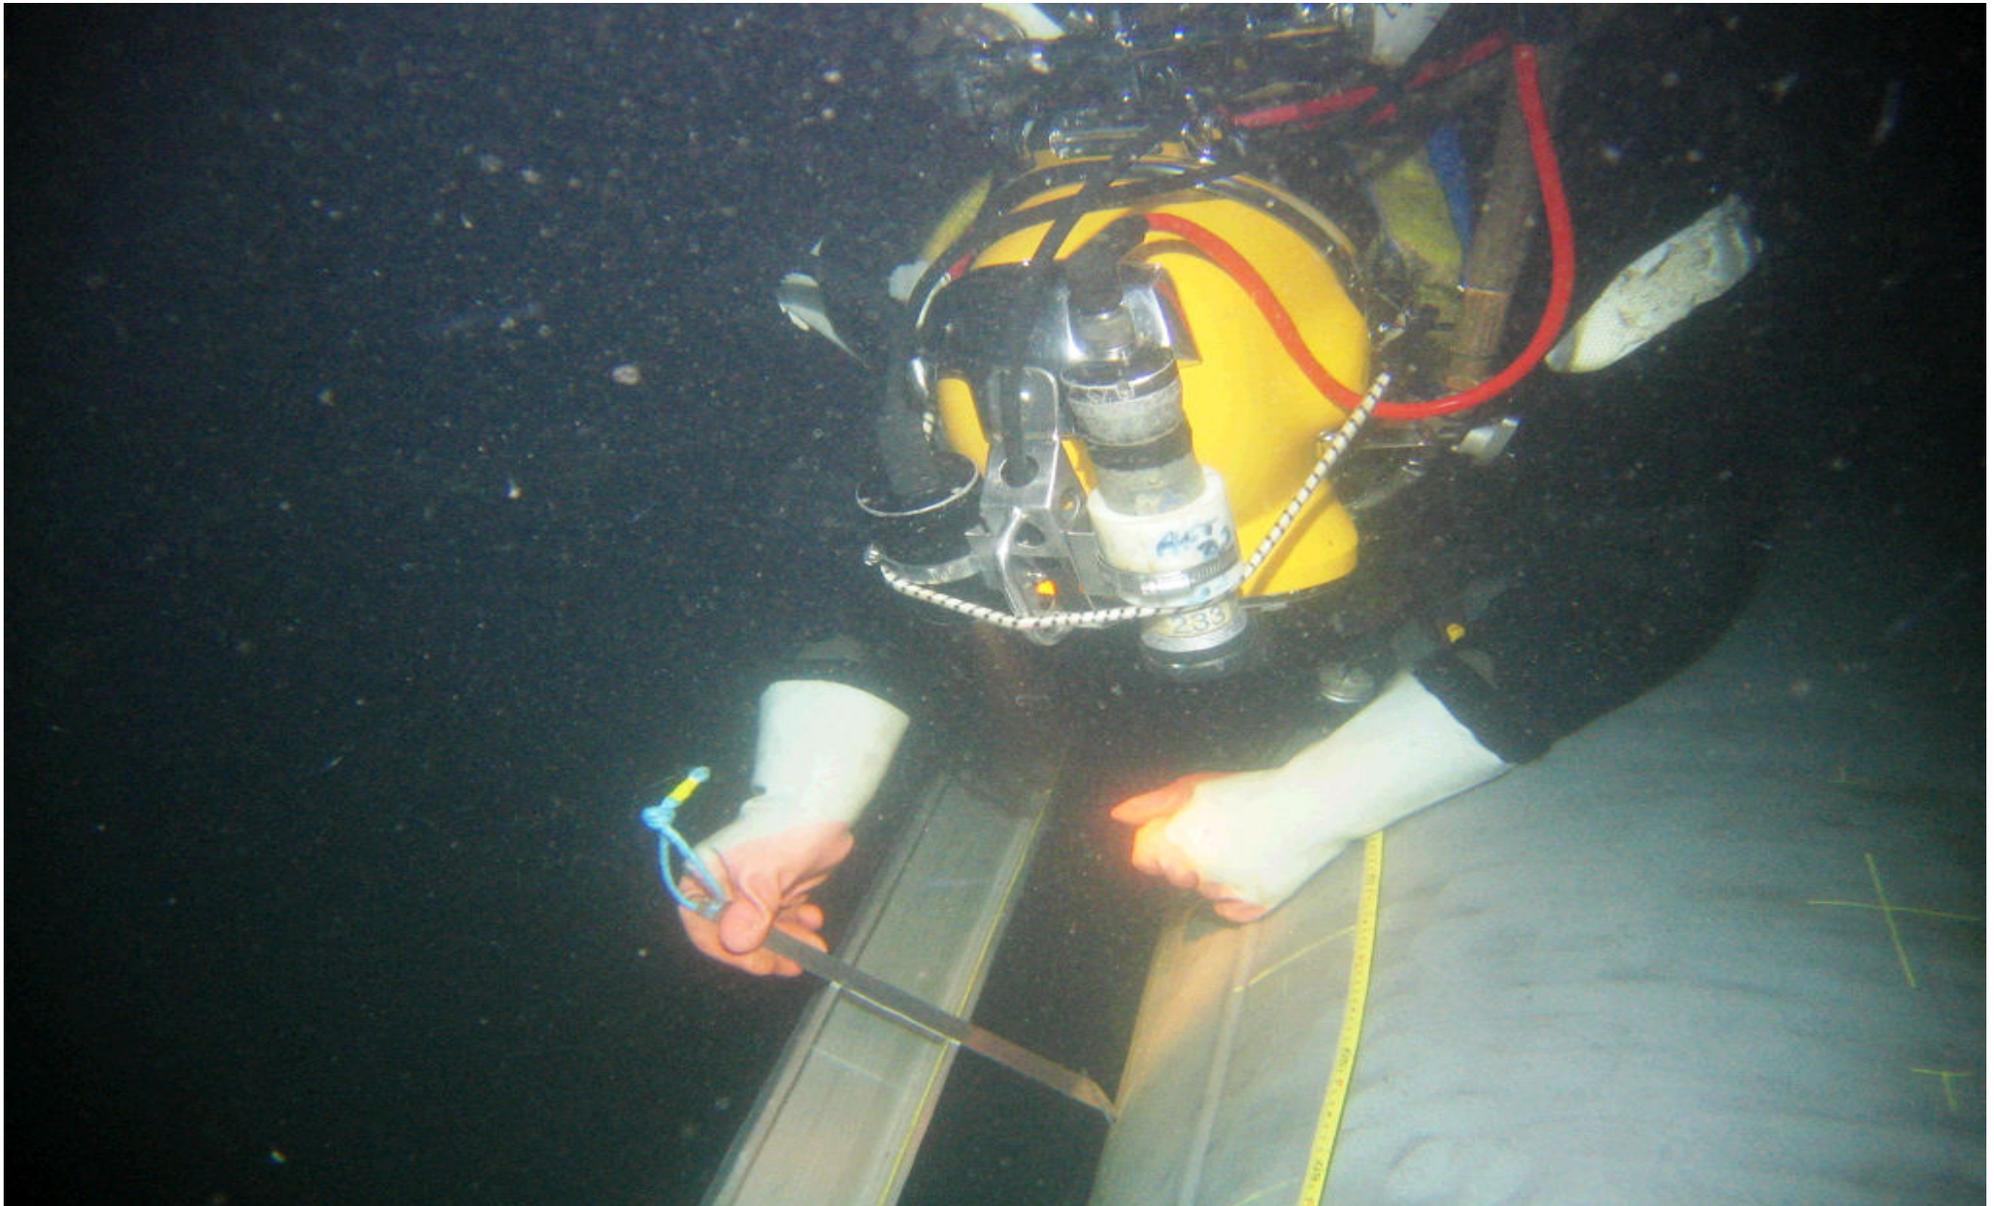
Metrology – Out of Straightness

1.5m vertical displacement
 4.5m horizontal displacement
 Damage over a 4m length in middle of spool

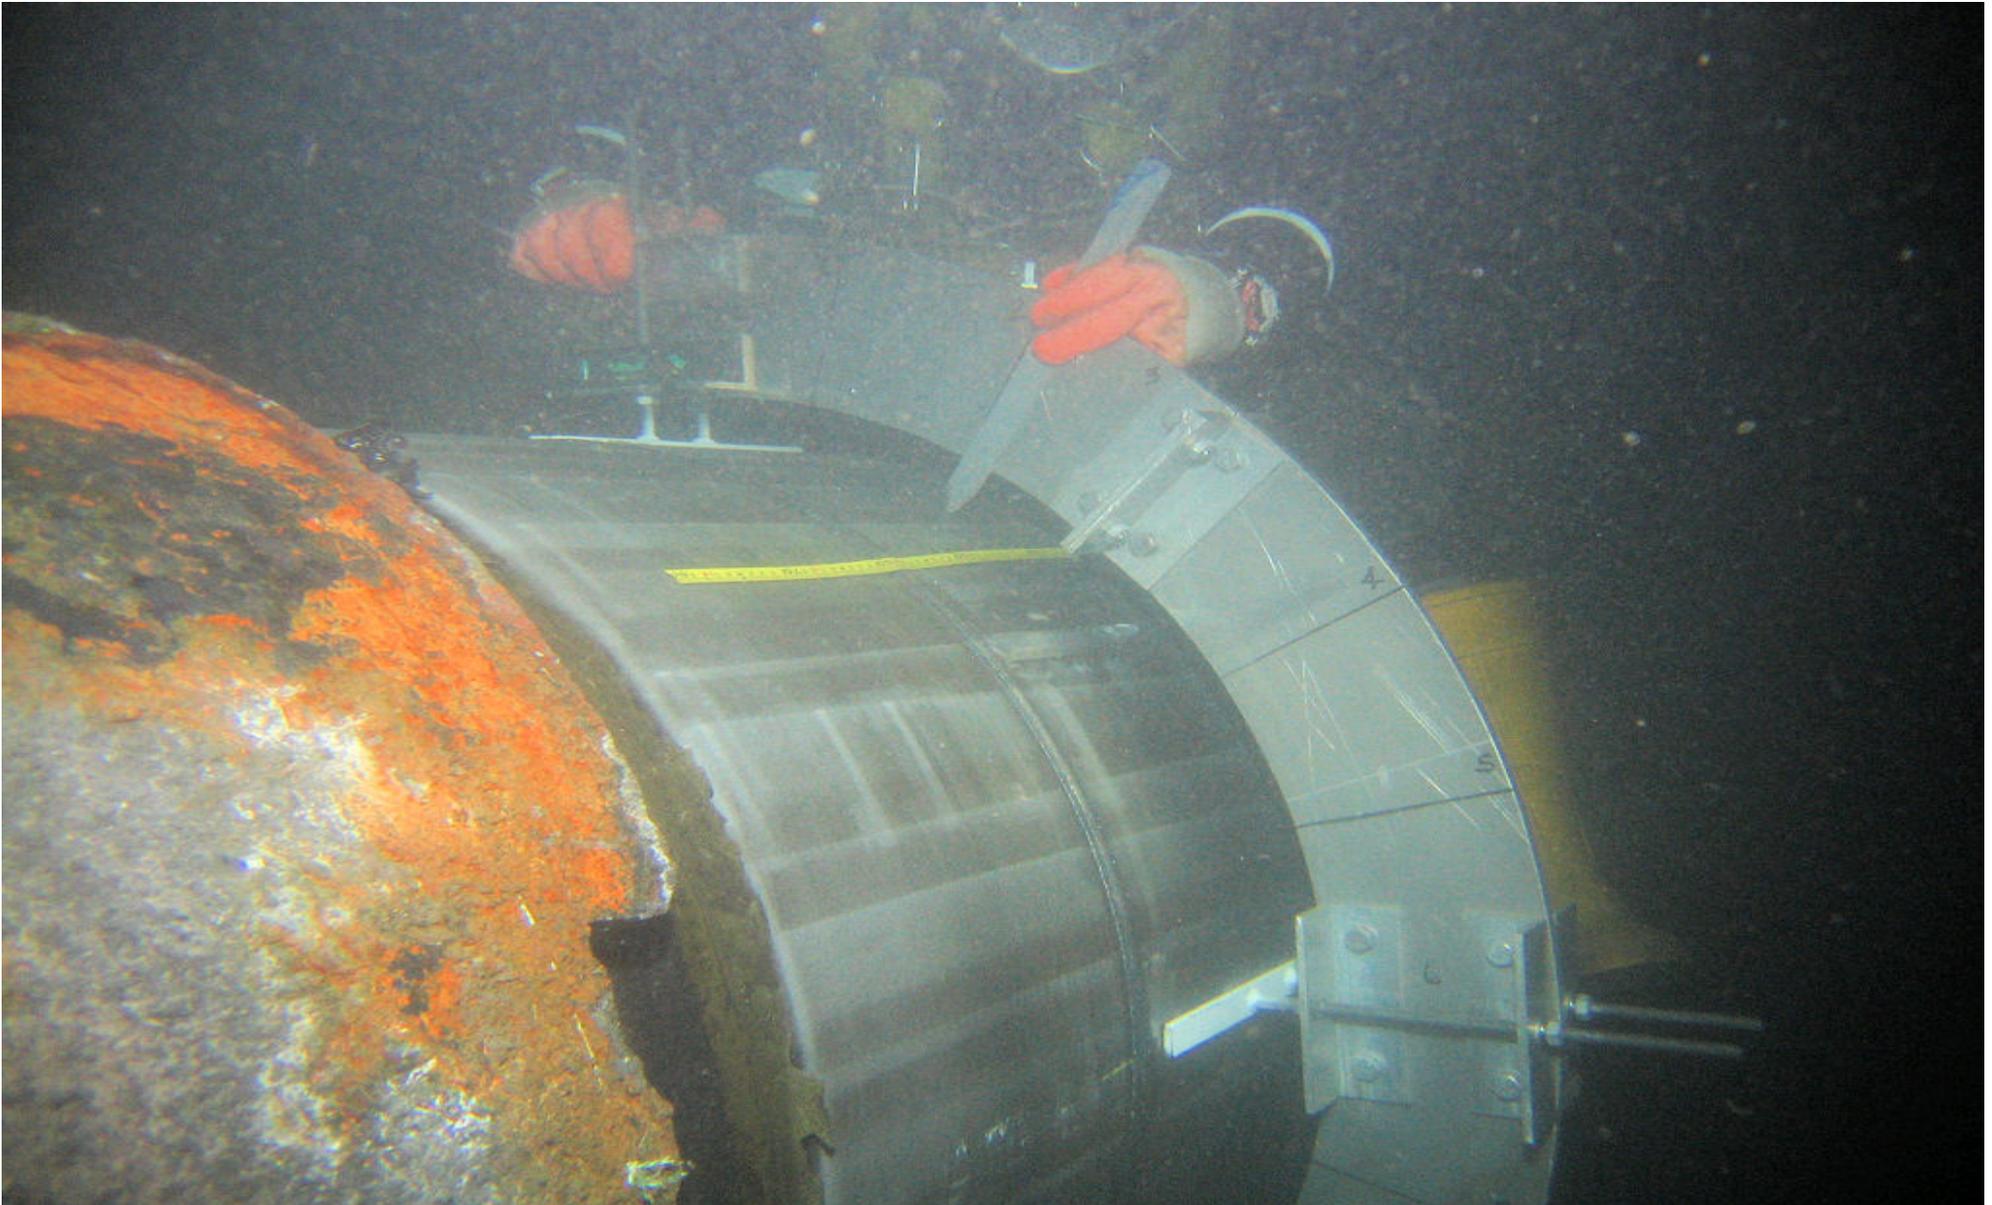
Metrology - Ovality

2 Dents within a larger deformed area
 31mm and 25mm max. depth (3.4%D)
 2 Protrusions of max. depth 15mm
 No ovality problems (other than dents)
 No weld defects / cracking
