## ILI Case Study

**Brian Woodhouse – Integrity Manager National Grid UK**  
**UKOPA Technical Seminar**  
**Eakring - 29 May 2012**

- Bathgate to Longtown
- Feeder 12
- Isolation between Bathgate to Pettinain
- 915 nom OD (36")
- 12.7mm nom W/T
- Constructed 1978
- 85 barg MOP
- > 72 % smys
- Inspection May 2011

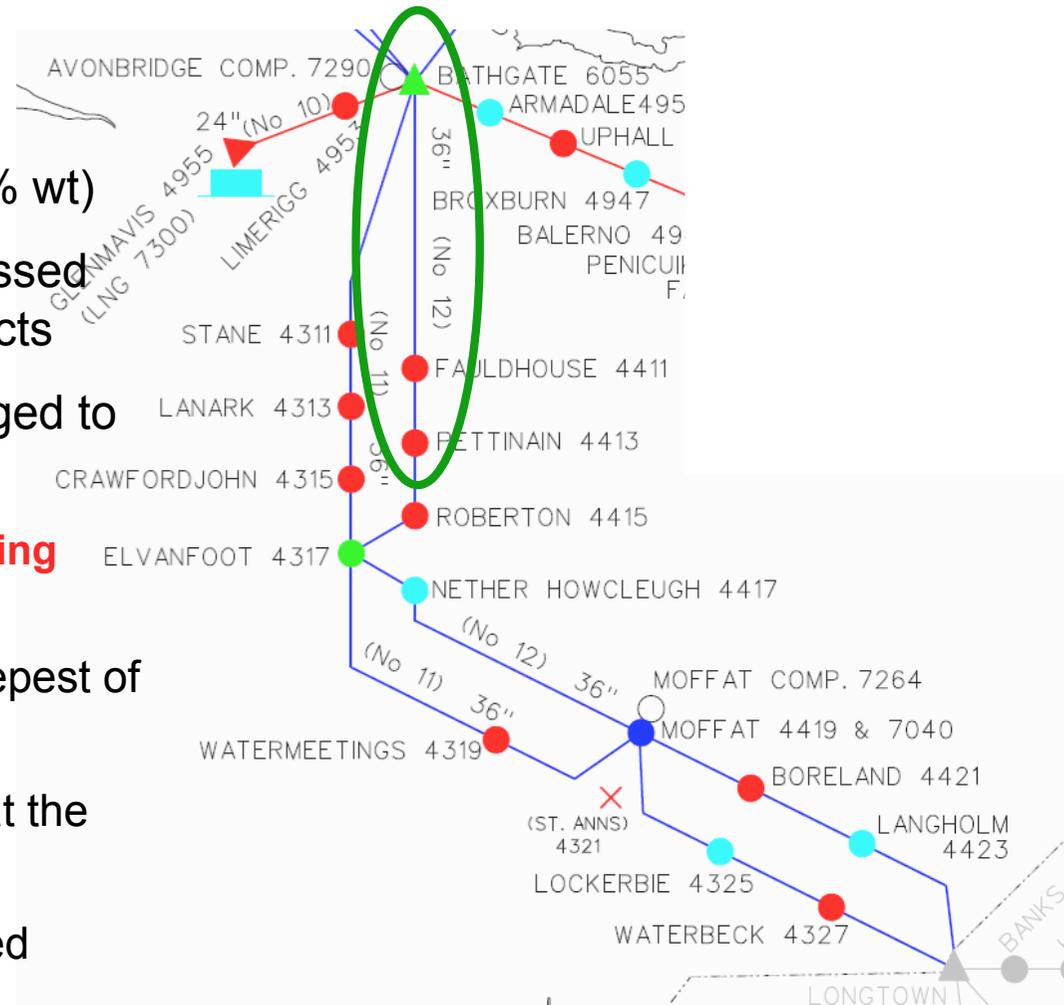
### ■ High Level Summary;

- 945 metal loss features were reported (deepest feature 46% wt)
- 742 of which have been assessed as milling/manufacturing defects
- 203 features were initially judged to be external corrosion
  - **18 judged to exceed reporting criteria**
- 54 dents were reported, the deepest of which is 3.2%ID
- All 54 of the dents are located at the bottom.
- 21 No. Weld Anomalies recorded ( 4 Girth /17 Long)

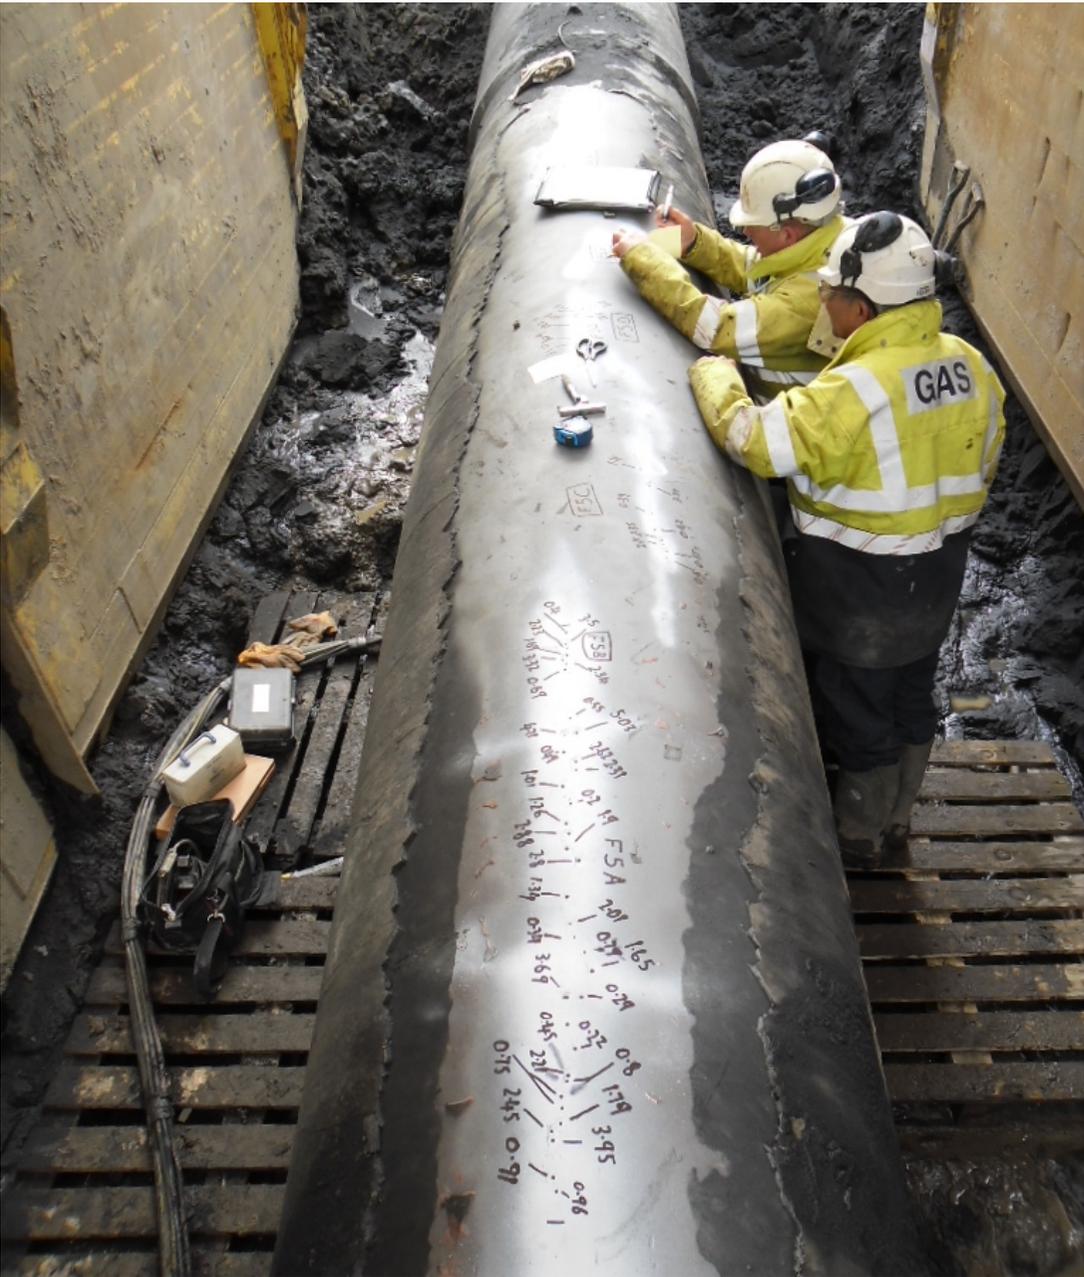
- Detailed Surveys

- Sleeve Repair
