Example of Pipeline damage and failure causes and case histories

Tony Stonehewer

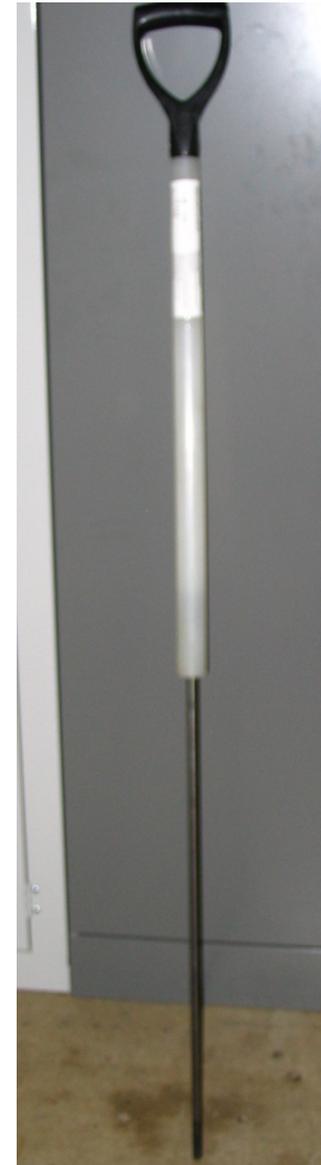
Immediate Causes – Human Factors

- Failure to follow Work Procedure Maint/5028
- Failure to follow Safe Operating Procedure SSW/22

Root Causes

- Inadequate training
- Shortfall in Competency Assessment
- No workplace monitoring carried out

Actions Taken

- 1 Raise awareness of Work Procedures
- 2 Training package to be introduced to cover supervision of mechanical excavation within 3 metres of HP pipelines (above 7 Bar)
- 5 Issue searcher bars
- 6 Pipeline Technician's to attend a people management course to help teach them how to be assertive
- 5 Pipeline technicians to be trained in the duties of banks person
- 6 Safety Technical Competency specific entry to cover supervision of mechanical excavation within 3 metres of HP pipelines (above 7 Bar). Training to have been attended.

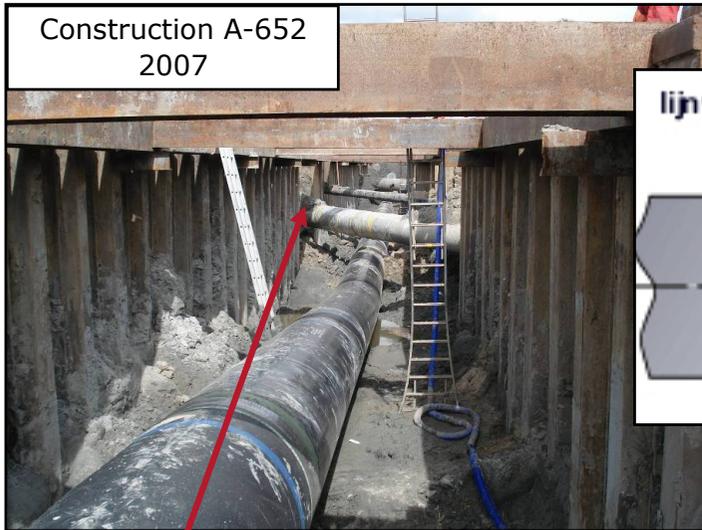
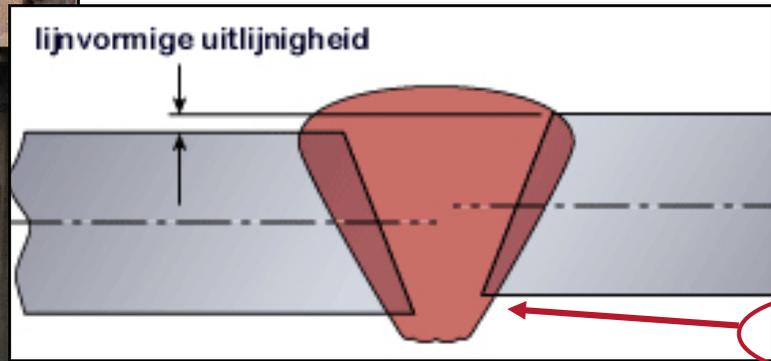
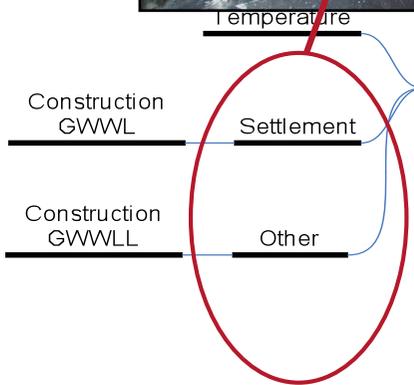
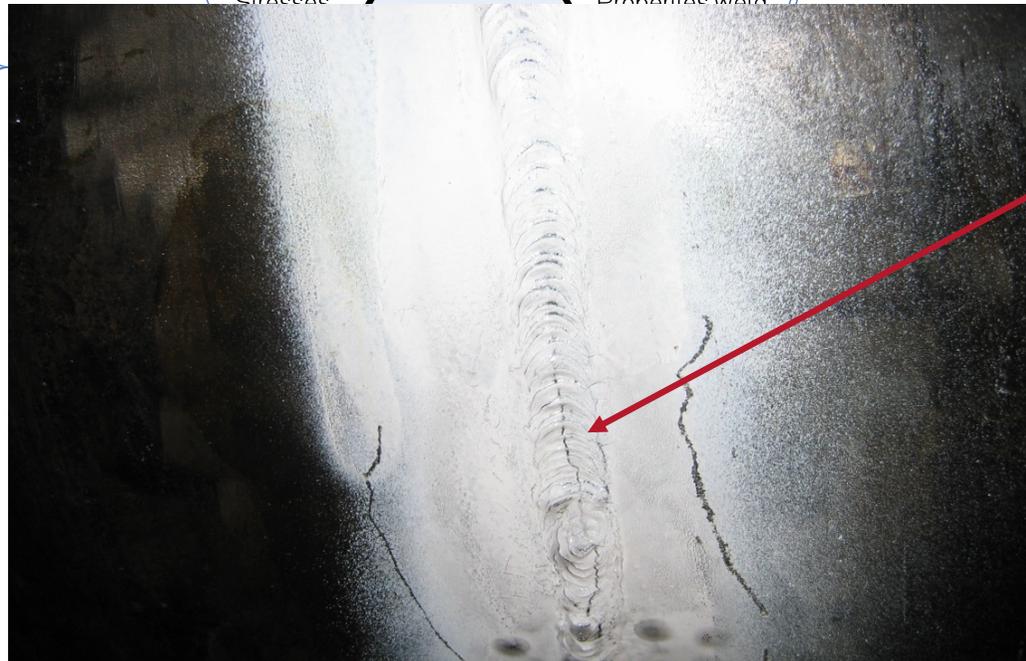
Material / Weld Defects

Geometry

- Strength
- Ultimate tensile strength
- Yield strength
- Fracture toughness
- Flow
- randinkarteling
- Gas inclusion
- Cold crack
- Other inclusions
- Corrosion
- Fatigue
- Stress corrosion cracking
