# Line Walking

# Line Walking as a Risk Reduction Measure

# Recent SEARs/RIDDOR report

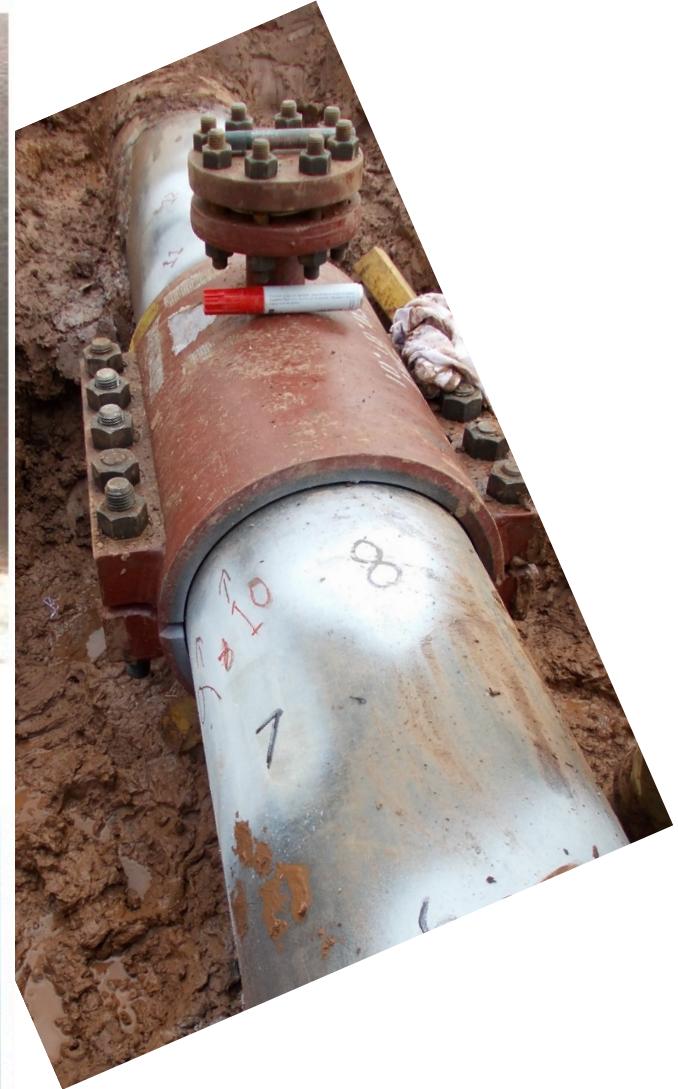
Dent:

Peak depth: 15.44mm

Gouge:

Peak depth: 1.5mm

Length: 48mm

Damage located at 09:00 around pipe circumference, 12:00 is the top of the pipe

1. Initially temporary shell fitted.
2. Permanent epoxy grouted repair shell fitted.
3. Pressure returned to 19 Bar
4. Coating and wrapping completed
