THE PALACEKNOWE PIPELINE DIVERSION FAILURE

On Wednesday 22nd December 1993 a steel pipeline carrying natural gas at high pressure fractured at Palaceknowe near the village of Beattock in Dumfries and Galloway.

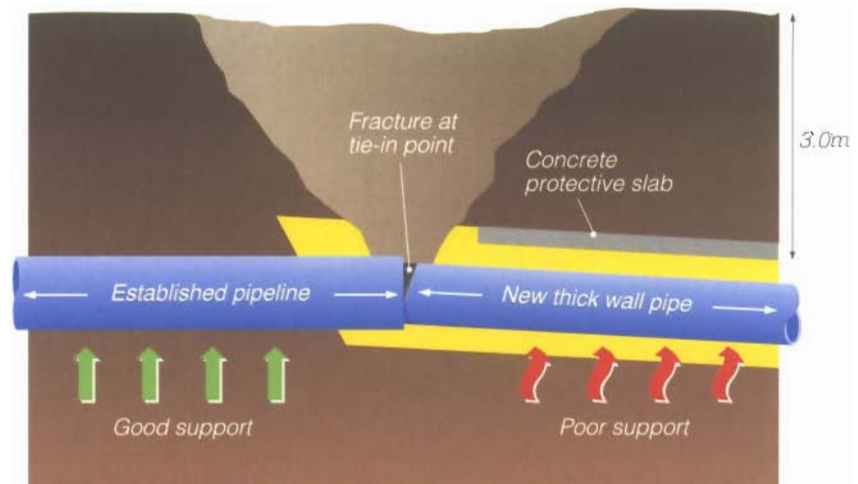
Beattock

The failed pipe could clearly be seen at the bottom of the crater

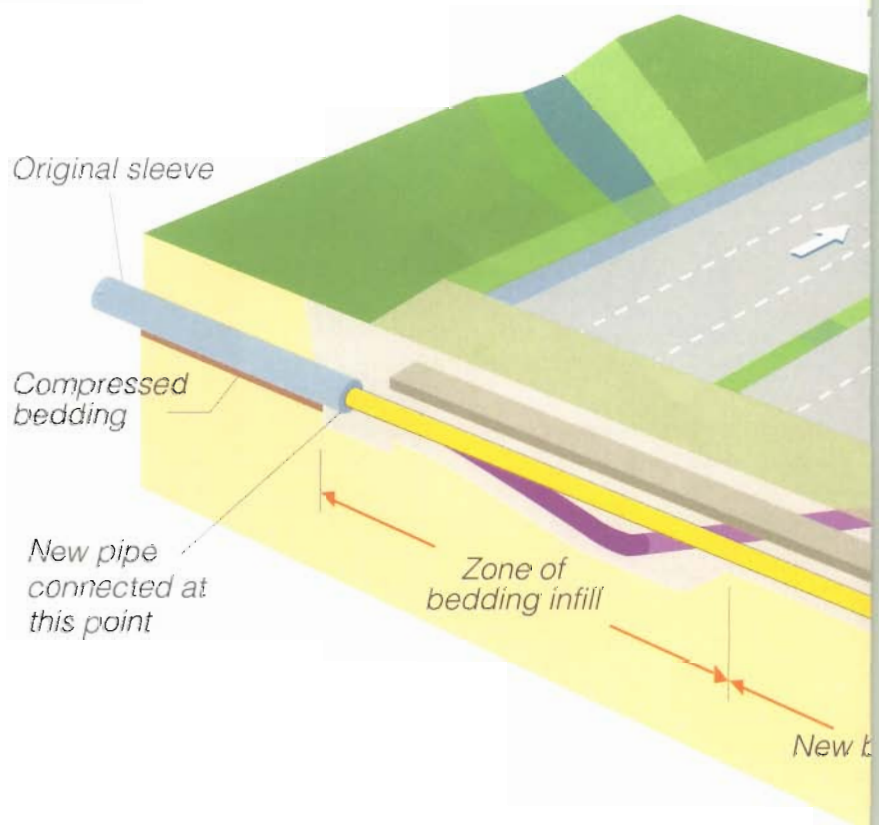
The new section of pipeline was connected to the original pipe at an existing steel construction joint. This special joint provided a seal to a casing around the thin walled pipe. The casing offers protection to the gas transmission pipeline where it crosses below the A74 trunk road. The pipeline failed in this component in the metal alongside the thick walled pipe connection weld.

The location of the motorway dictated a modification to the pipeline alignment. This involved a change to the position of a stream crossing and a reduction in the pipeline depth over part of the diversion length. This placed the new pipeline on an area of disturbed ground where the original pipeline had been deeper.

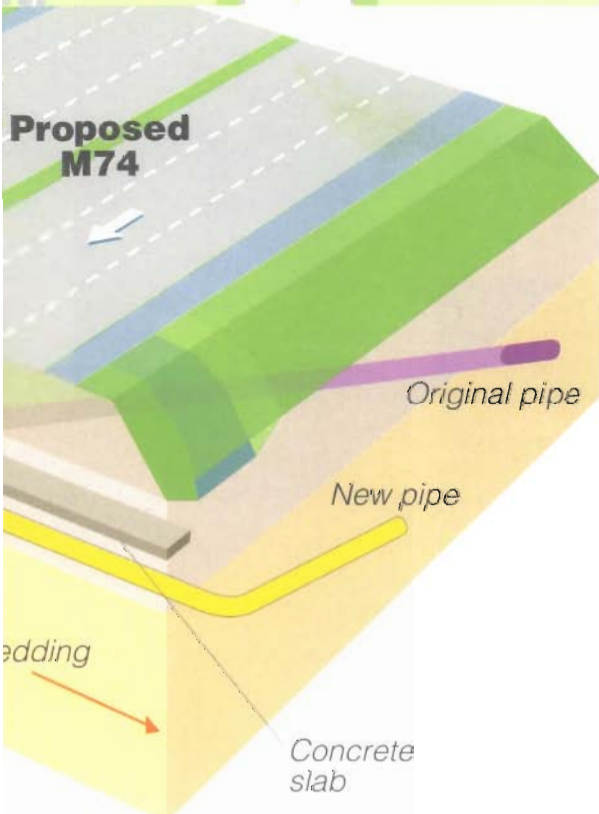
The diversion had involved a change in the vertical level of the pipeline and this had placed the new pipe on a layer of soil infill materials. One of these materials was subsequently found to be sensitive to compression under water saturation. This would have occurred at some time after pipeline construction and backfilling. The soils also exhibited compression under the action of the considerable depth of material above the pipeline. A concrete protective slab produced additional loading and compression to the soils below the pipeline. The combined loading from the concrete slab and overburden material produced a differential settlement along the pipeline which produced a very high bending load at the pipe to casing joint.

Cut out section of pipeline containing the fracture
