Feeder 15

Feeder 15 Key Points

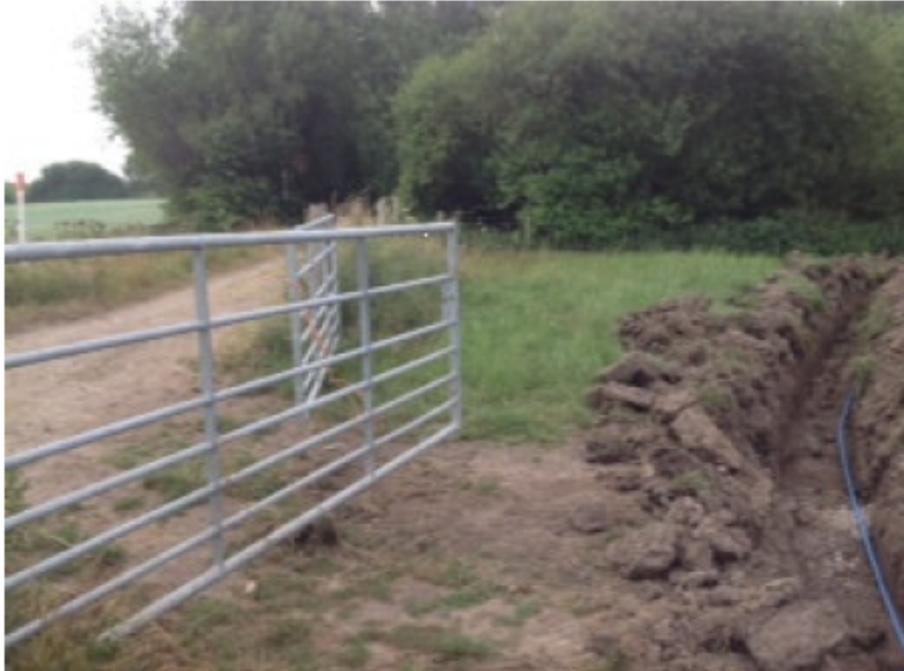
- Work found by Aerial Surveillance
- Contractor stopped work when he came across red backfill sand
- Landowner (Mother) responded to annual letter, Tenant farmer (Son) was aware of pipeline
- Planning Application to Wigan council for new Barn
- Work started before Planning Approved
- Local Authority did not identify pipeline at risk (failed to turn on screen which contained pipeline details)
- Despite visit to site after first incident farmer crossed pipeline again few days later.
