Investigation of RMA Valves - Weld Defects

UKOPA Members Meeting

February 2023

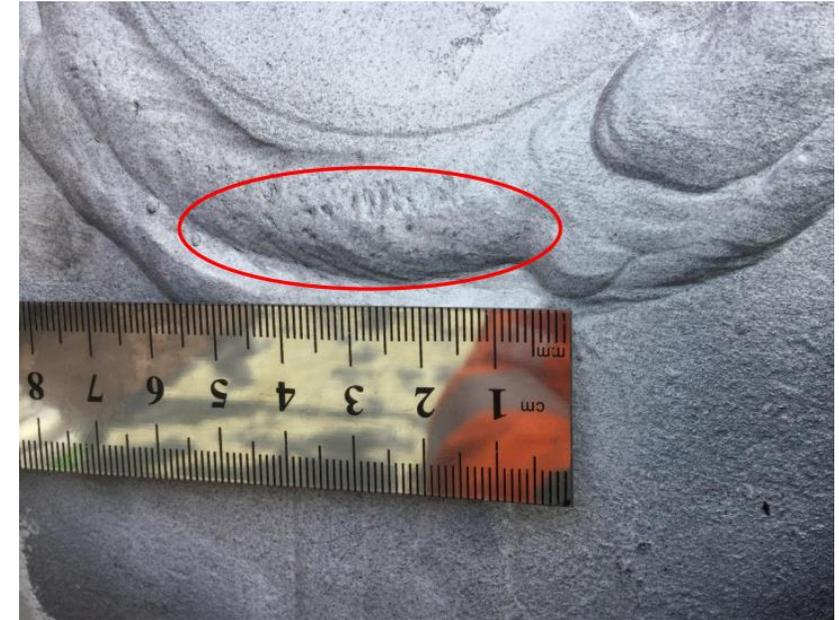
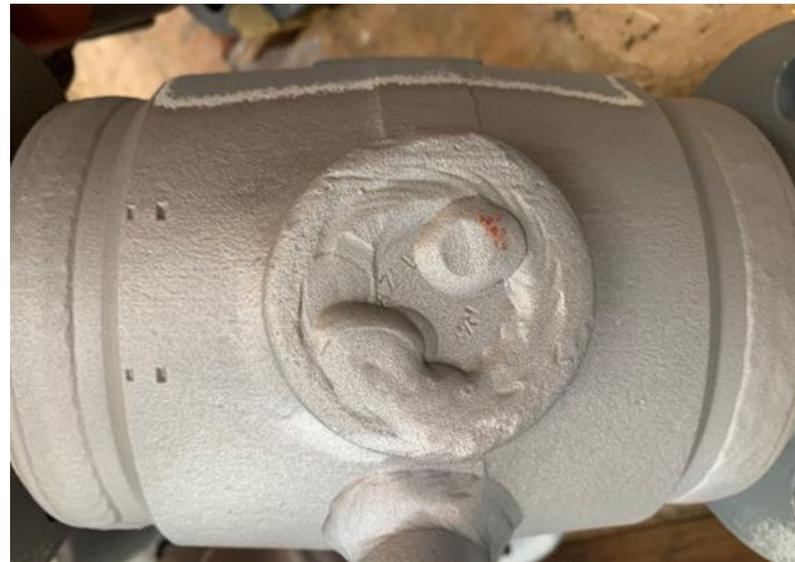
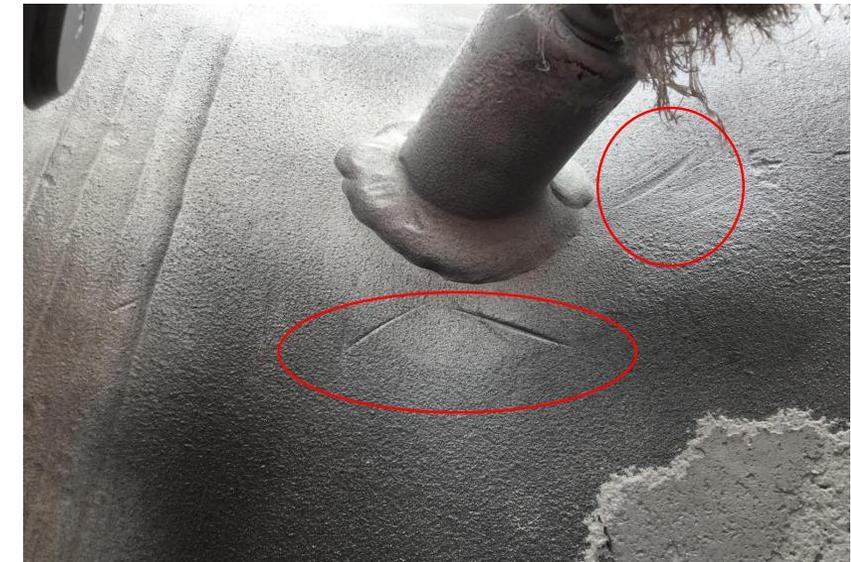
Ranges of defects were found highlighting signs of poor workmanship quality

Developed Engineering Investigation with ROSEN to understand the extent of the impact

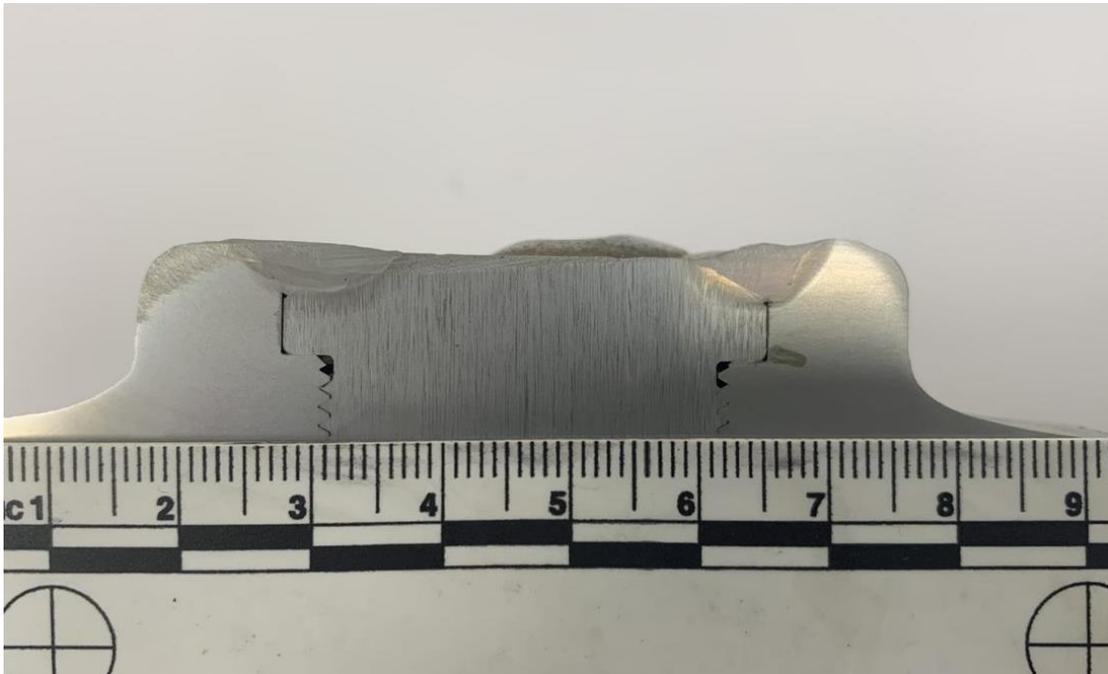
Stage 1 – Initial Inspection

ROSEN I/D	Serial Number	Nominal Diameter	Class Rating	Databook	Comment
16480-1	19A038736	2"	600	RMA ref - A11900082, PO – 3400006749-2	Documentation provided suggests that one, some or all seven of these valves were subject to rework.
16480-2	19A038733	2"	600	RMA ref - A11900082 PO – 3400006749-2	
16480-3	19A038735	2"	600	RMA ref - A11900082 PO – 3400006749-2	
16480-4	19A038732	2"	600	RMA ref - A11900082 PO – 3400006749-2	
16480-5	19A038734	2"	600	RMA ref - A11900082 PO – 3400006749-2	
16480-6	19A038731	2"	600	RMA ref - A11900082 PO – 3400006749-2	
16480-7	19A038730	2"	600	RMA ref - A11900082 PO – 3400006749-2	
16480-8	21A003244	4"	600	RMA ref – A12100375 PO – 3400127257	Nameplate not attached upon receipt - Origin confirmed in email from Josh Blake dated 11th Feb.
16480-9	19A038725	4"	600	RMA ref – A11900082 PO – 3400006749-2	-
16480-10	20A082915	4"	900	RMA Ref – A12002564 PO – 3400090687-2	Surface breaking defect on branch fillet weld.

Sample	Visual	MPI	DPI
1 DN50 CL600 SN 19A038736	Poor restart, Crater crack	LOF	Surface pore
2 DN50 CL600 SN 19A038733	-	LOF	-
3 DN50 CL600 SN 19A038735	-	-	-
4 DN50 CL600 SN 19A038732	Poor restart / LOF/ cold lap Trunnion repair	LOF	Overlap
5 DN50 CL600 SN 19A038734	-	-	-
6 DN50 CL600 SN 19A038731	Poor restart / LOF/ cold lap	LOF	Overlap, Gas pore
7 DN50 CL600 SN 19A038730	Incompletely filled groove	LOF	-
8 DN100 CL600 SN 21A003244	Linear porosity Incompletely filled groove	Multiple pores, LOF Surface anomaly noted	Overlap
9 DN100 CL600 SN 19A038725	Incompletely filled groove	Overlap, LOF Incompletely filled groove	Overlap, Gas pore Incompletely filled groove
10 DN100 CL900 SN 20A082915	Porosity / elongated cavity	Crater crack LOF, Mechanical damage reported	Gas pores
11 DN250 CL600 SN 19A038668	Linear porosity / isolated pores Incomplete weld, Spatter	Crack like indications, Gas pores	Gas pores Incompletely filled groove

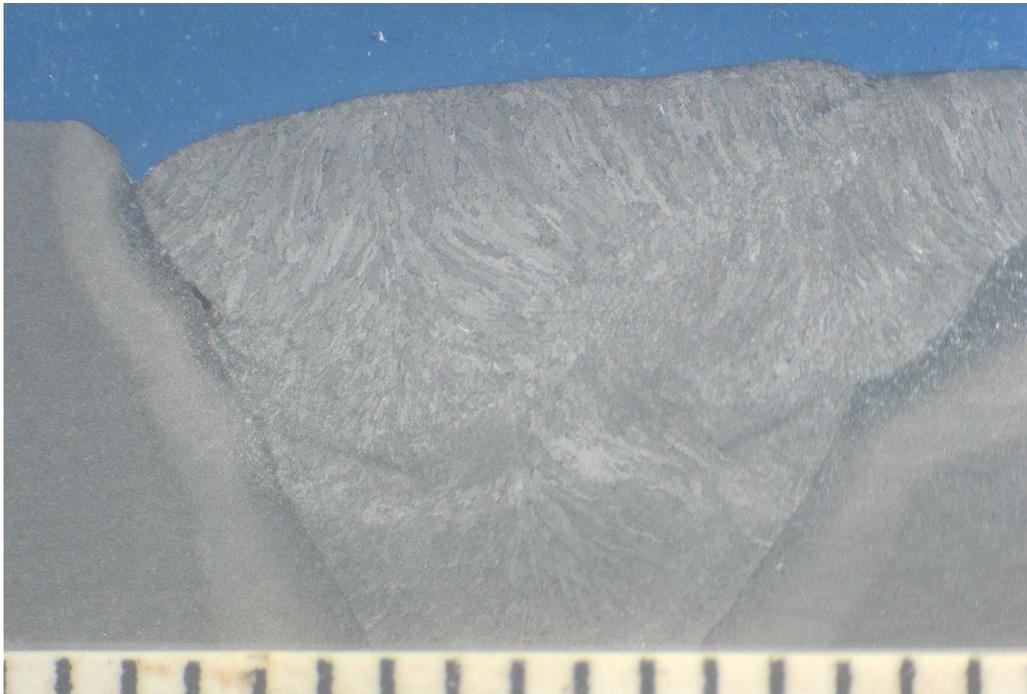
Stage 1 – Databook Review

- Some high level documents do not correlate
- Generic ITP / QCP used across databook's states DN400 to DN1400
- NDT consistently reported to be to ASME.
 - No evidence of PD 5500 criteria, as per V/6 requirements
- Material Certification:
 - Have V/6 requirements for tensile and impact testing been met?
 - Regular use of “dual qualification” generated some inconsistencies.
- Reference to P355NL / Q&T contradictions

- Some supporting PQR's over 20 years old. This would typically require supplementary weld testing
- All welding multi pass qualified

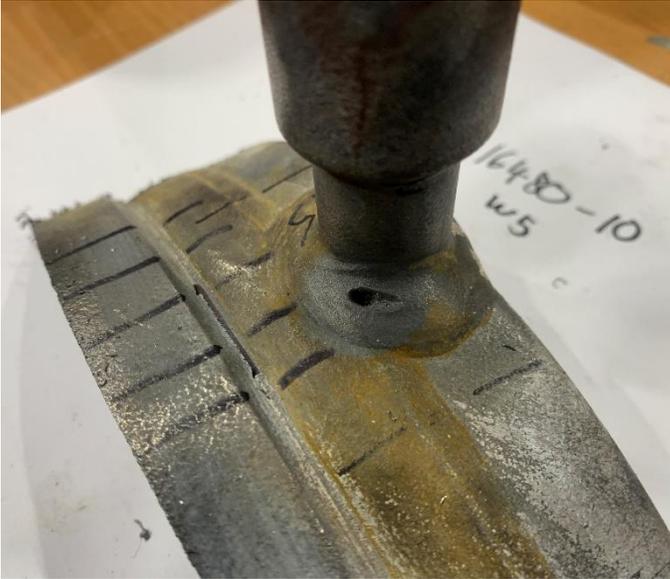
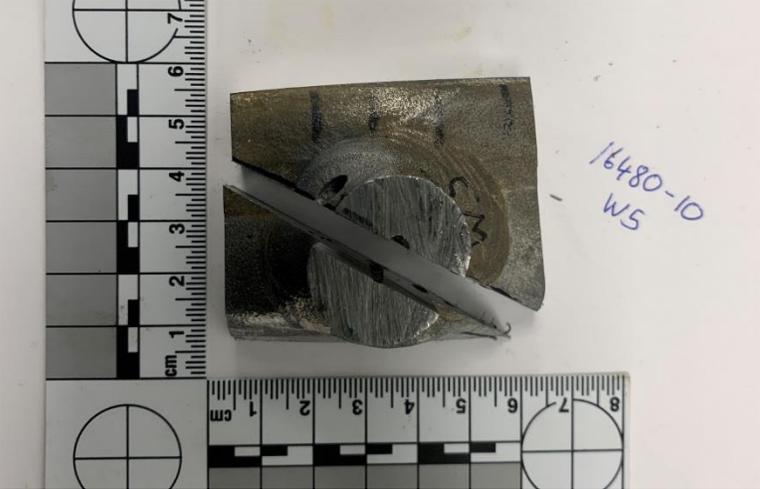
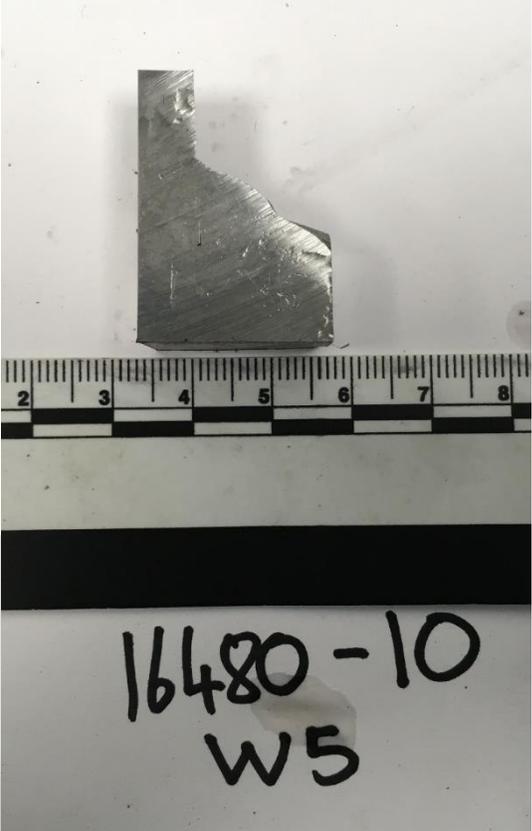
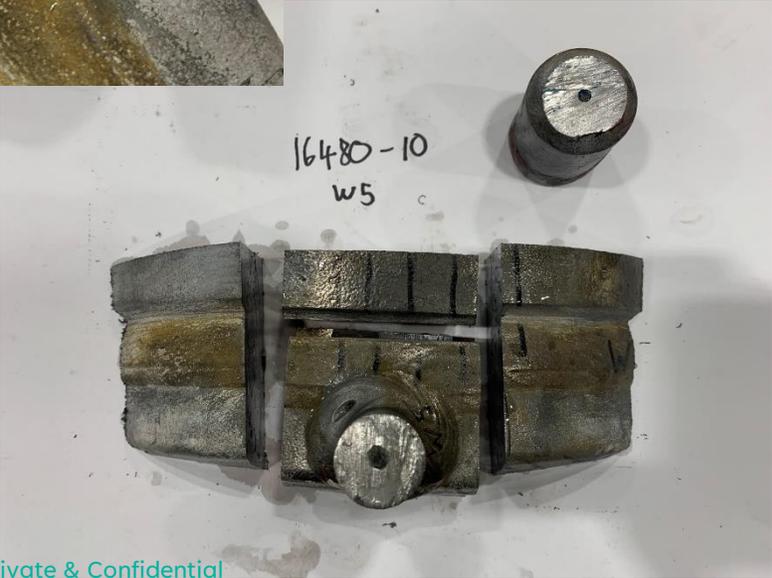
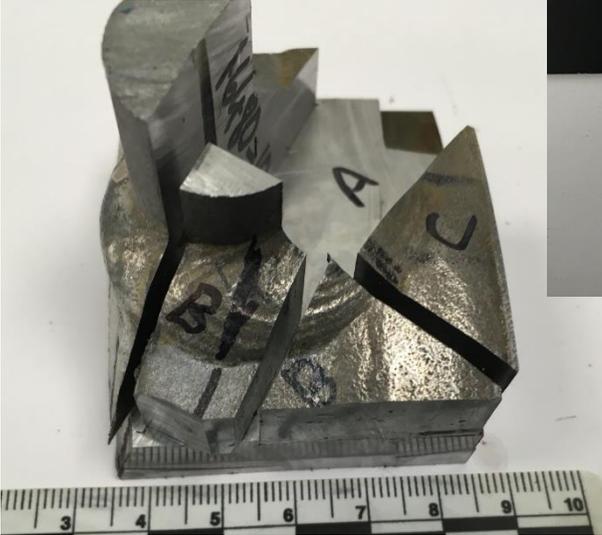
Lab Findings – Metallographic Examination

NDT Findings were sectioned and examined using metallographic techniques to gain information on the morphology and associated feature severity.

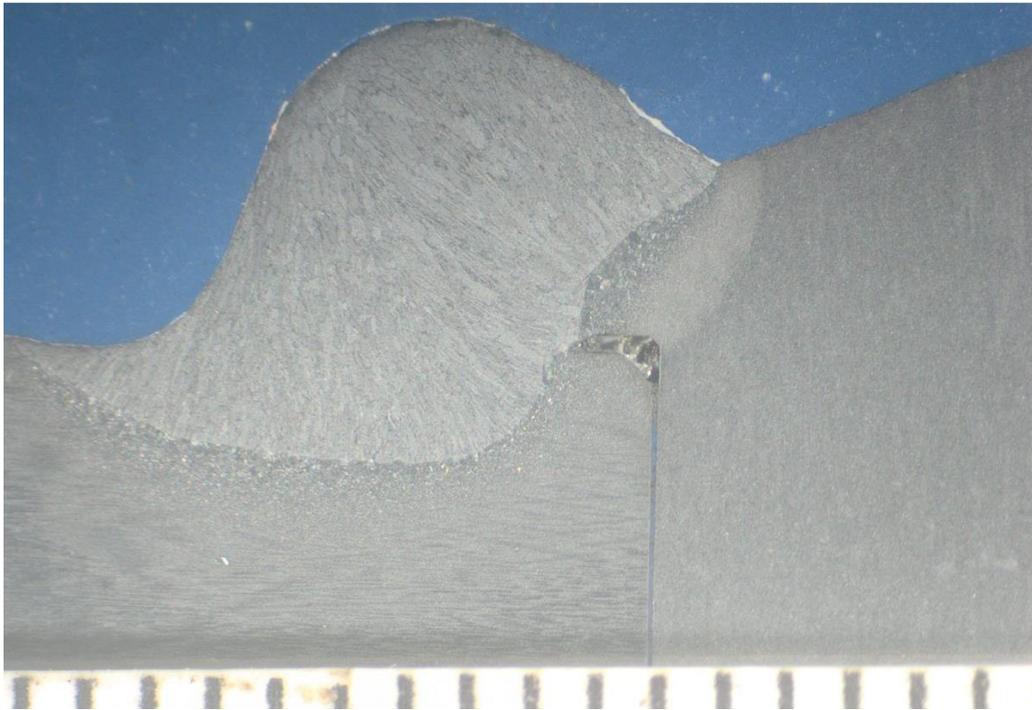
Stage 2 – Engineering Analysis

- Concern that poor quality welds could lead to disruptive failure of the pressure containment
- Calculations to assess:
 - Strength of socket welds for vent / drain / sealant connections
 - Implications of cracks in circumferential butt welds
- Models can predict if a crack or small weld is stable, but cannot predict leakage rates (or if leakage would occur from a through wall feature)
- Analyses do not consider functional aspects of the valves i.e. ability to seal or operate under pressure

- B31.3 has the lowest allowable stress, hence the largest tolerable crack sizes
- P355 materials are not listed in B31.3 but allowable stress would be virtually the same A350
- TD/12 allowable stress depends only on the yield strength, so results vary depending on the grade
- Smallest sizes are found for P355 due to the higher SMYS

The analyses cannot predict leakage from undetected small weld imperfections, only whether a failure of the pressure containment will occur from gross imperfections.

Leakage can only be prevented by a combination of quality control of welding, for example identifying undersize welds or stop-start defects, together with the factory pressure test.

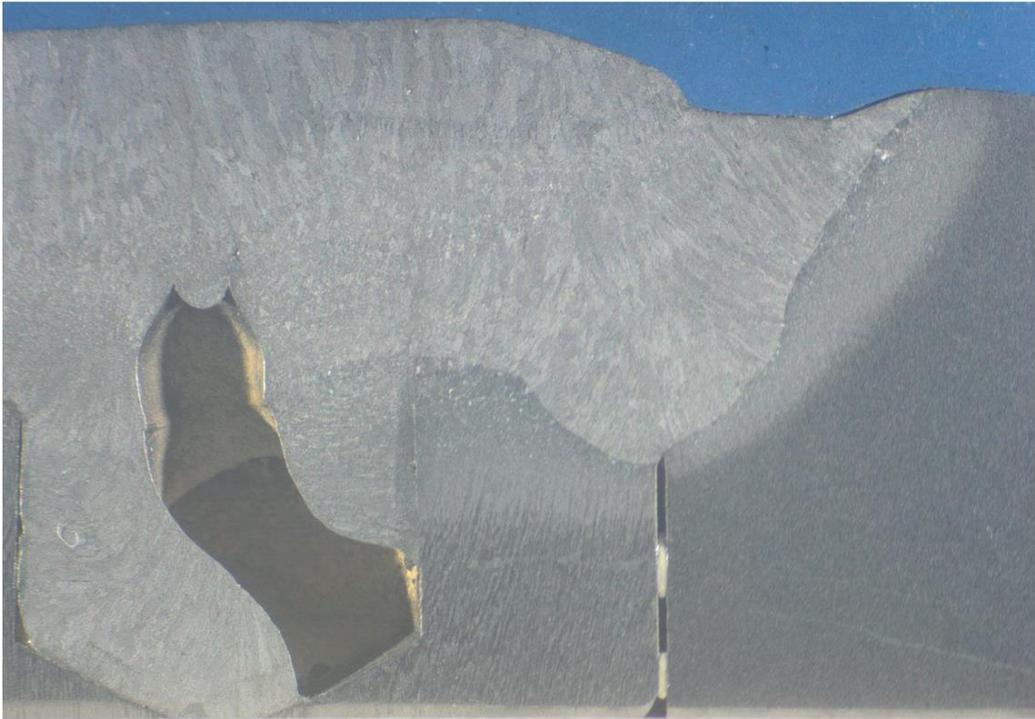
Conclusions & Next Steps

1. Systematic lack of process and quality control
2. Weld procedures and inspection reports are incomplete and lack detail.
3. No production welding traceability records in any of the documentation
4. Documentation relating to a single weld repair was insufficient and lacked important detail.
5. NGT surveillance is inconsistent across the documentation reviewed
6. There is evidence of failure to fully meet the requirements of V6
7. Material certification is incomplete or incorrect
8. Features in the welds that are consistent with poor quality welding, poor process control and poor quality control.
9. Catastrophic failure is unlikely to occur (cannot predict leakage)

- Risk Assessment is being developed to review all the valves on the NTS.
- Monitoring existing valves
- Quarantined existing valves to be scrapped.
- Qualifications of new suppliers undergoing a more rigorous process
- Monitoring visits on existing manufacturers particularly Legacy contracts
- Standardise internal processes for review of Databook's from suppliers
- Further work looking at the defective valves in hydrogen to understand the 'acceptable' defect sizes that could be present can still maintain a design life in hydrogen environment
 - Functional Tests & Destructive Tests
 - Collaboration Opportunity?
