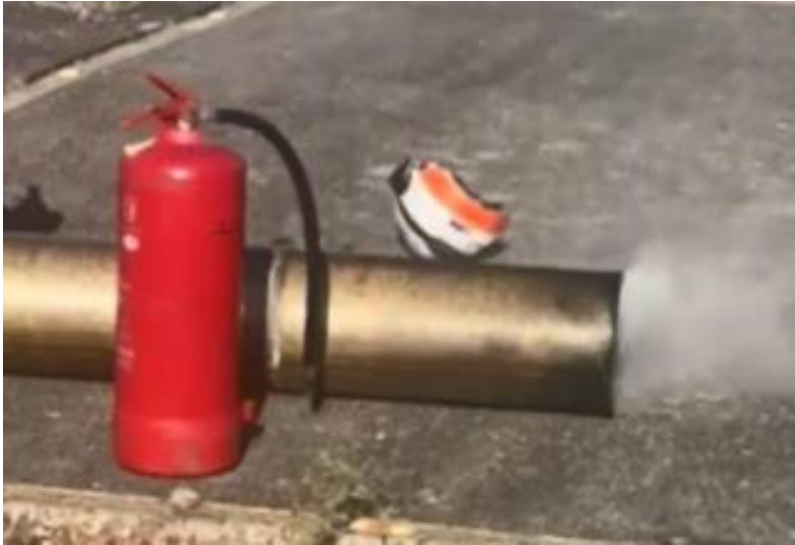
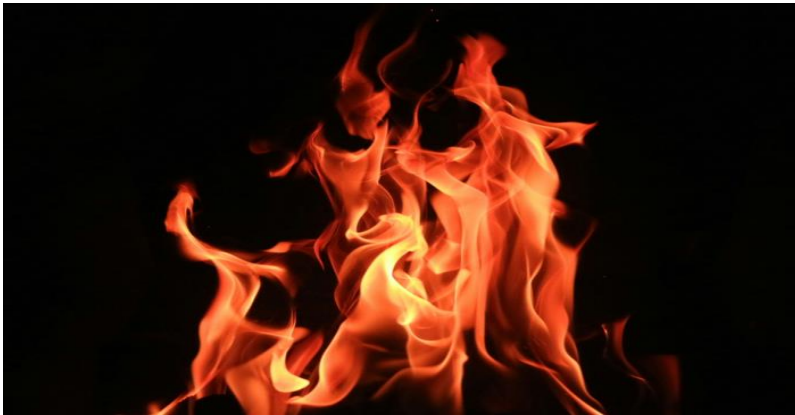
- When a gas installation was opened-up, pyrophoric dust inside ignited
- The combusting dust was extinguished with water and no damage occurred

- Dust can accumulate in gas installations such as filters and pipelines
- Some dusts may be pyrophoric in nature - they will spontaneously oxidise when exposed to air and release heat
- In gas pipelines, pyrophoric dust is likely to be iron sulphide – a result of the reaction between rust (from iron pipelines) and hydrogen sulphide
- Whilst in an enclosed gas installation, there is insufficient oxygen to allow combustion to take place but when containment is broken, the oxygen levels rise leading to oxidation
- Spontaneous oxidation of pyrophoric dust can result in the ignition of flammable substances such as natural gas
- When breaking containment if smouldering, smoke or burning embers are noted, the dust should be moved to a safe area (if safe to do so) and dampened down with water
