Sunoco Marcus Hook Refinery Ethylene Unit Fire - May 17, 2009 Lessons Learned

**API Subcommittee on Inspection
Dallas, TX, November 11, 2009**

**By Art Jensen, Mechanical Reliability Specialist
610-833-3901, ajensen@sunocoinc.com**

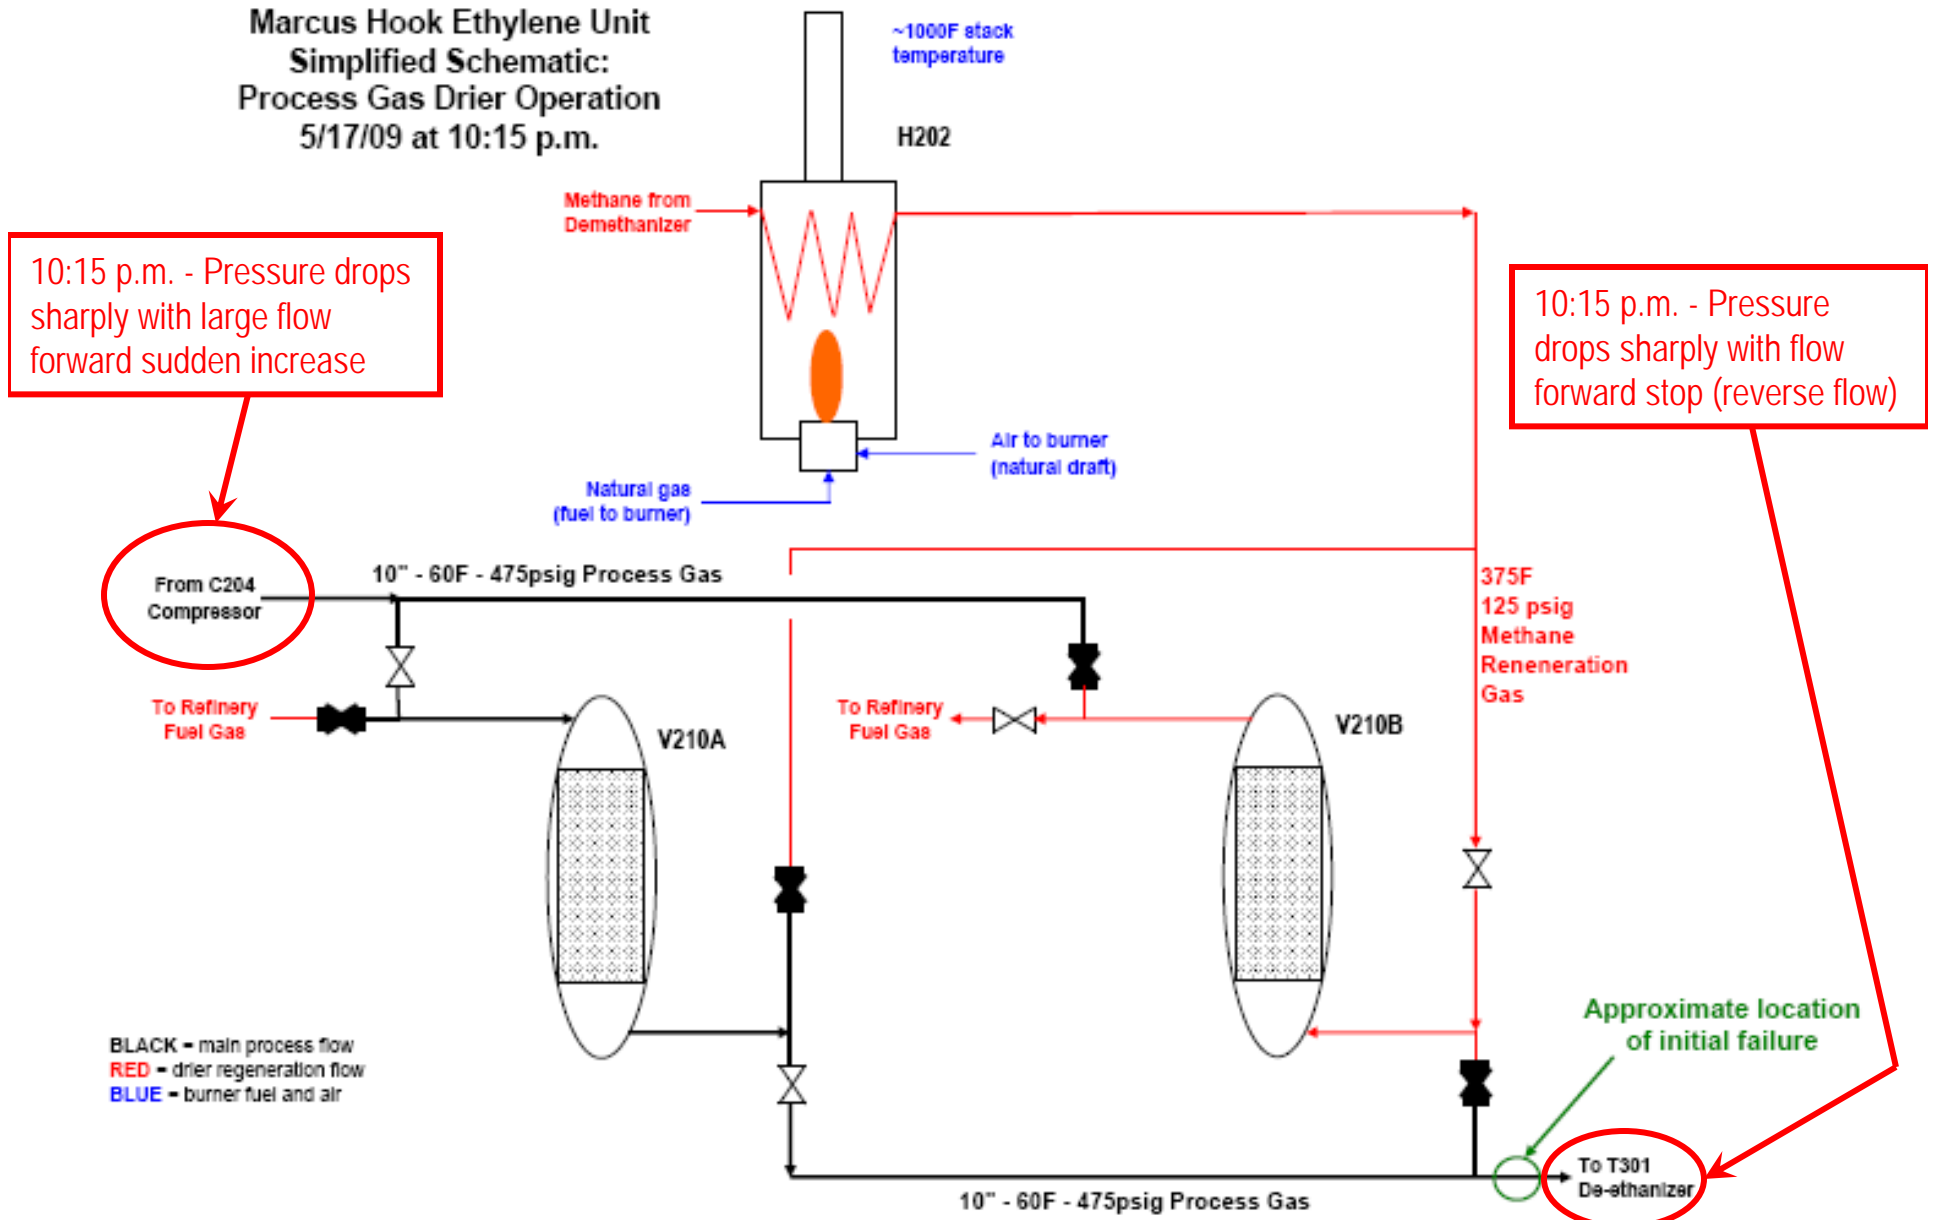
Process Drier Simplified Schematic

Marcus Hook Ethylene Unit
Simplified Schematic:
Process Gas Drier Operation
5/17/09 at 10:15 p.m.

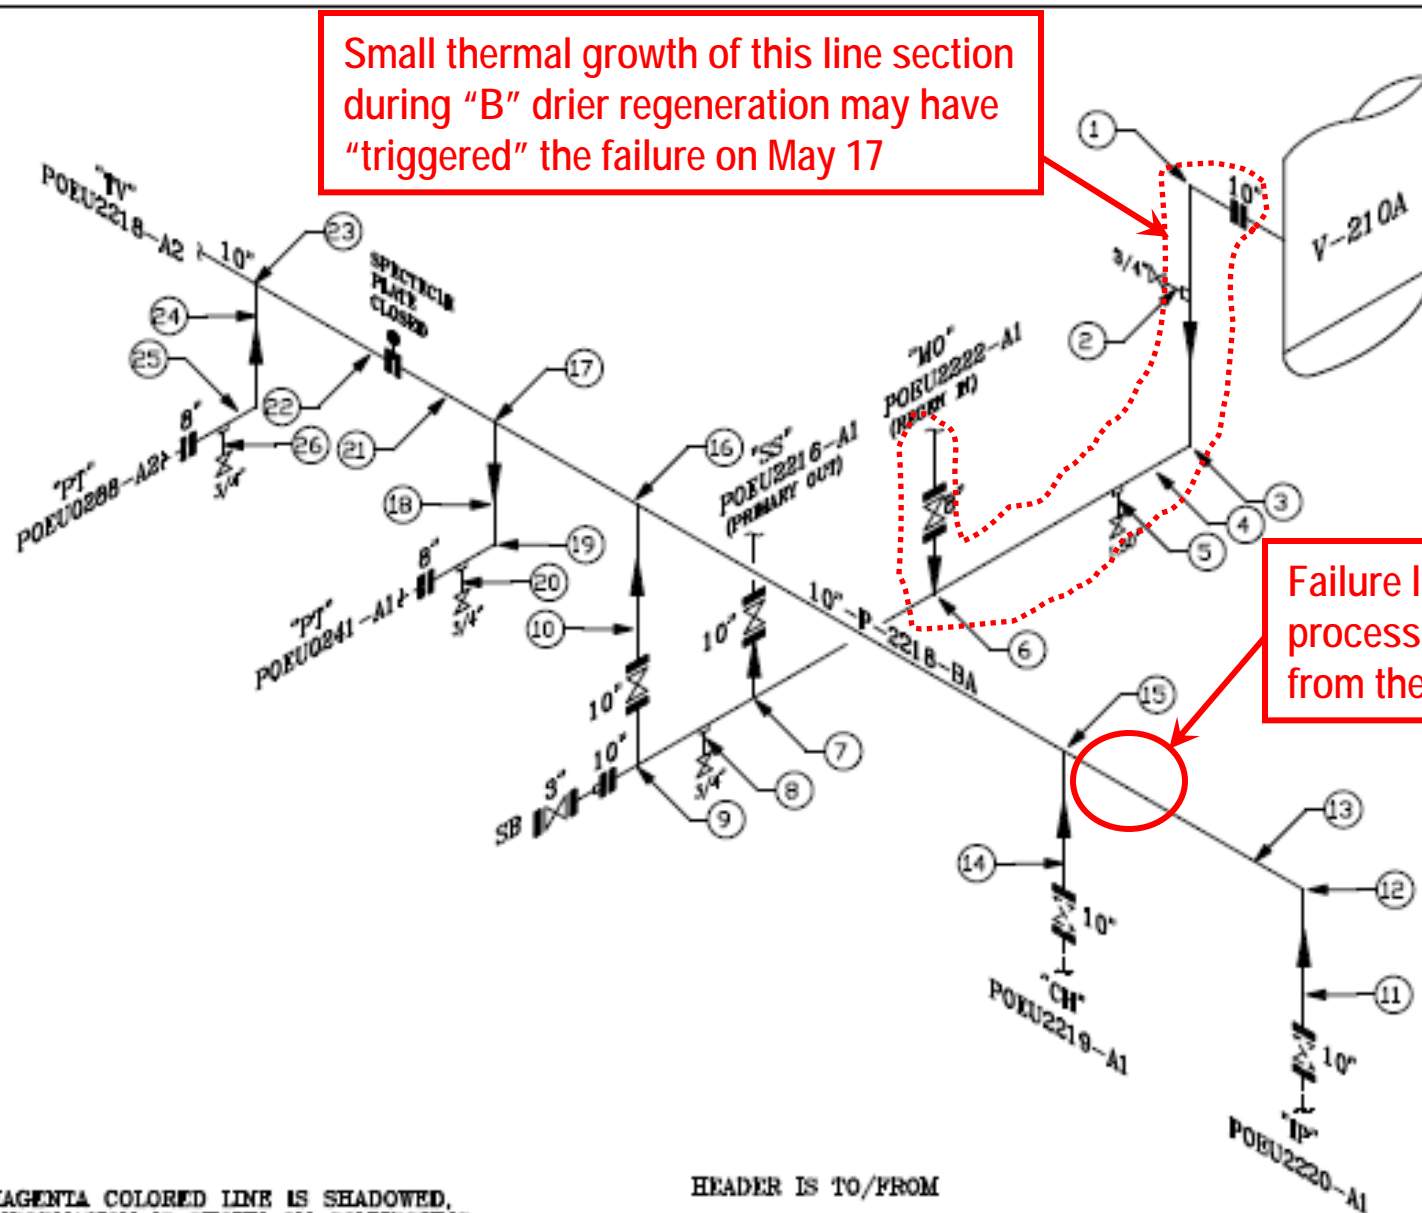
- Minimal wall loss over ~48 years; service is non-corrosive.
- Pipe would need to be <0.050" thick before it would burst.
- Data from March 2009 shows >0.350" remaining thickness (original nominal thickness of 0.365").
- Thickness data detects general thinning, and is not effective for localized problems such as contact corrosion.
- External visual inspections are also made per API-570.
