## IMCA Safety Flash 21/15

December 2015

The focus or theme of this safety flash is lifting. All the incidents involve cranes, lifting or loading operations.

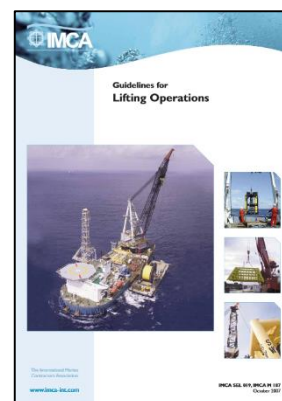
- ◆ The SWL plate fell from the crane auxiliary block and there were similar plates still on this block and on the main block. Both these blocks, and the whip line block, had all been replaced during the re-fit period to enable the crane to operate subsea for a particular project;
- ◆ The means of securing the plates was of poor design – several plates including the one dropped were attached by four rivets of dissimilar metals (aluminium vs steel) promoting galvanic corrosion process and salt water corrosion;
- ◆ All plates showed signs of corrosion behind the plate – however deterioration of the rivets was not visible on the plate surface;
- ◆ All plates were flush against their fixings and looked secure to any visual inspection;
- ◆ There was no significant weather at the time of the incident.

The plates were removed. SWL and other identifying information was stencilled on the crane instead. There was an inspection of similar hook blocks elsewhere to verify that there were no loose objects or unsecured plates. The crane supplier/manufacturer was informed of the incident (lessons learnt to prevent further reoccurrence).
