# Hard Spot and Mechanical Damage Characterization Using the Dual Magnetization Technology

UKOPA 2012 Technical Seminar  
Thomas Beuker  
29-May-2012

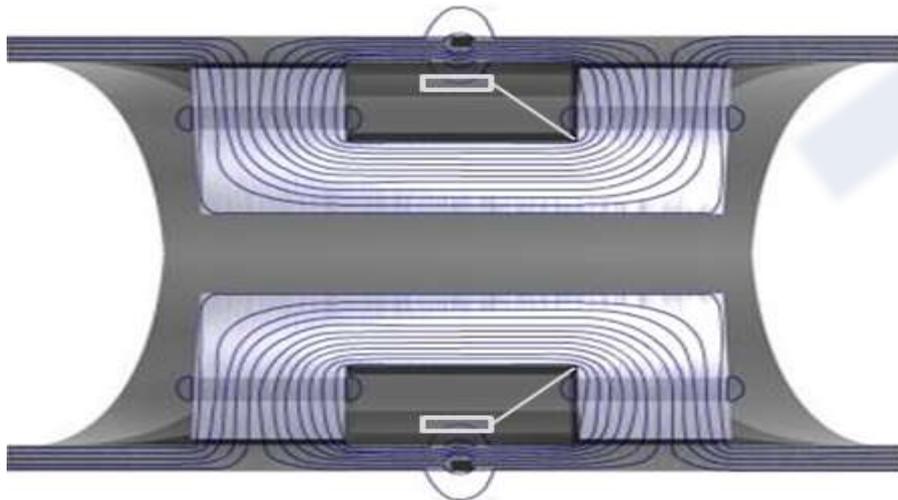
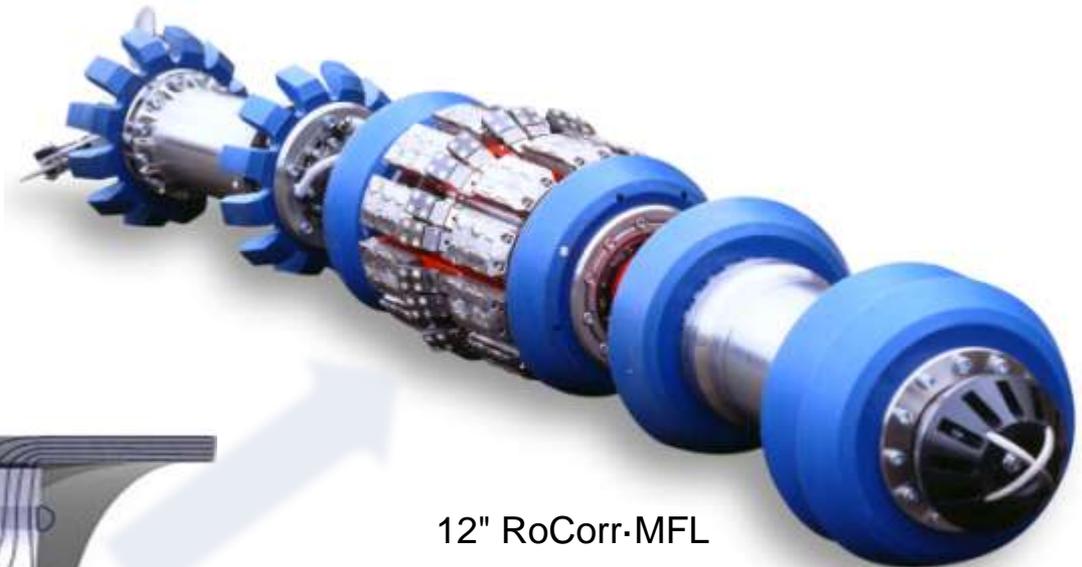
12" RoCorr-MFL

Axial Magnetic Flux Leakage magnetic circuit consist of permanent magnets, backing iron and the pipeline wall

pipeline anomalies like corrosion or metal loss generate a disturbance of the magnetic flux in the pipe wall

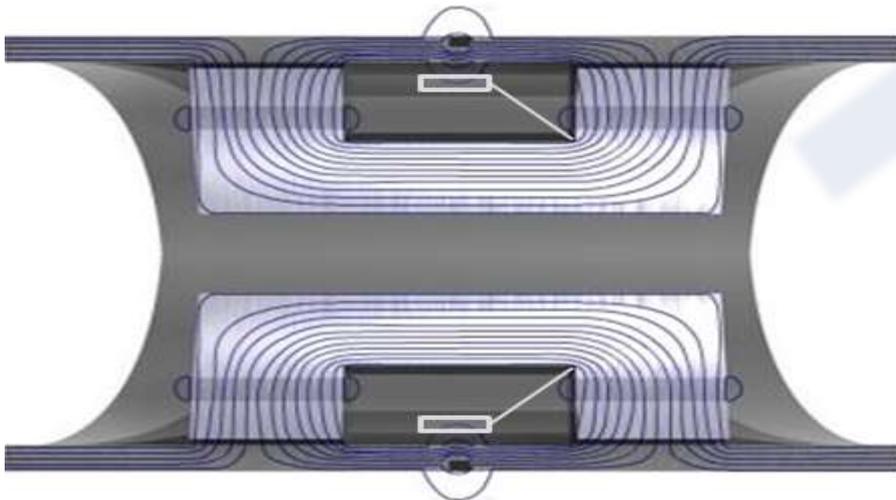
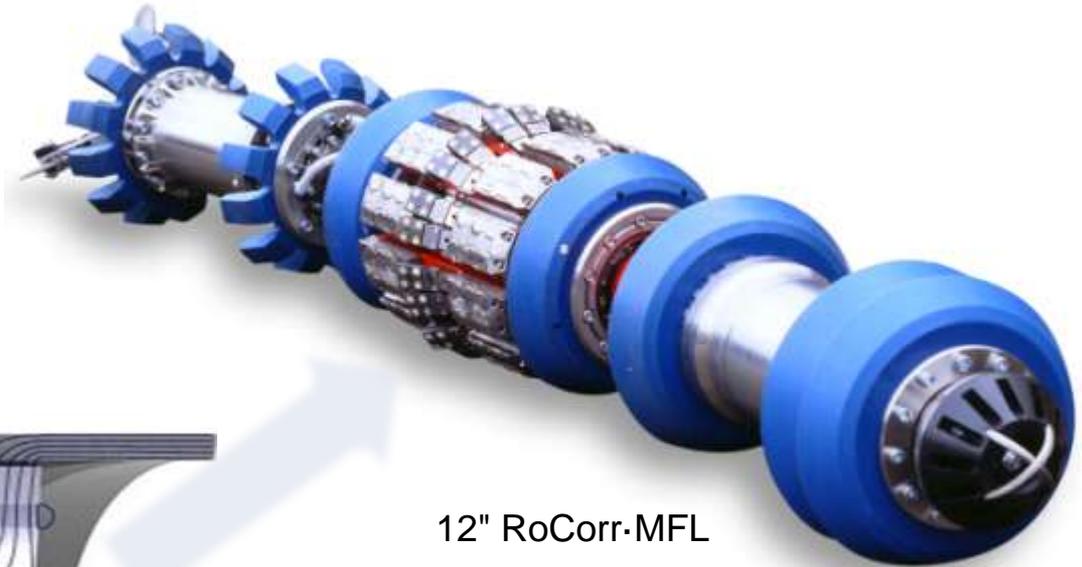
12" RoCorr-MFL

Axial Magnetic Flux Leakage magnetic circuit consist of permanent magnets, backing iron and the pipeline wall

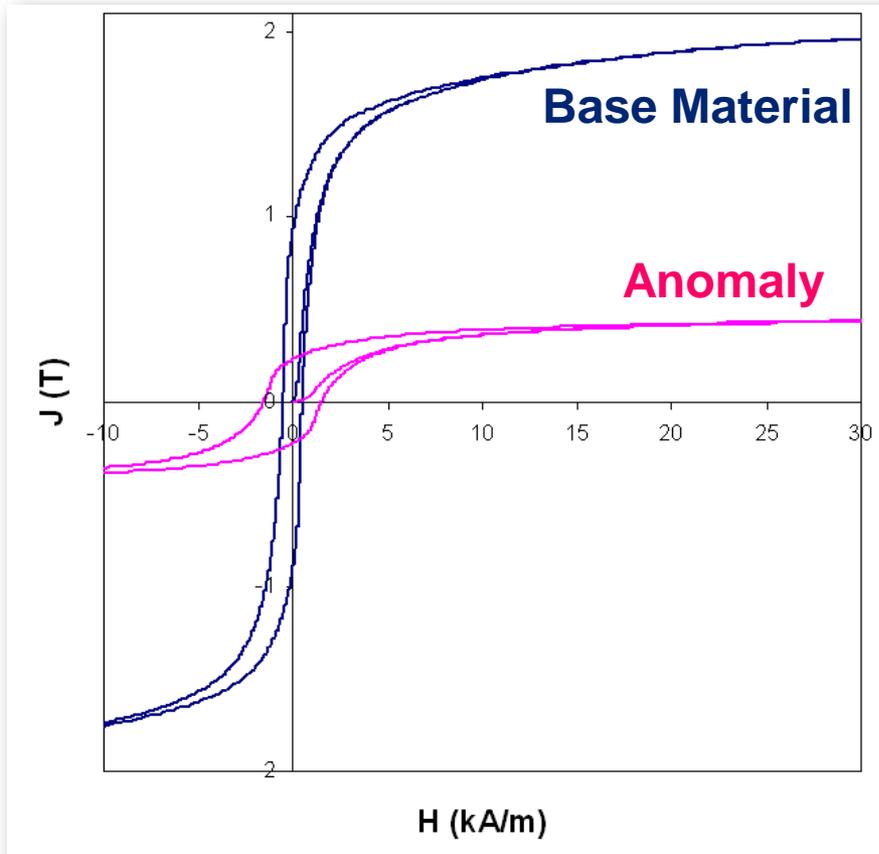
Microstructural Changes in the pipe material is generating different magnetic responses

Applies for various anomalies  
**hard spots, plastic deformation, cold working, overheating, arc burns ...**

Such anomalies are not changing the geometry of the pipewall

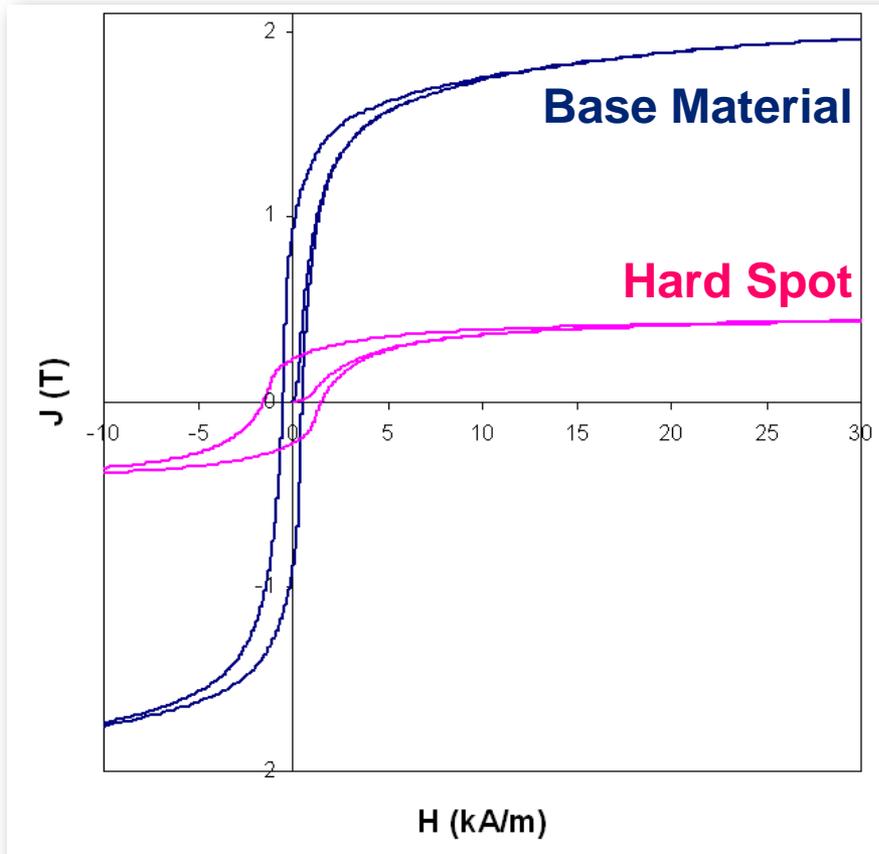
## Detection of Hard Spots by using Different Magnetic Responses

Differences in

- Saturation  $J_s$ ,
- Coercive Force  $H_c$ ,
- Remanent Magnetization  $J_r$   
**(but cannot be used !)**

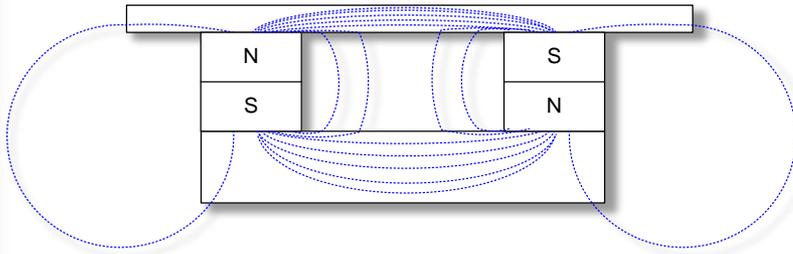
**HIGH Field 10-30 kA/m**

## Detection of Hard Spots by using Different Magnetic Responses

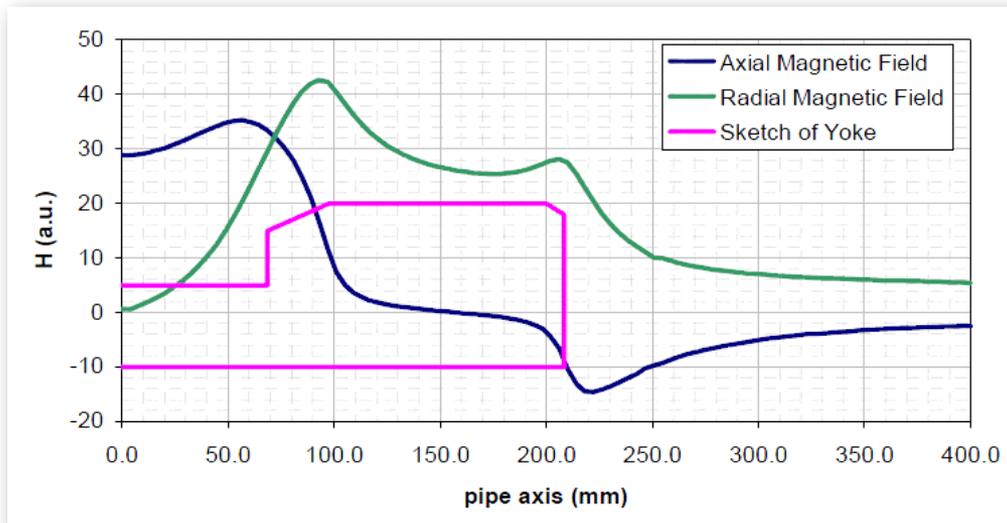
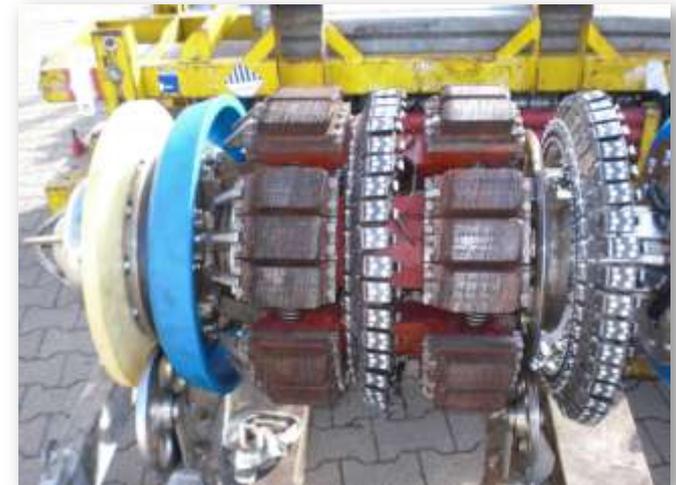
### Single Unit Tool

- position of low field sensor crucial
- avoid measurement in remanent magnetization ( $H=0$ )! **unpredictable results**

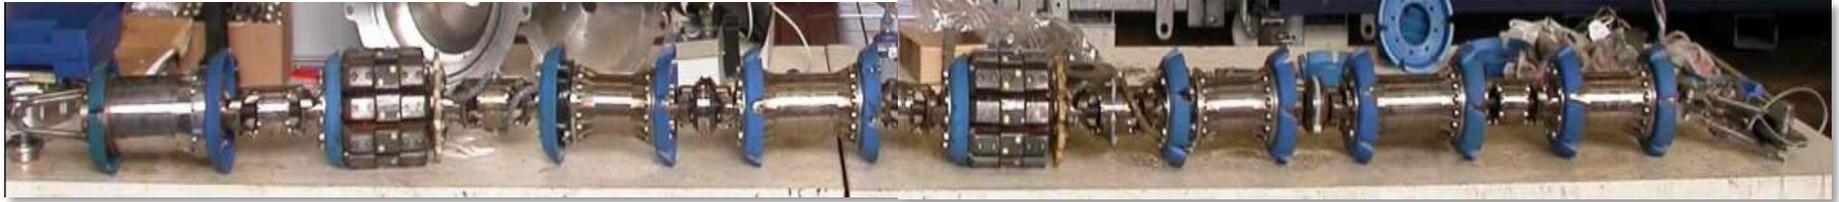
06" Dual Magnetization MFL Tool

alternative design is utilizing two magnet units for high and low field magnetization

mandatory for smaller diameter to achieve controlled magnetization condition

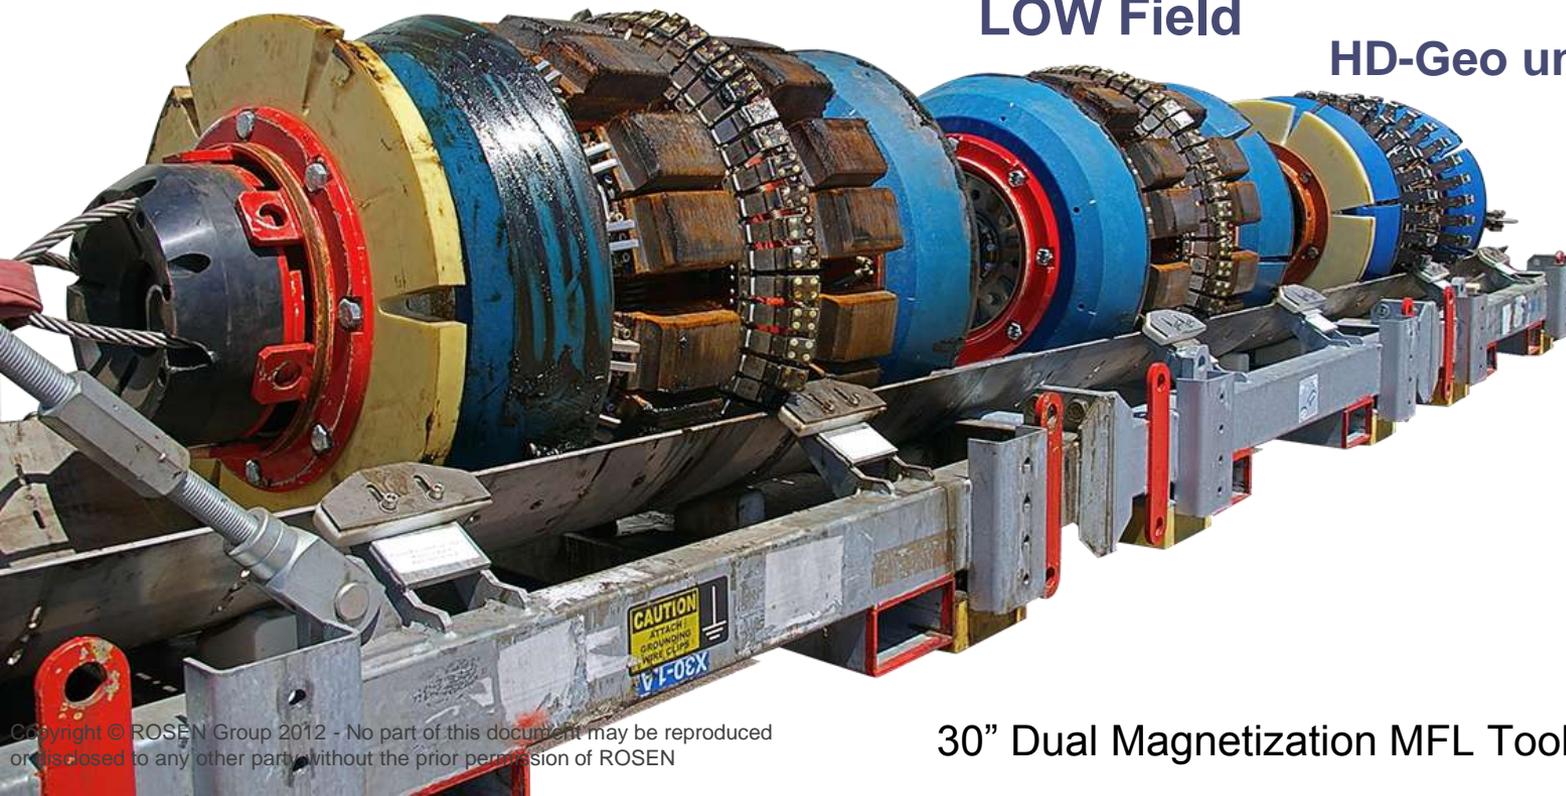
30" Dual Magnetization MFL Tool

drag of second MFL unit significant lower due to low field.

**HIGH Field**

**LOW Field**

**HD-Geo unit**

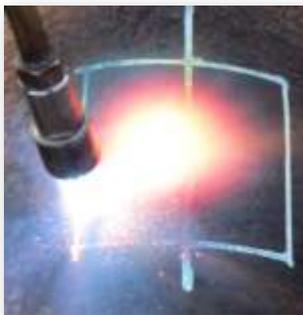
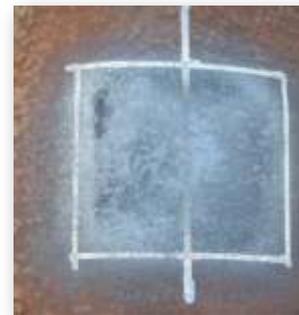
hard spot experiment for pulltest calibration

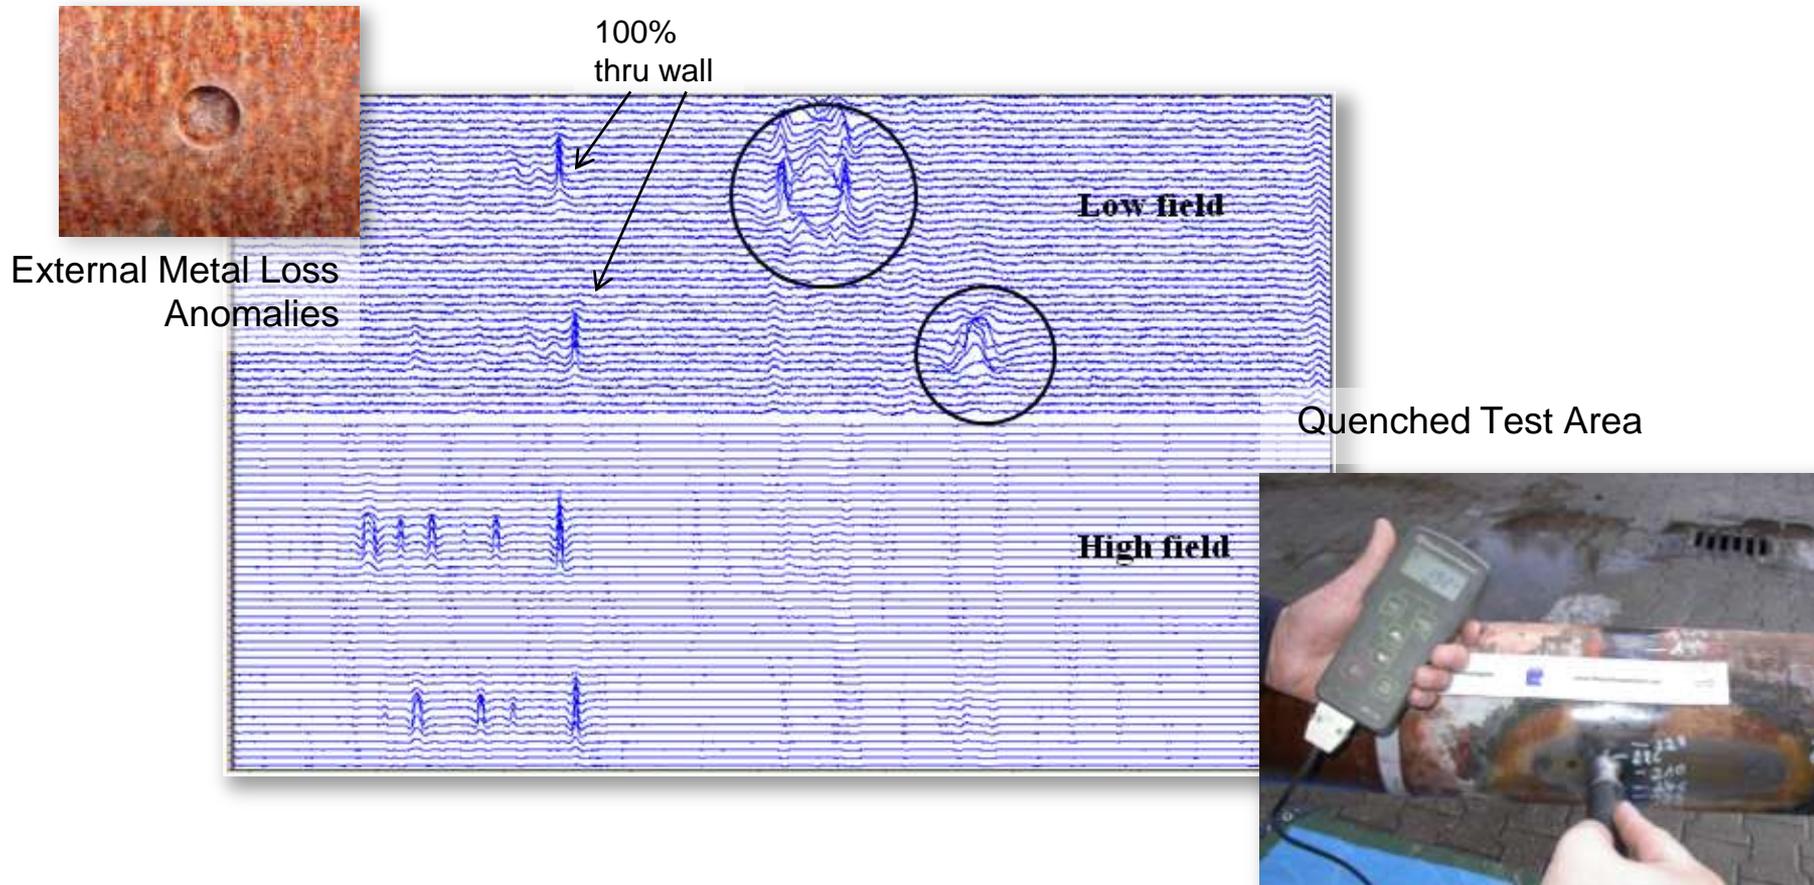
# Hard Spot Detection

Example of low field and high field data. Hard spot signals (circled) are clearly visible in the low field data, but not in the high field data.

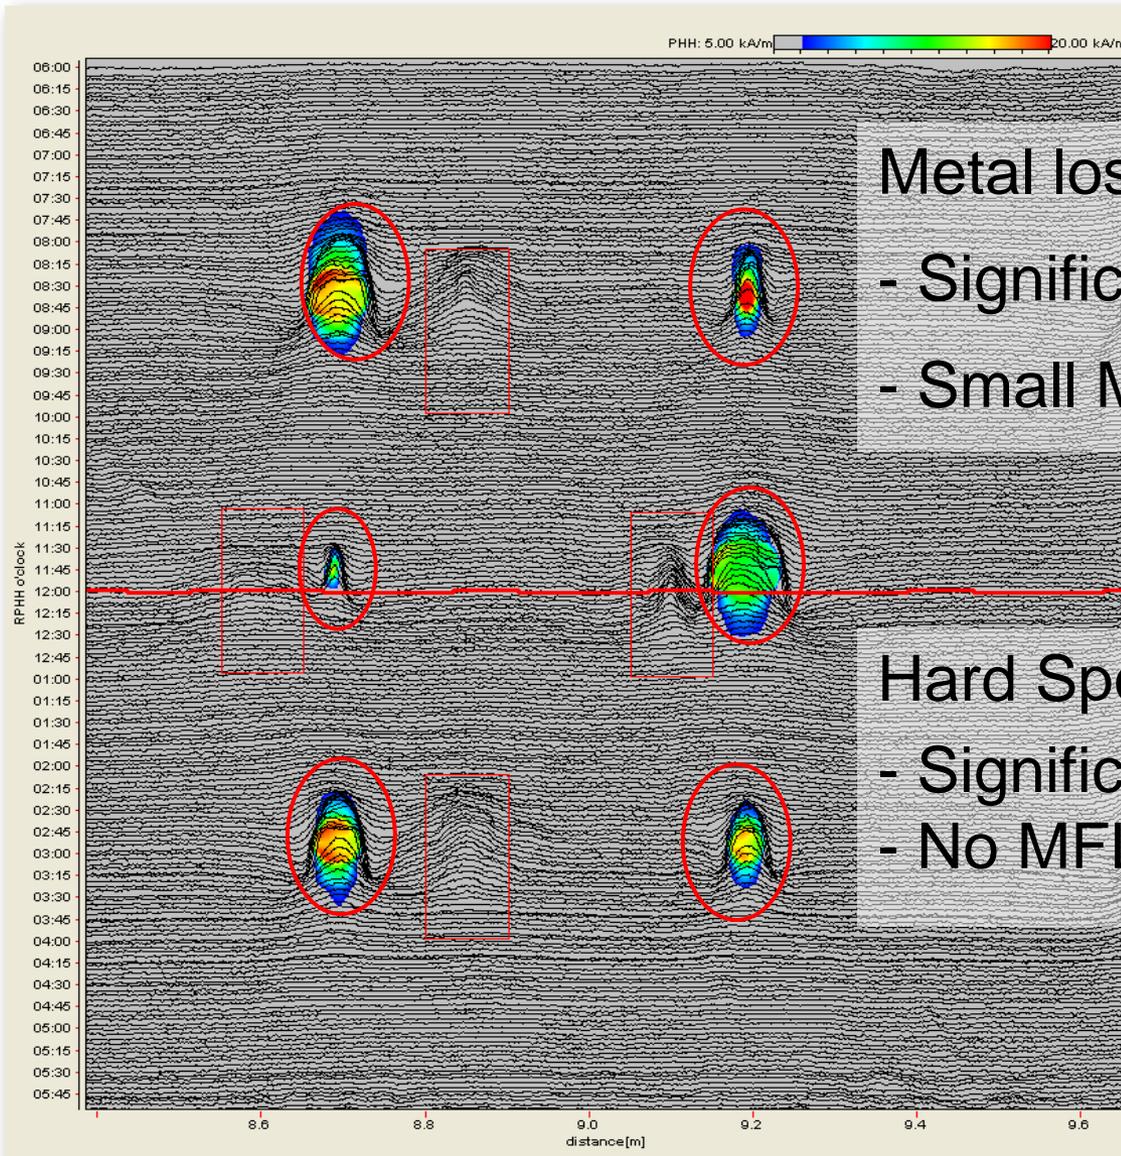
# Pull test examples

Metal loss (Ellipses):

- Significant MFL at HIGH field
- Small MFL at LOW field

Hard Spot (Boxes):

- Significant MFL at LOW field
- No MFL at HIGH field

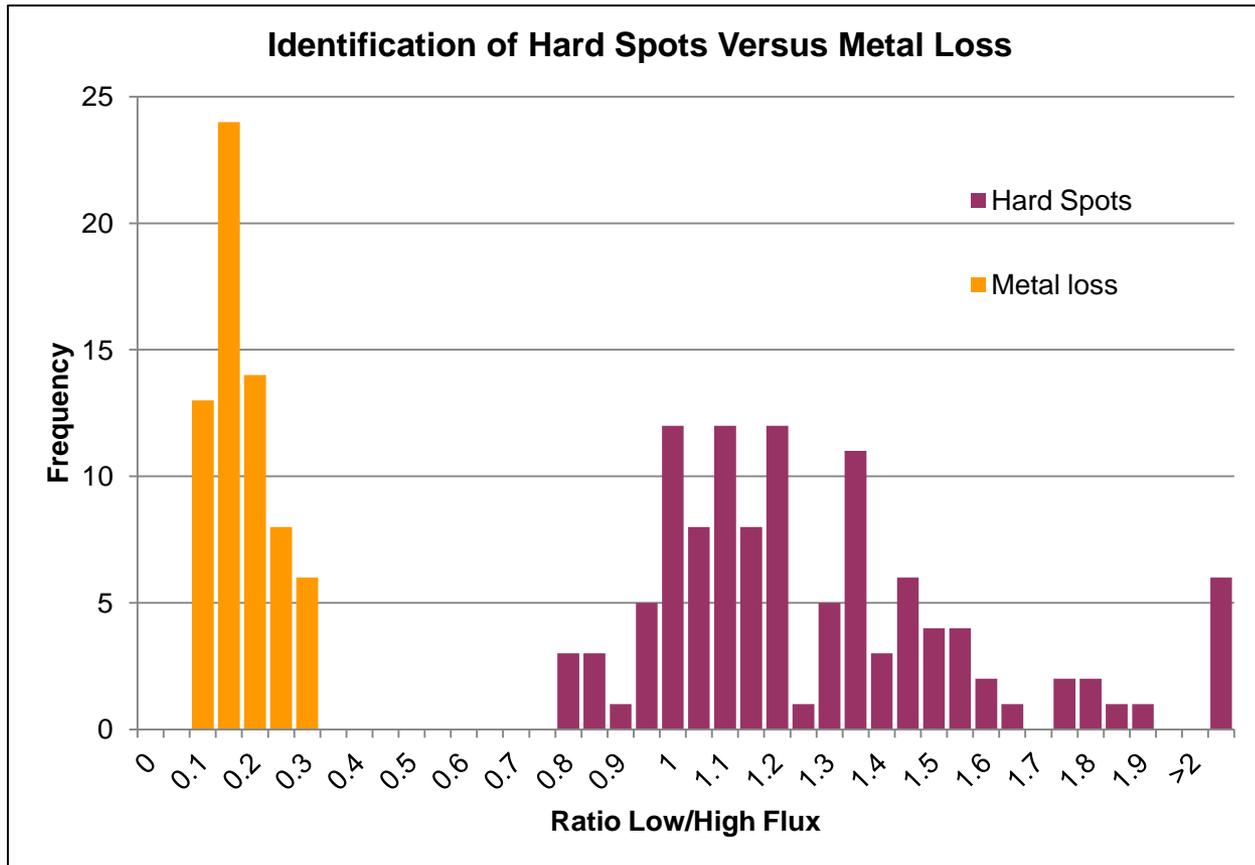
The ratio of flux leakage on the low magnetization unit and flux leakage on the high magnetization unit provides a clear separation between hard spot and metal loss:

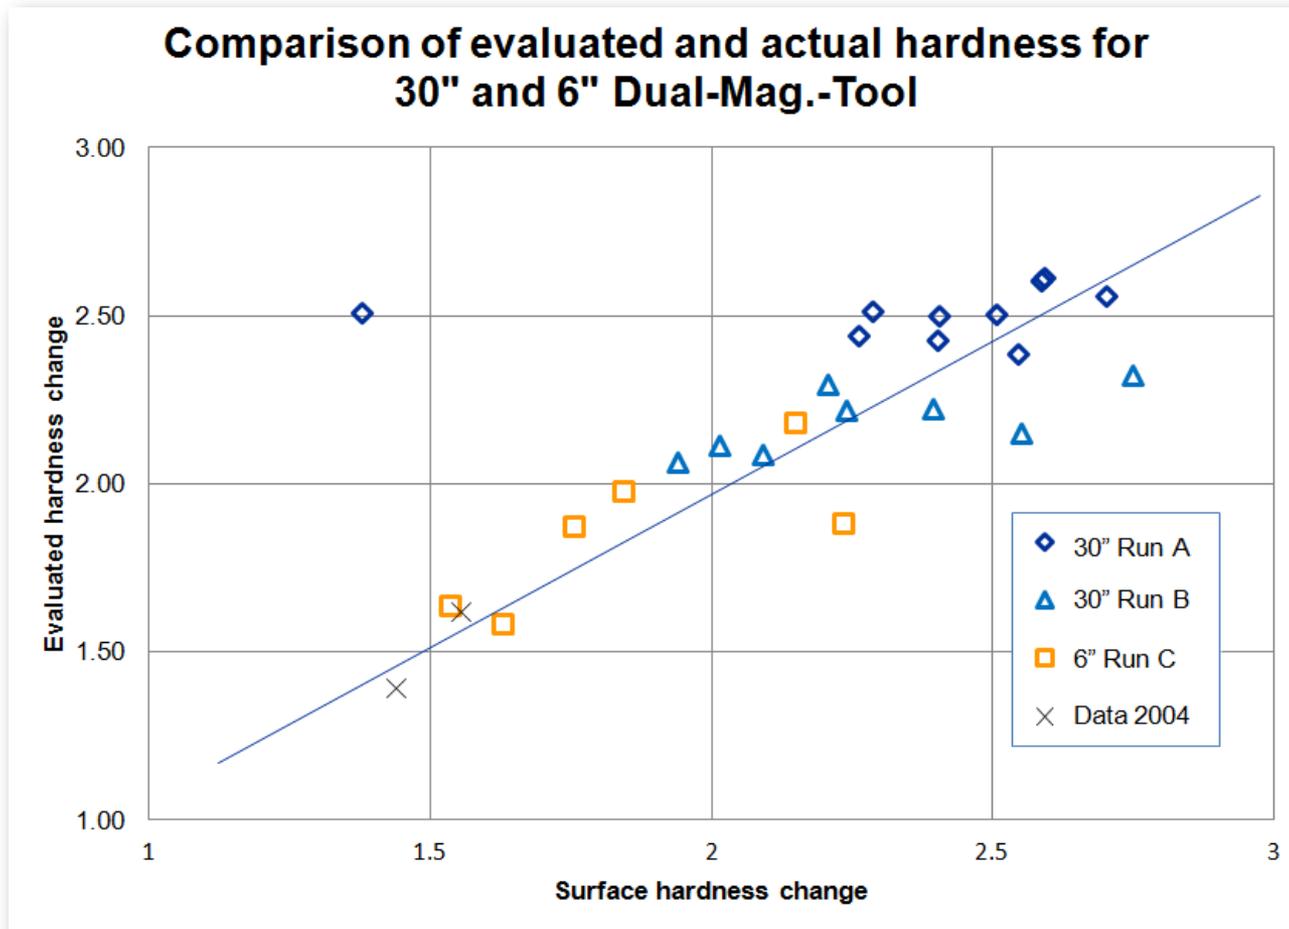
# Sizing – Reporting of Hardness

Sizing quality can be estimated from unity graph of hardness change:

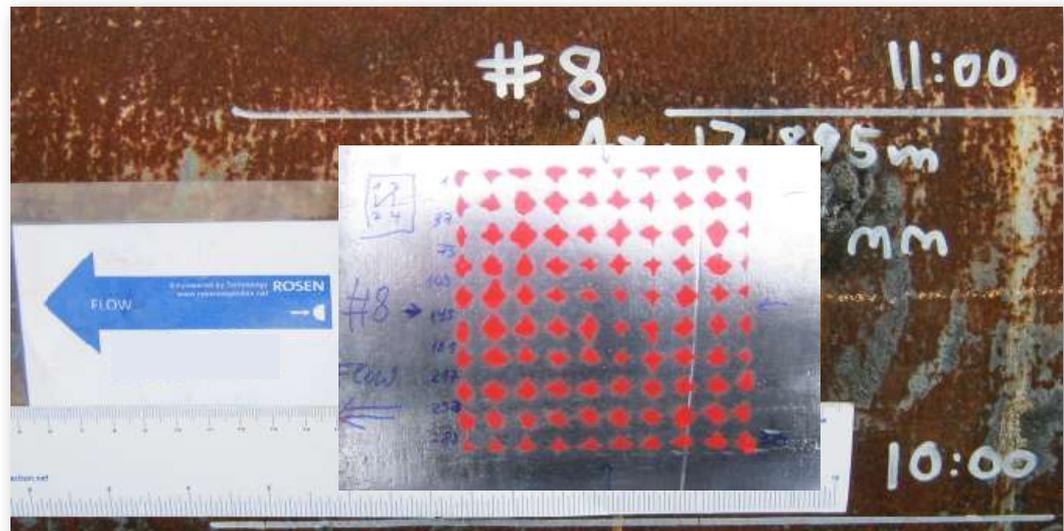
# Hardspot Verification

- spots grinded up to smooth surface
- absolute hardness of joints determined with mobile rockwell hardness tester
- complete shape of defect measured with Ultrasonic Contact Impedance (UCI)
- measurement grid 10 mm

1	2	3	4	5	6	7	8	9
A	191	192	182	192	194	183	193	181	179
B	190	189	210	184	189	176	186	189	182
C	210	204	198	193	180	195	197	204	175
D	198	212	198	189	181	207	187	182	181
E	218	198	197	197	184	194	195	197	175
F	186	172	219	185	202	198	215	203	168
G	209	201	170	217	209	212	205	189	179
H	229	235	250	236	257	209	213	189	215
I	236	233	246	267	236	189	199	165	203
J	206	208	241	241	187	197	205	184	201
K	201	193	211	208	182	183	207	187	202

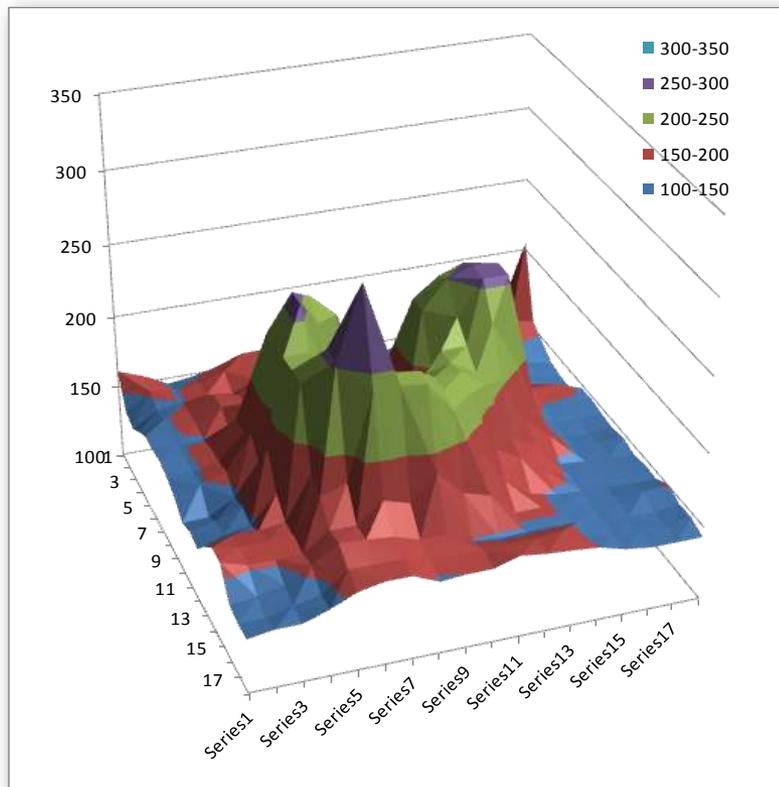
-Procedures for effective hardness determination

-A: Median of 9 values,  
e.g. Max. of 301 HB

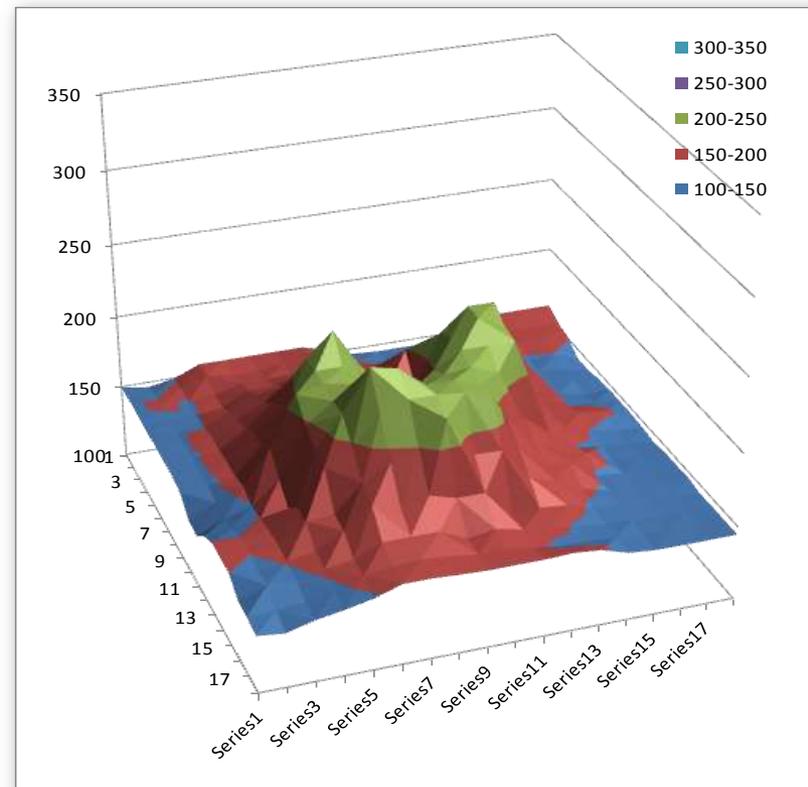
-B: Median of 21 values,  
e.g. Max. of 239 HB

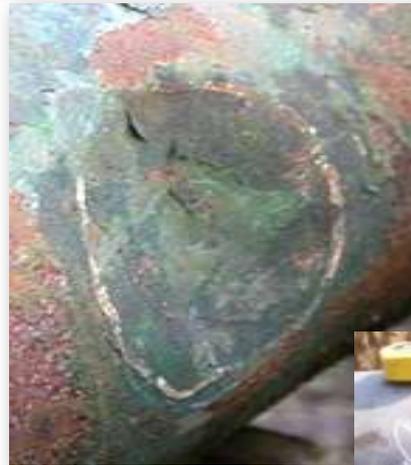
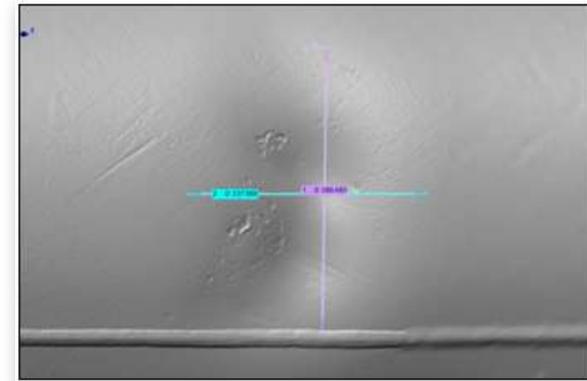
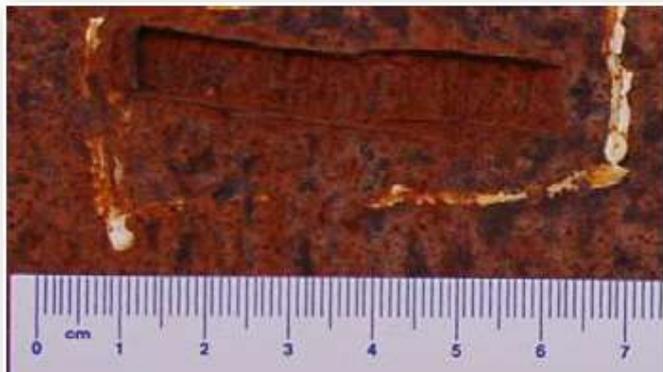
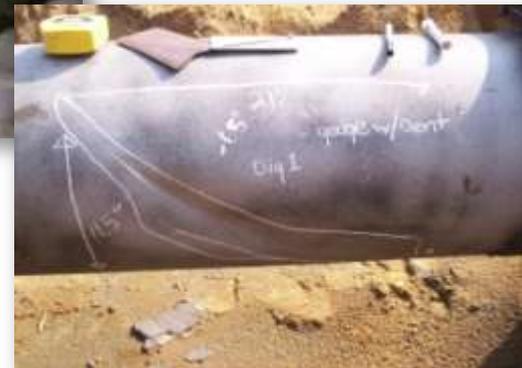
### Denting, Re-rounding and Pressure Cycling

a blunt dent is re-rounded due to the internal pipeline pressure; pressure cycles work on cold worked areas around a dent

### Gouging and Plowing

plowing is the start point of the indentation process; gouging the lateral continuation of cold working and forming of the material

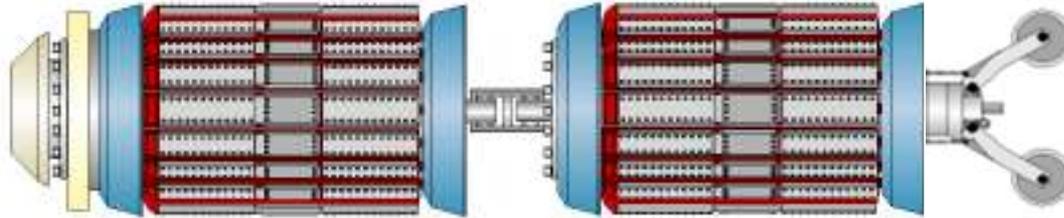
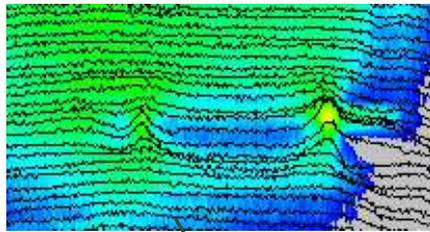
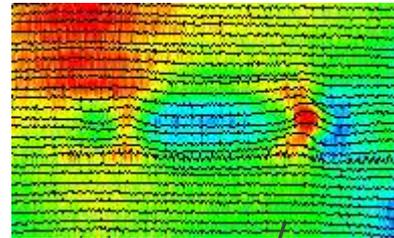
Dent Defect

HIGH Field

LOW Field

Decoupled MFL Data

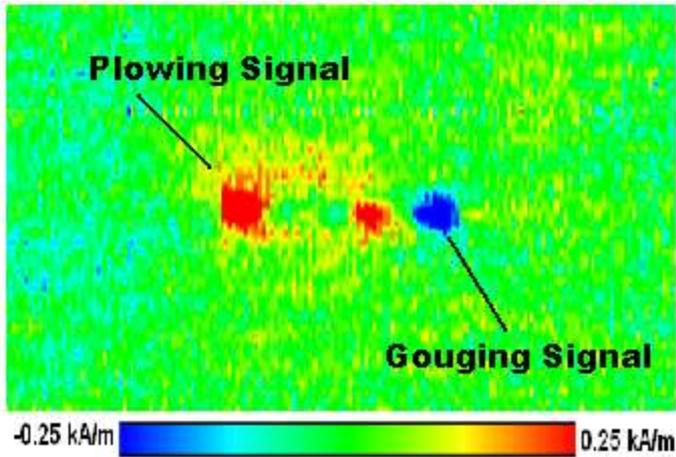
# Gouging and Plowing

Decoupled pull test results with background subtraction from gouge

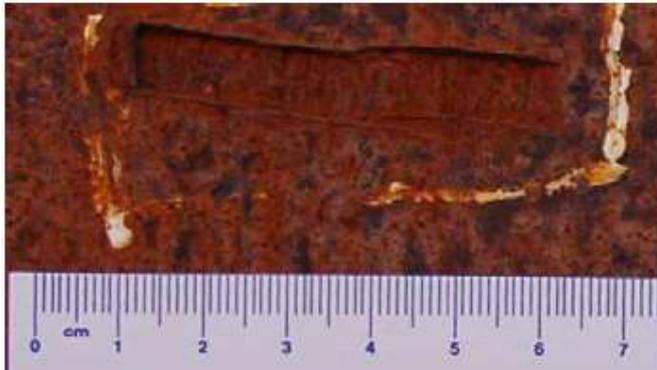
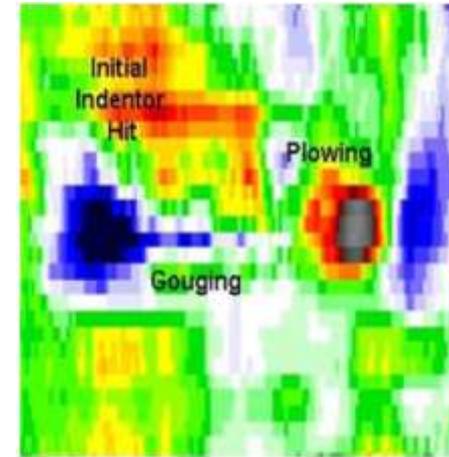
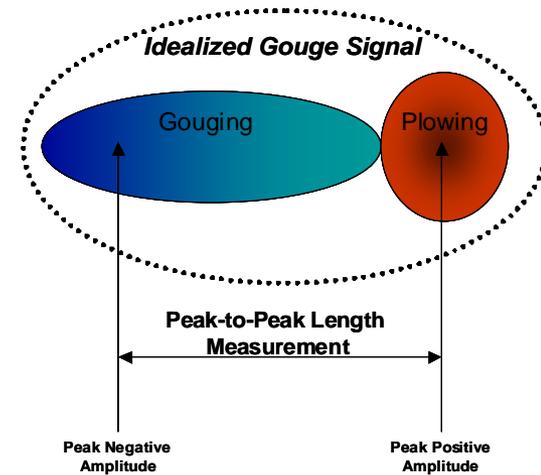
Signal pattern from initial laboratory work

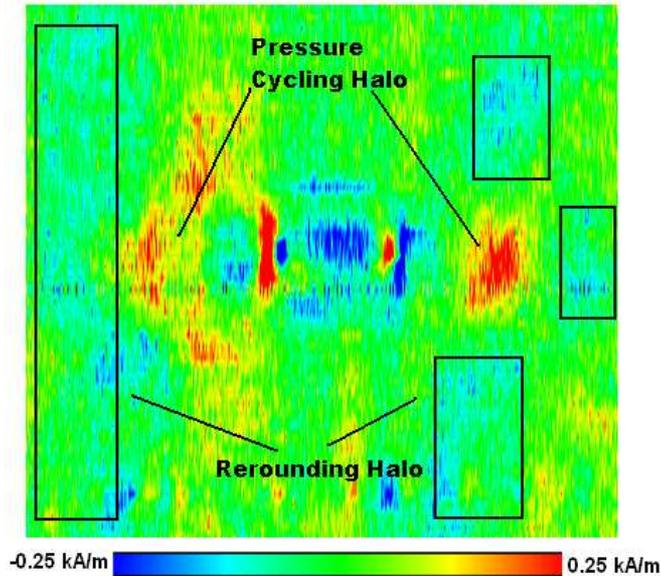
# Denting and Pressure Cycling

Decoupled pull test results with background subtraction from gouge

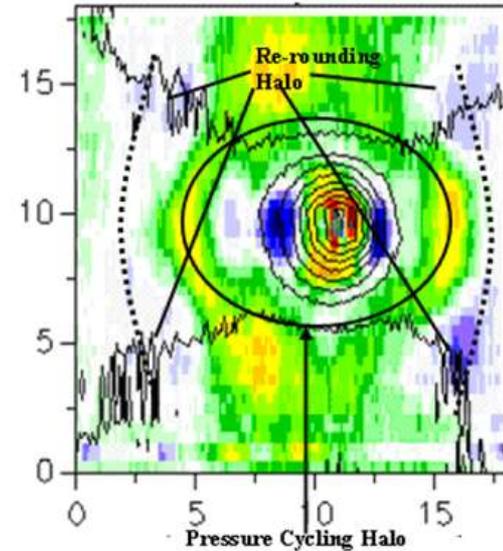
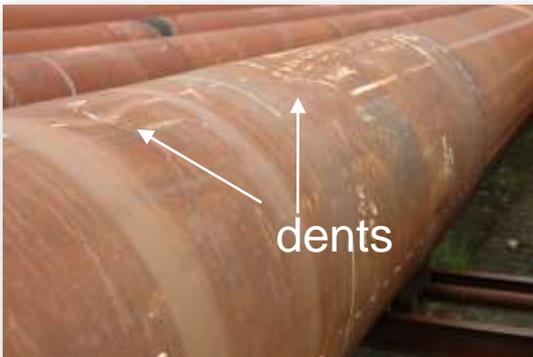
Signal pattern from initial laboratory work

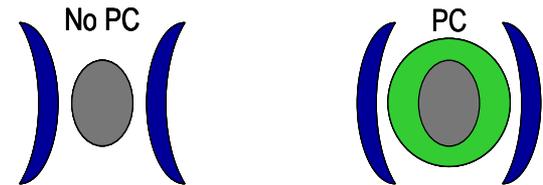
2% Dent made with cylindrical indenter; pressurized pipe; subsequent cyclic loading

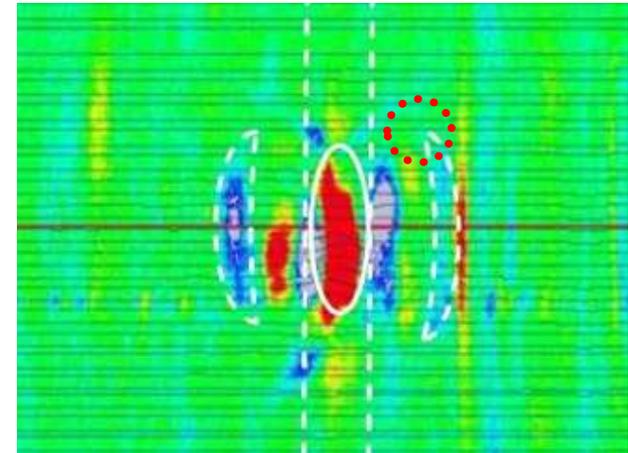
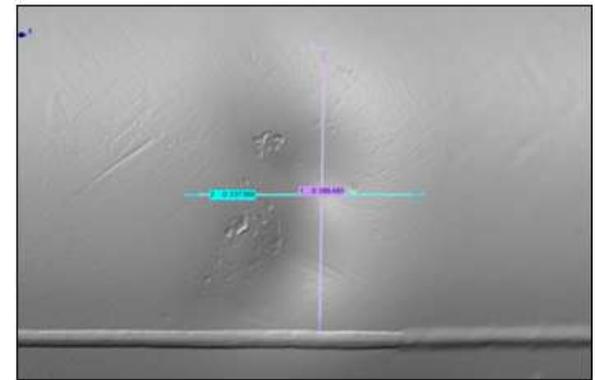
- No Plow/Gouge Signal,
- Pressure Cycling,
- Residual Dent > 2%, > 6% Dent Strain
- with 11:46 on Top of Pipe
- Hard Spot in Dent Area

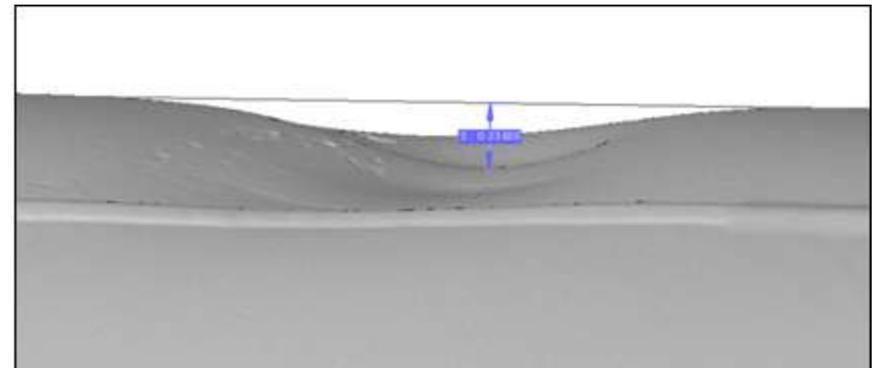
- > 2% Dent Depth
- No Gouge

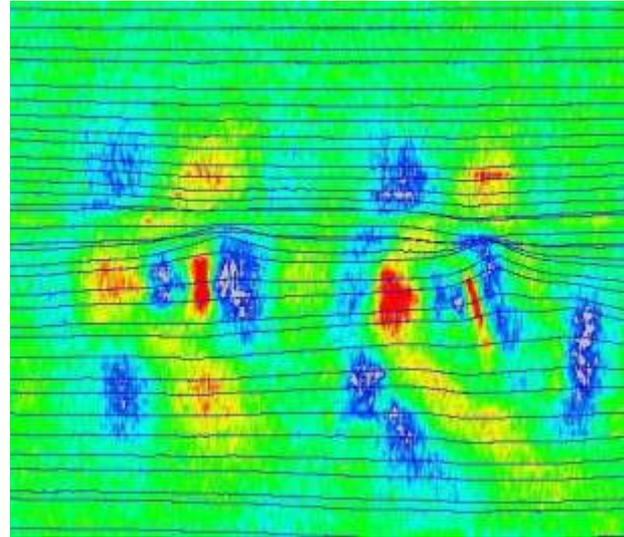
- Plow/Gouge signal,
- Re-rounding, Pressure Cycling
- Residual Dent >2%,
- With 5:30 Bottom of Pipe

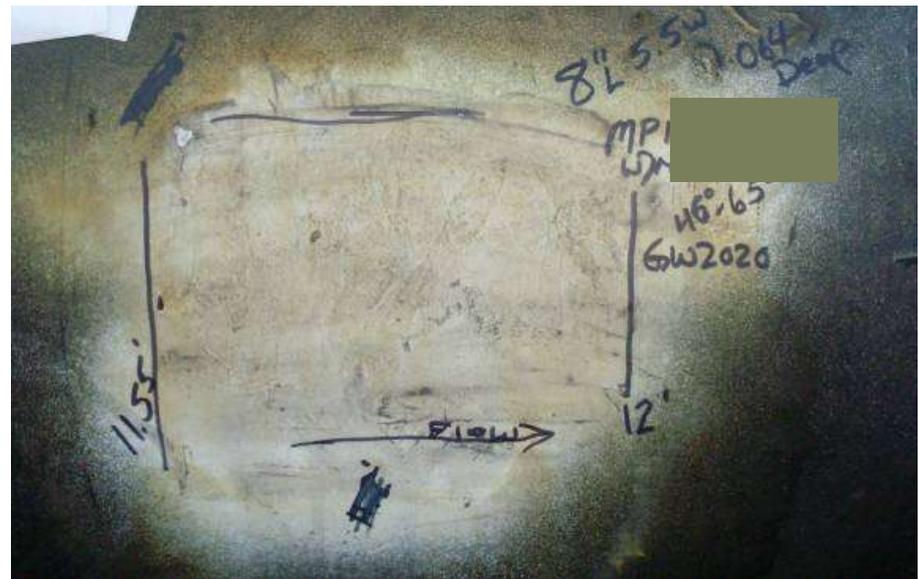
- 9% Wall Thinning
- 1% Field Depth
- Gouging confirmed

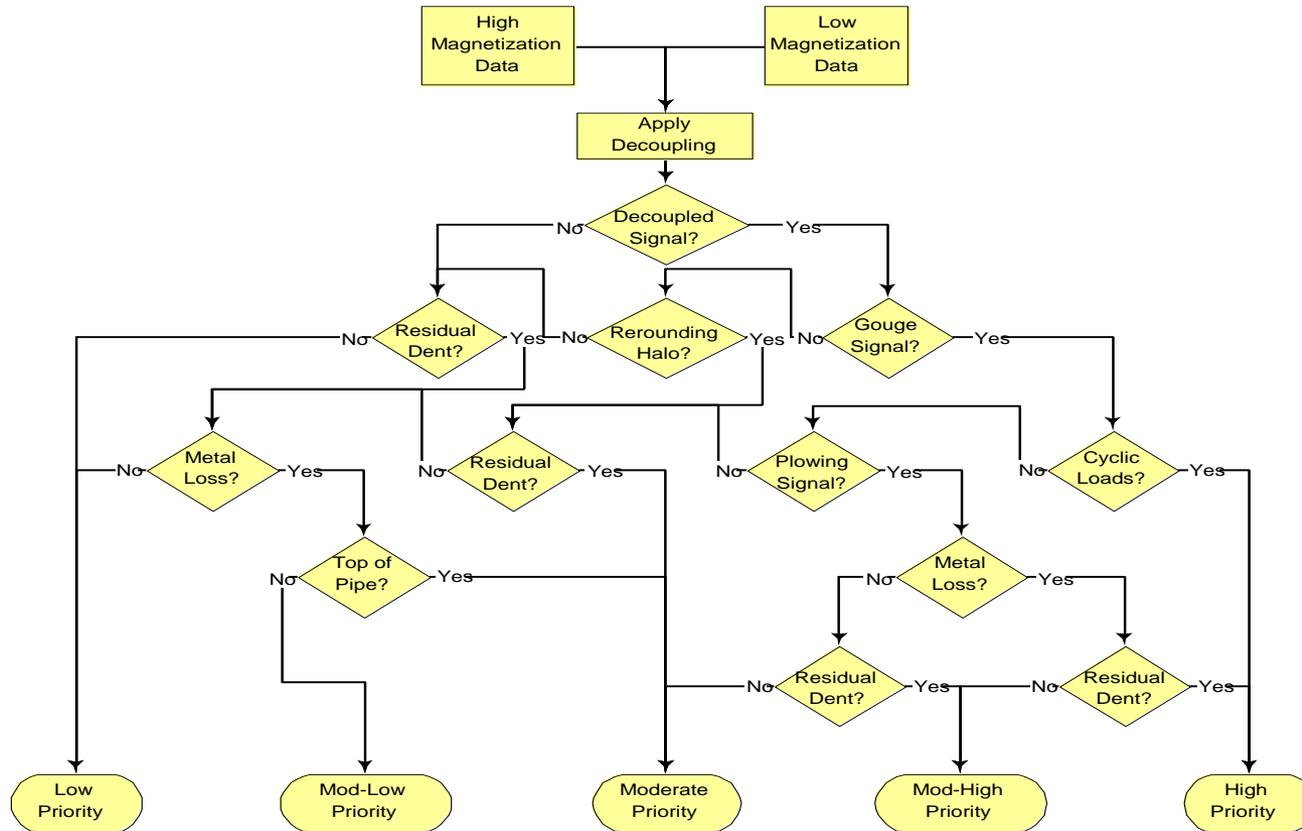
## Classification and Priority Ranking

Detailed Classification Process of Decoupled Dual-Mag Signal, leads to Characterization and Prioritization of Mechanical Damage. Prioritization Model based on PRCI Research

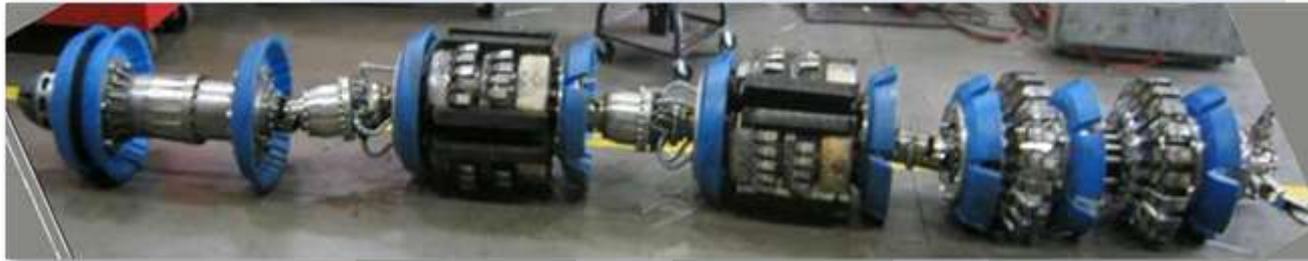
corrosion – pitting – axial anomalies – ID/OD – deformation – IMU

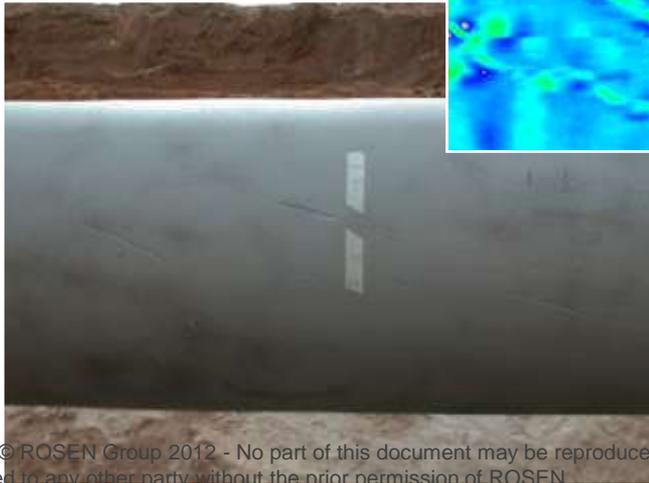
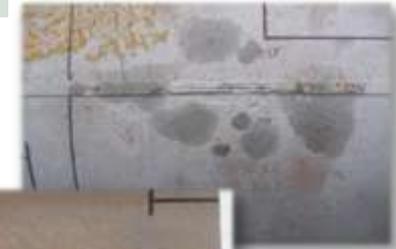
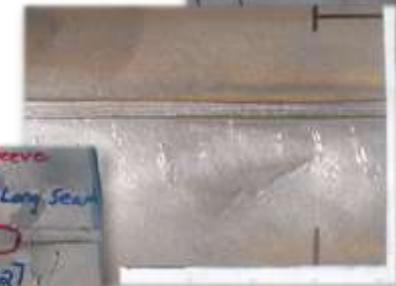
Needs Sleeve  
Lack of Fusion in Long Seam

ODG22  
MAX D = .040"  
LENGTH = .02  
CIRC W = .015"  
AX: +26.52  
TDC: +.42  
UT: 330

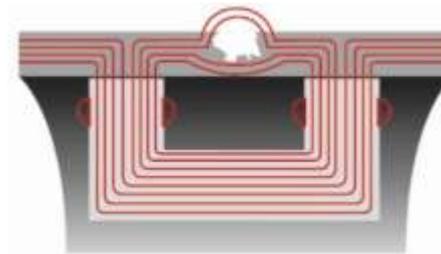
seamless variation affect MFL path. MFL Raw data require adaptive noise filter to reduce influence of seamless pattern. Filter Method typically sufficient for smaller wt-tolerances

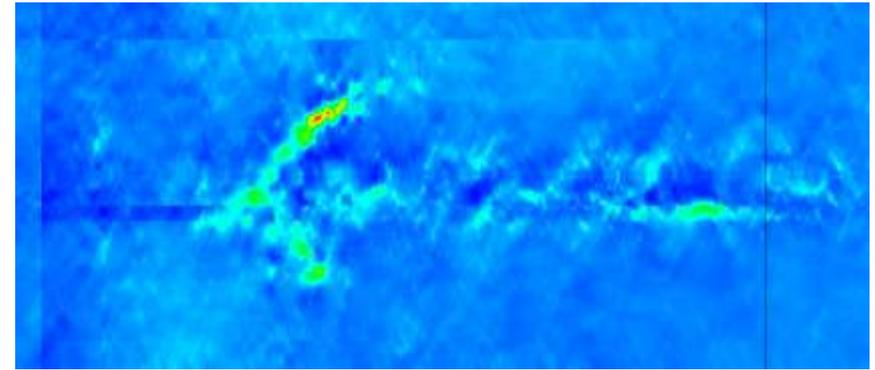
CMFL RAW Data – **Principal Noise Cancellation**

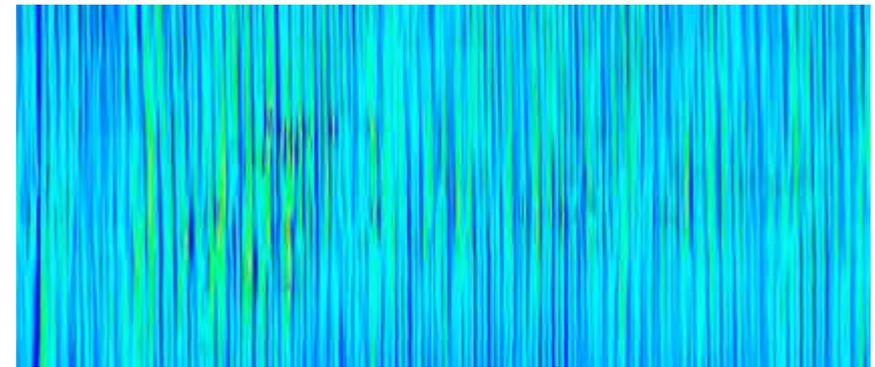
MFL RAW Data – **Adaptive Noise Filter** Required

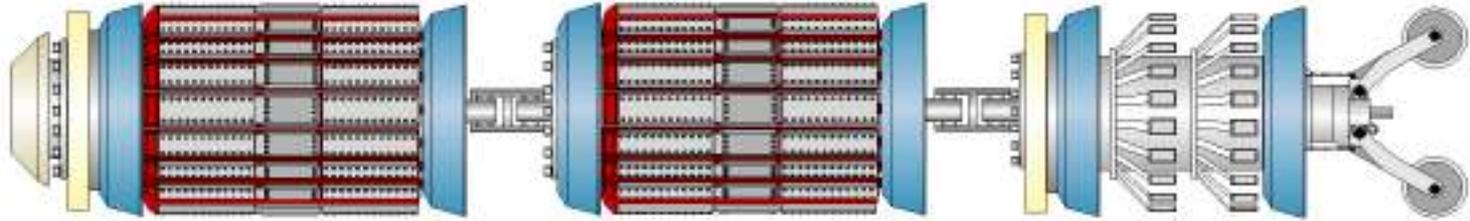
**HIGH Field**

**LOW Field**

**Geometry**

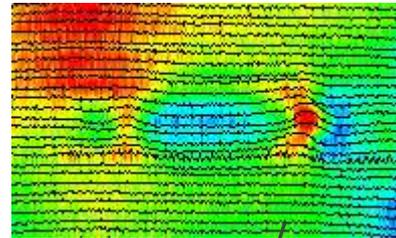
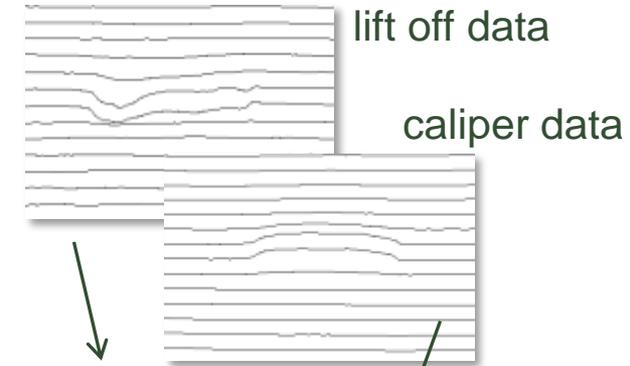
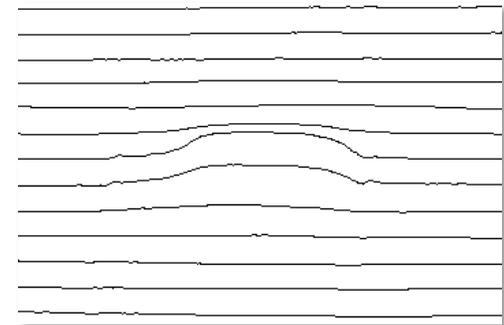
Dent Defect

Decoupled MFL Data

Combined Profile
