UK ONSHORE PIPELINE OPERATORS' ASSOCIATION - INDUSTRY GOOD PRACTICE GUIDE

MANAGEMENT OF PIPELINE ILLEGAL TAPPINGS

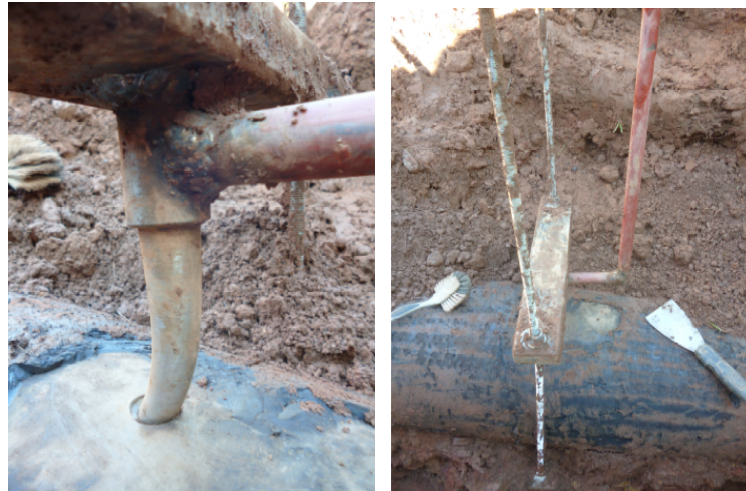
- **Metal spike:** The pipe wall thickness is reduced by grinding (usually in a star shape); a fitting is then attached by welding or by clamp, this is then followed by perforating the pipe using a metal spike. An example is shown in Figure 4.1.

Figure 4.1: Metal spike (left) with its clamp and stand-pipe (right)

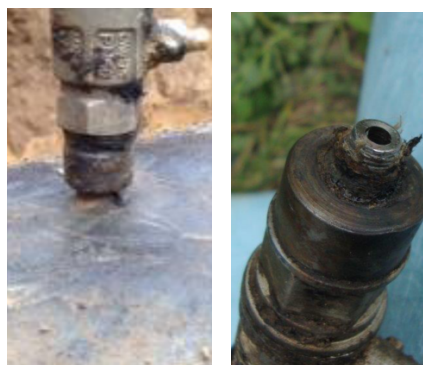
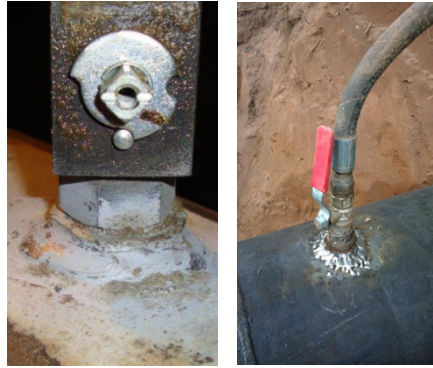
- **Directly connected valve:** A valve is connected directly to the pipeline and the pipe wall is drilled through the valve. Attachment of the valve is achieved by either partial drilling of the pipe wall, threading it, then screwing the valve in place or, alternatively, by direct welding of the valve to the pipe. The connection may be reinforced with solder or weld deposit. A coupon may also be welded to the pipe prior to attachment of the valve. Examples are shown in Figure 4.2.

Figure 4.2: Directly connected valves

(clockwise from top left: threaded valve in-situ; threaded valve removed from pipe; solder deposit; weld deposit)

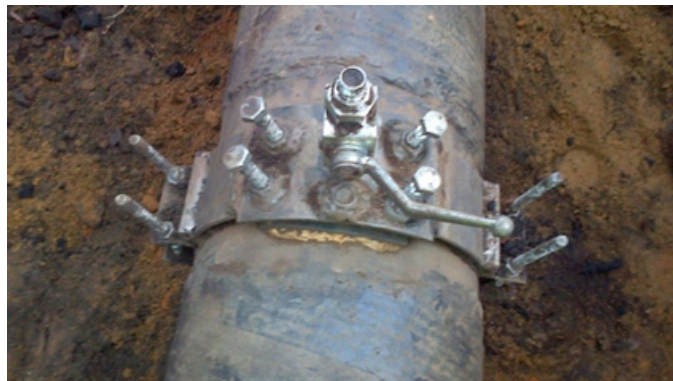
- Clamped connection: A pre-formed circumferential clamp with pre-welded fitting and valve is attached to the pipe. The pipe wall is then drilled through the valve. An example is shown in Figure 4.3.

Figure 4.3: Circumferential clamp with pre-welded valve

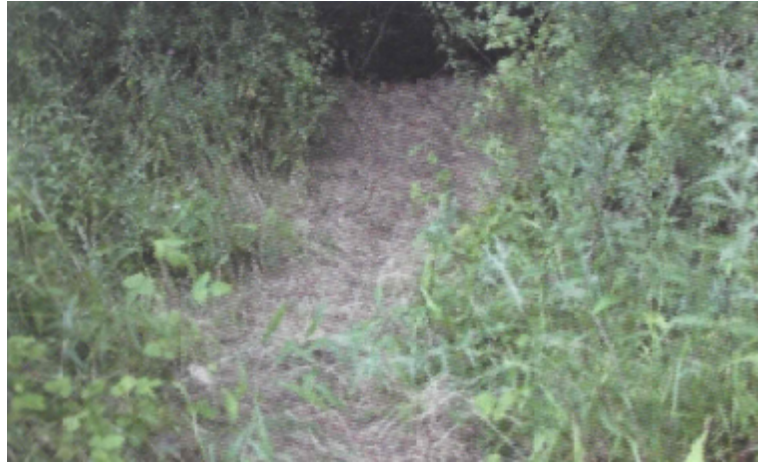
- Disturbed ground over the pipeline where it has been excavated;
- Disturbed ground or slit trench leading away from the pipeline where trenching of a flexible hose has been carried out (see Figure 6.1);

Figure 6.1: Disturbed ground due to trenching

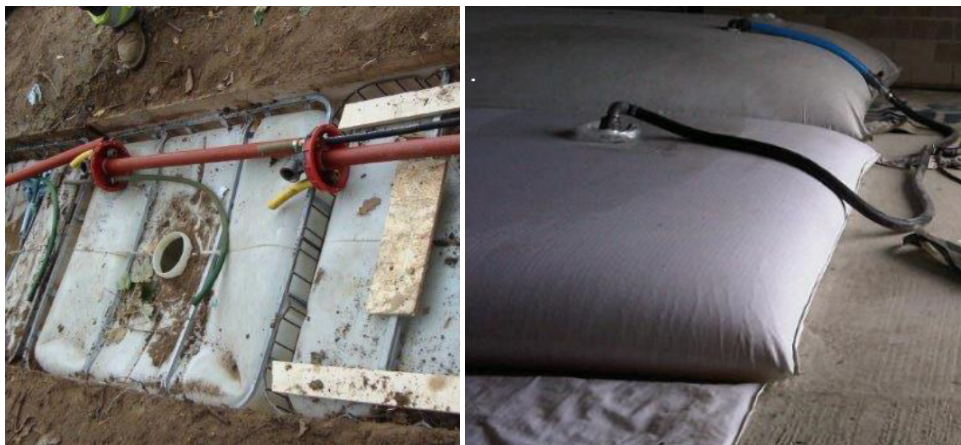
- Evidence of tanks including disturbed ground where tanks have been buried (see Figure 6.2);

Figure 6.2: Example of tanks: buried IBCs (left); pillow sacks in shed (right)

Product storage has normally involved the use of IBCs (intermediate bulk containers) or bladders located in a van, warehouse, or buried in the ground (see Figure 6.2). Any area where vehicles could approach within several hundred metres of the pipeline should be considered including:

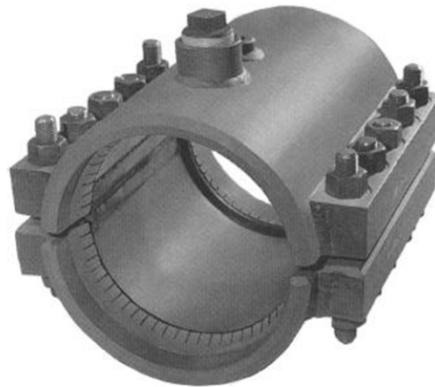
Figure 8.1: Stand-off repair clamp

- Mechanically bolted stand-off repair clamps (see Figure 8.1);
- Grouted sleeves and tees (see Figure 8.2);
- Welded tees (see Figure 8.3);
- Composite wraps (see Figure 8.4);
- Purpose designed epoxy filled split tees (see Figure 8.5);
- Pinhole repair clamps (see Figure 8.6).

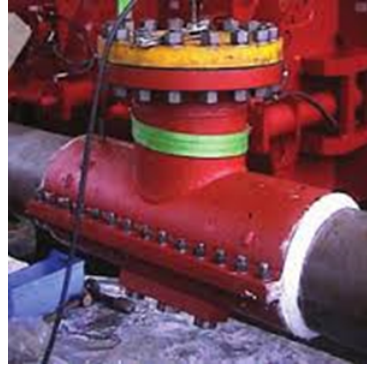
Figure 8.2: Grouted tee

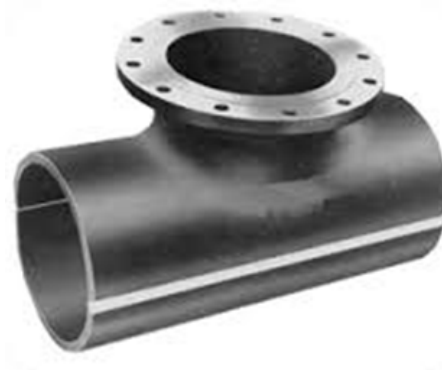
Figure 8.3: Welded tee

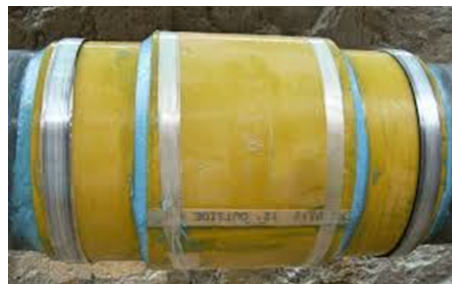
Figure 8.4: Composite wrap

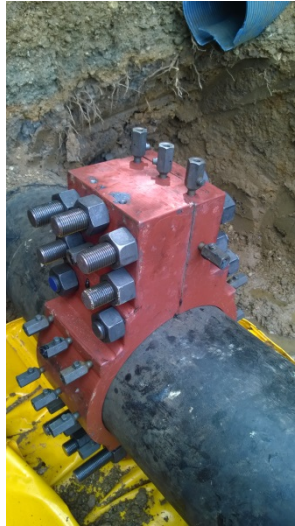
Figure 8.5: Epoxy filled split tee

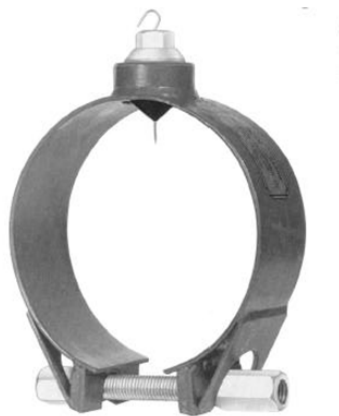
Figure 8.6: Pinhole clamp
