UKOPA Technical Seminar June 2009

Case Study – Pipeline Damage & Repair

Trans-Pennine Ethylene Pipeline – Seamer, North Yorkshire

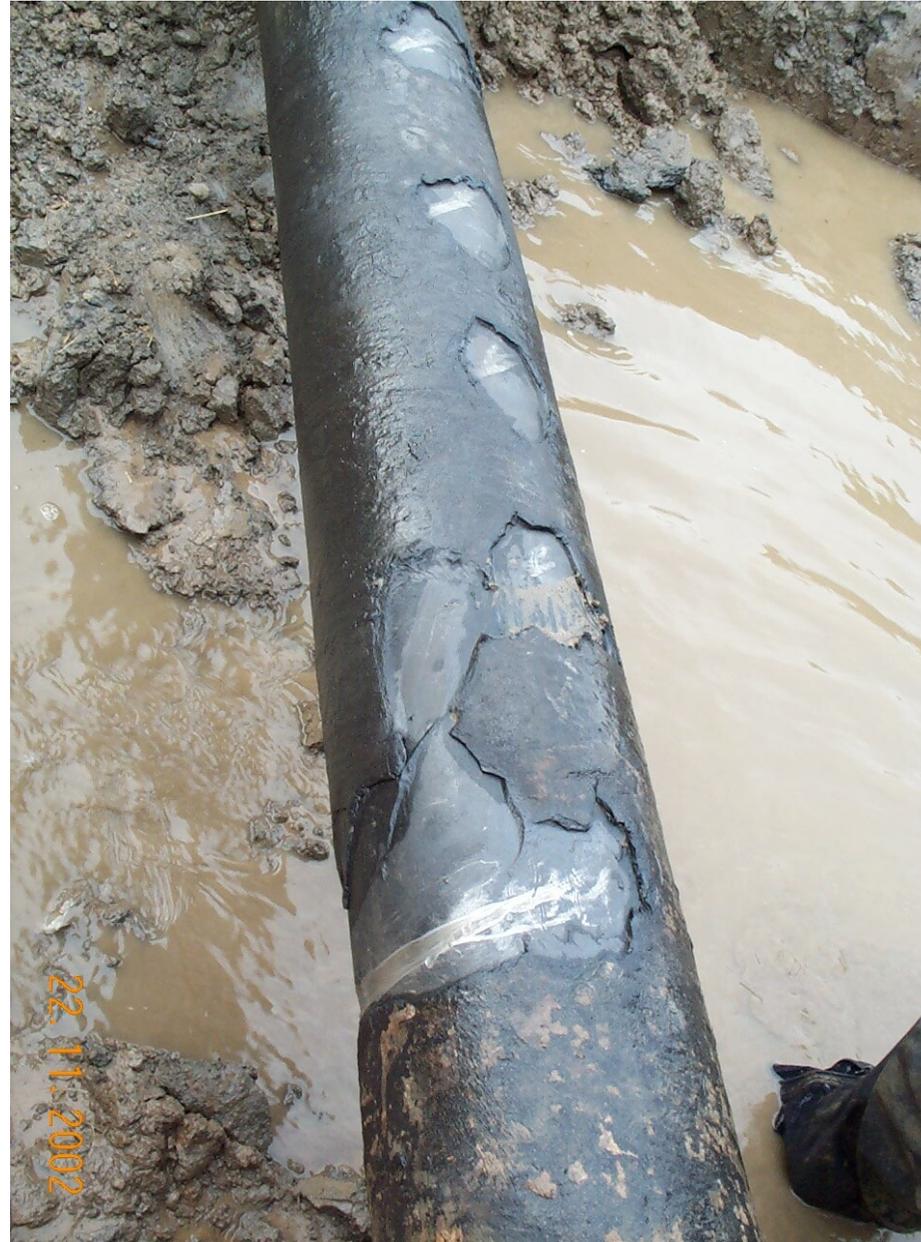
- Date of incident 18th November 2002
- Date of discovery by Operator 21st November 2002
- 'JCB' excavation to install new land drain on farmland
- Routine awareness visits (last one in 2001, when map of pipeline route on land parcel also provided)
- Landowner did not contact Operator prior to commencing work
- Landowner did not inform excavation contractor of pipeline route or proximity

Extensive strike damage to pipeline

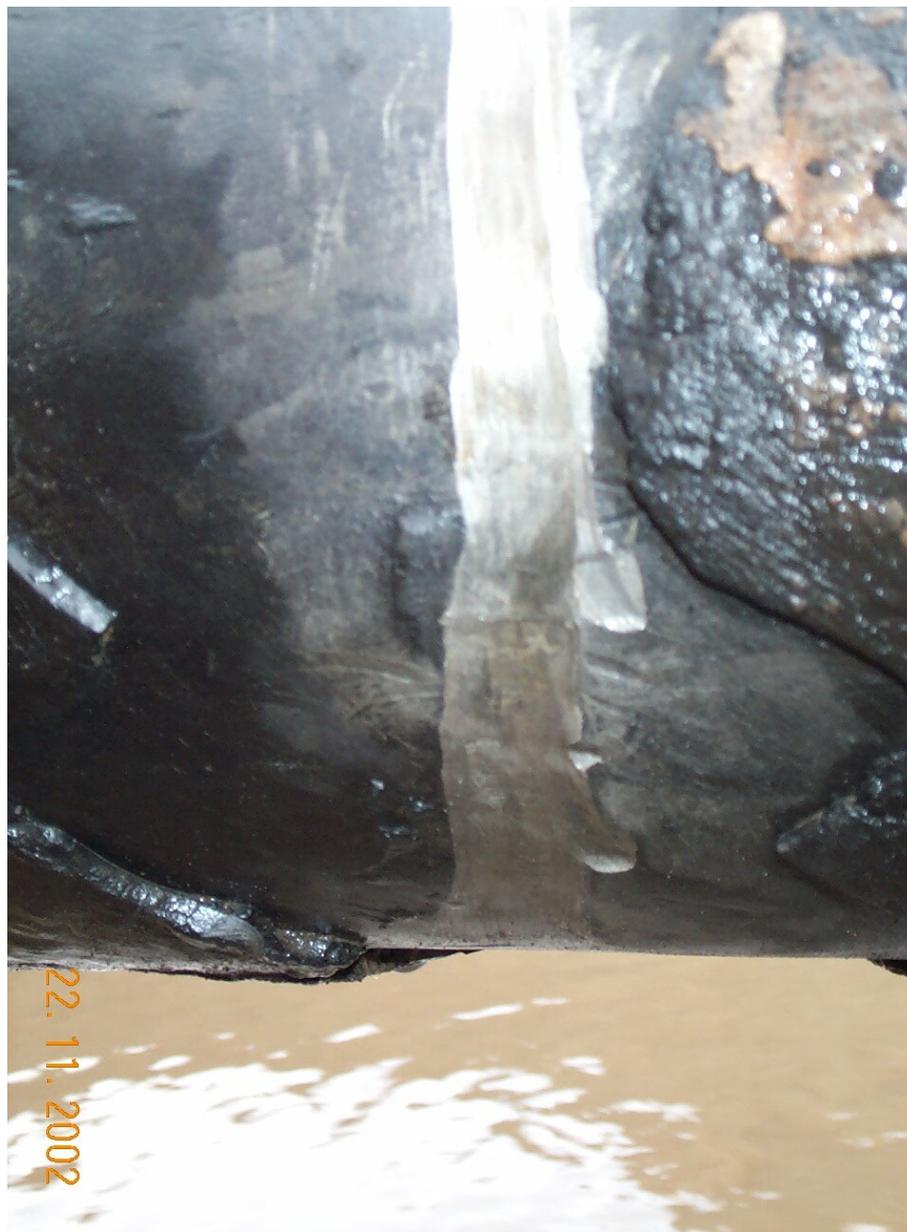
22. 11. 2002

Significant metal loss suffered

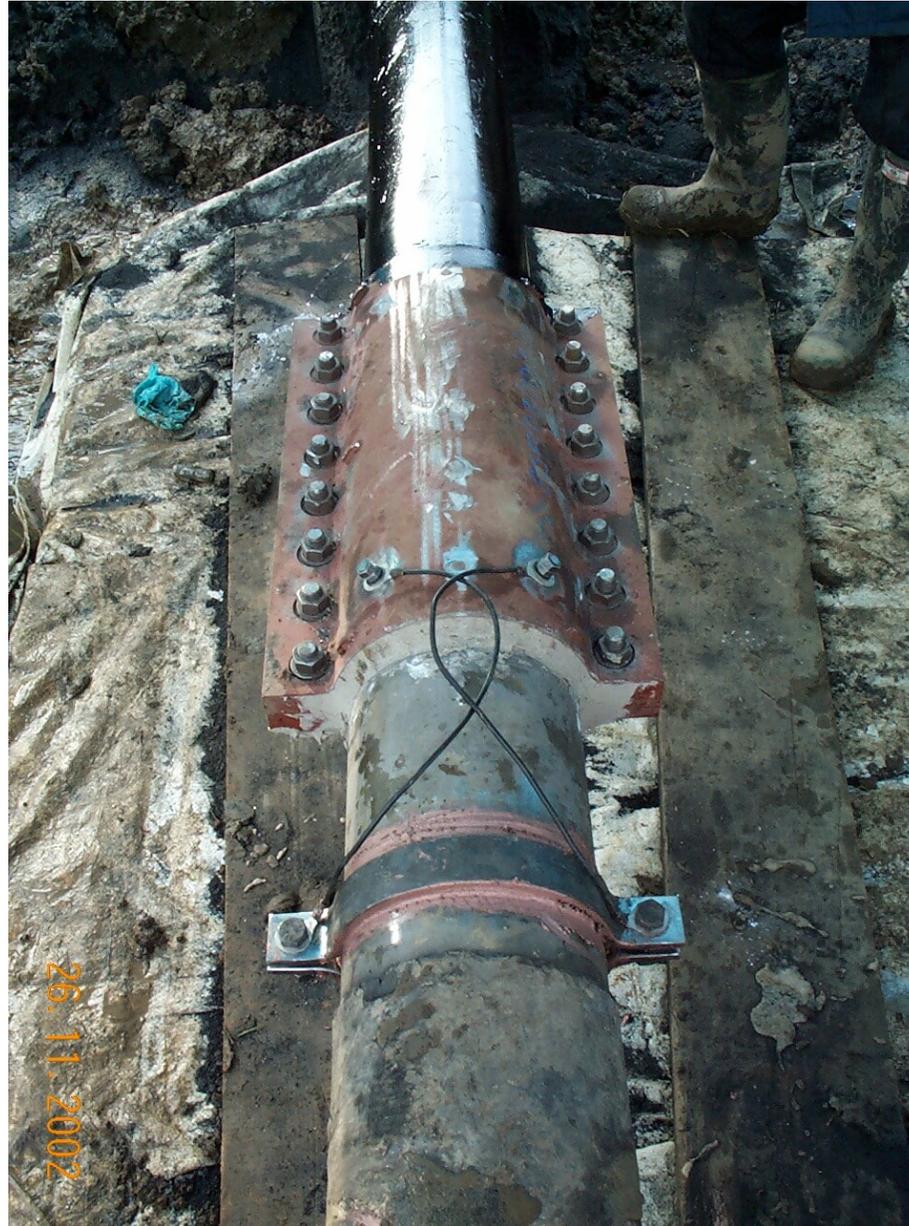
Epoxy clamp repair

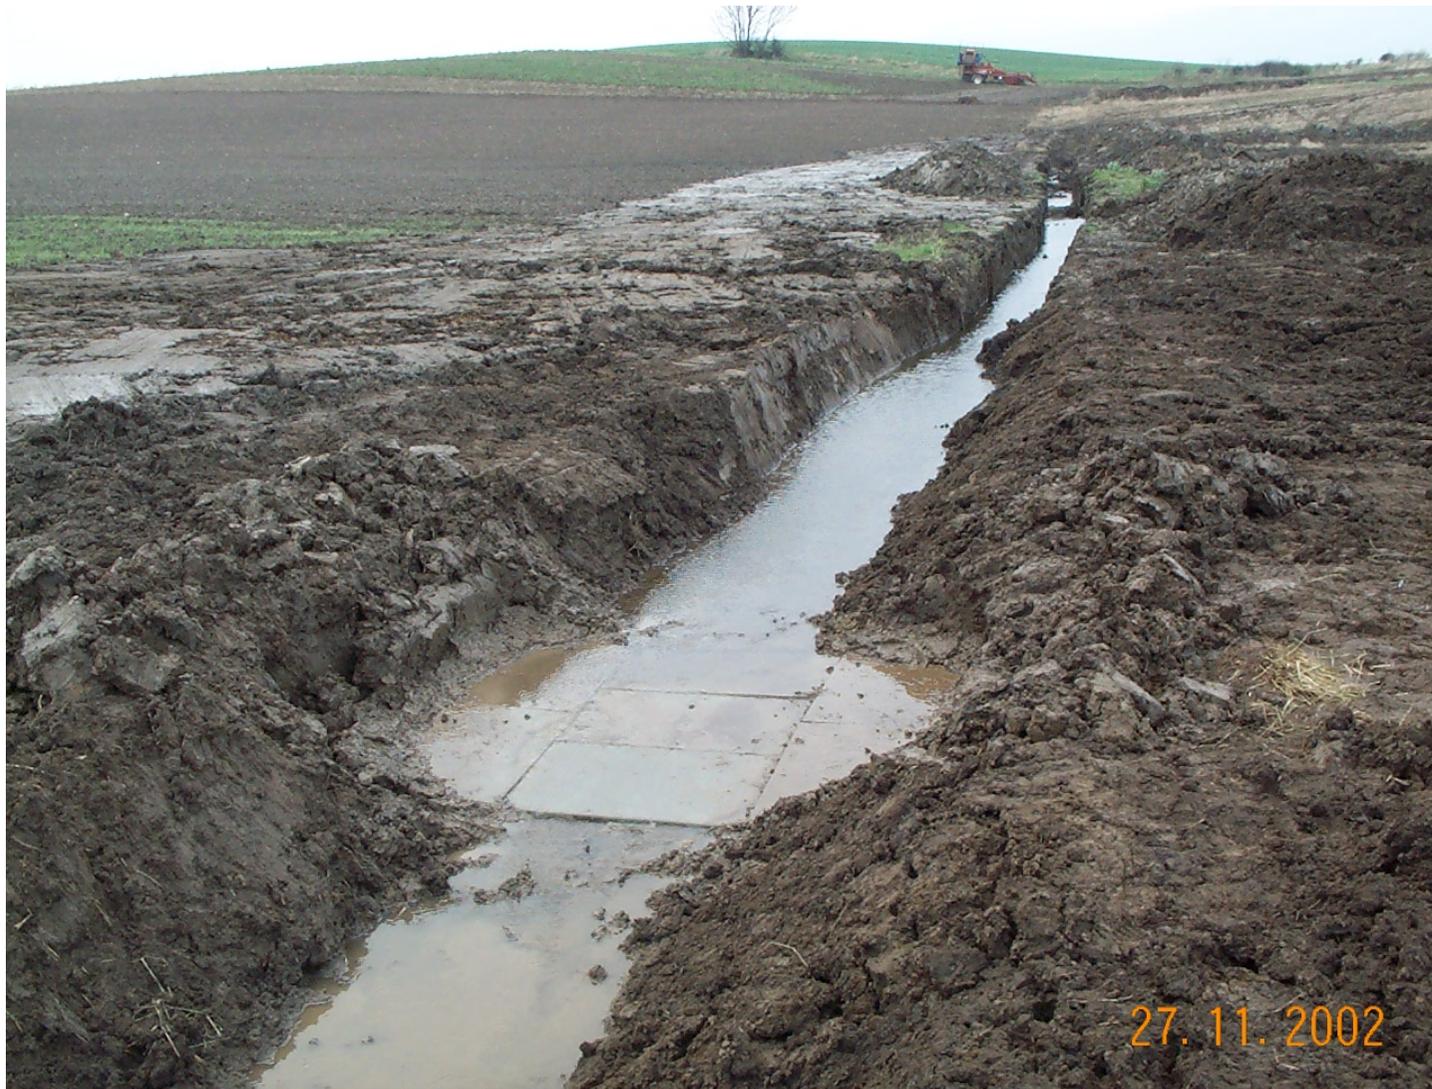
27. 11. 2002

Following reinstatement
