# The Buncefield Investigation

Progress report

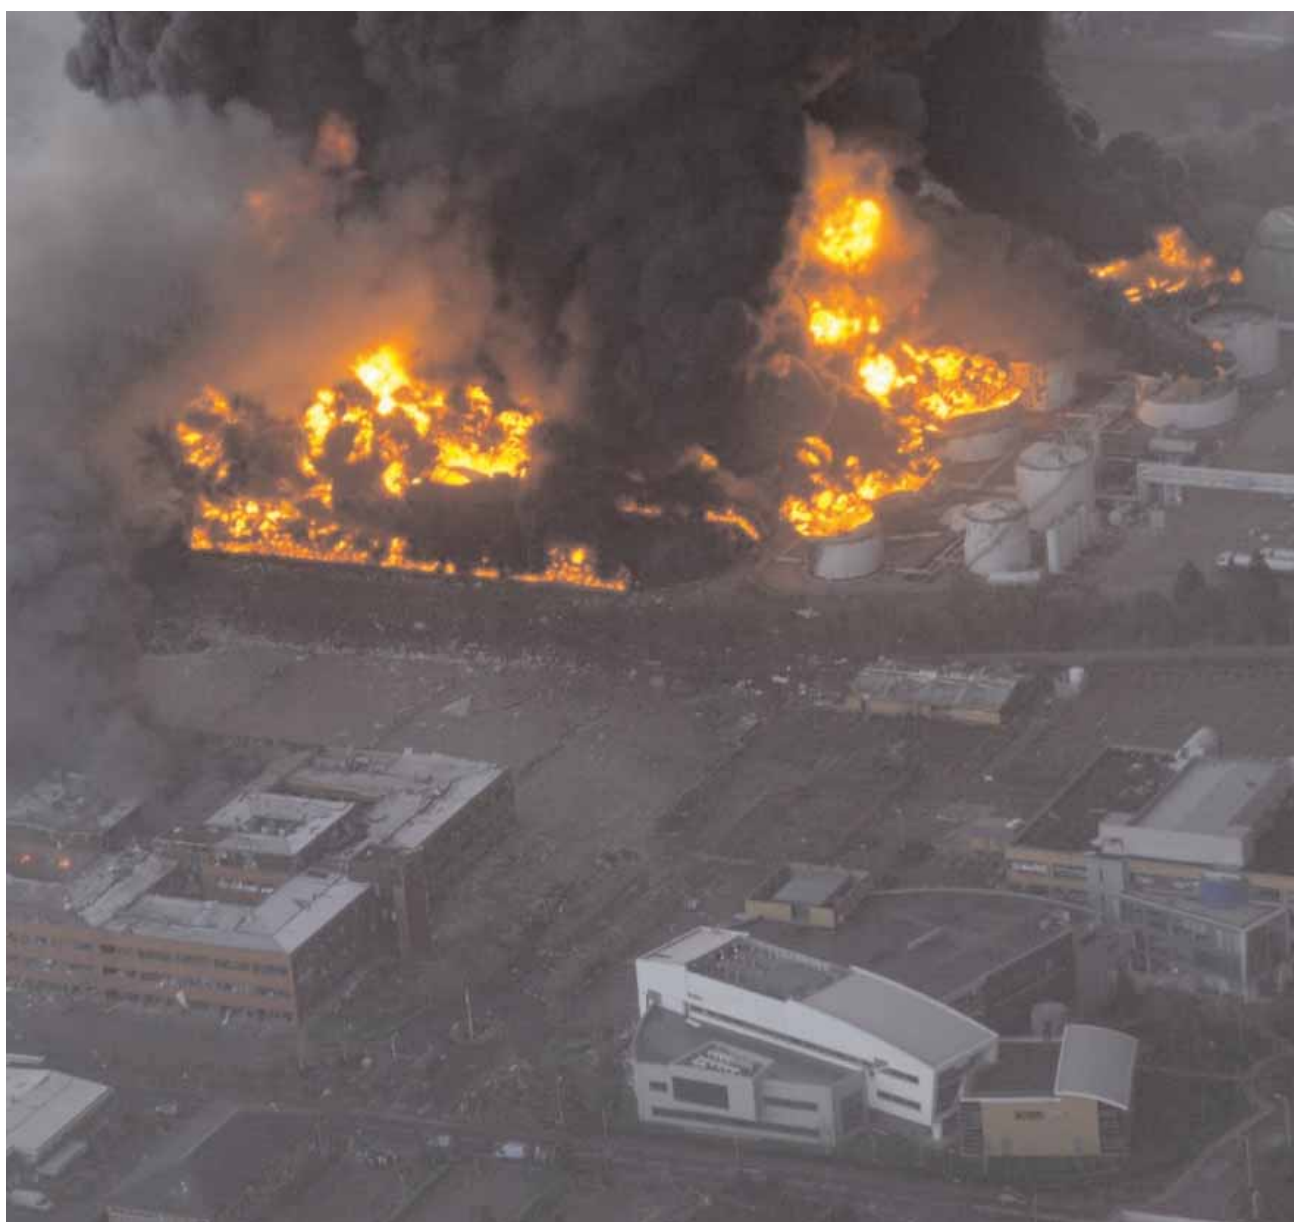
**Figure 1** This photograph shows the Buncefield site on the first day of the fire. The Northgate building can be seen burning towards the lower left corner of the photograph.

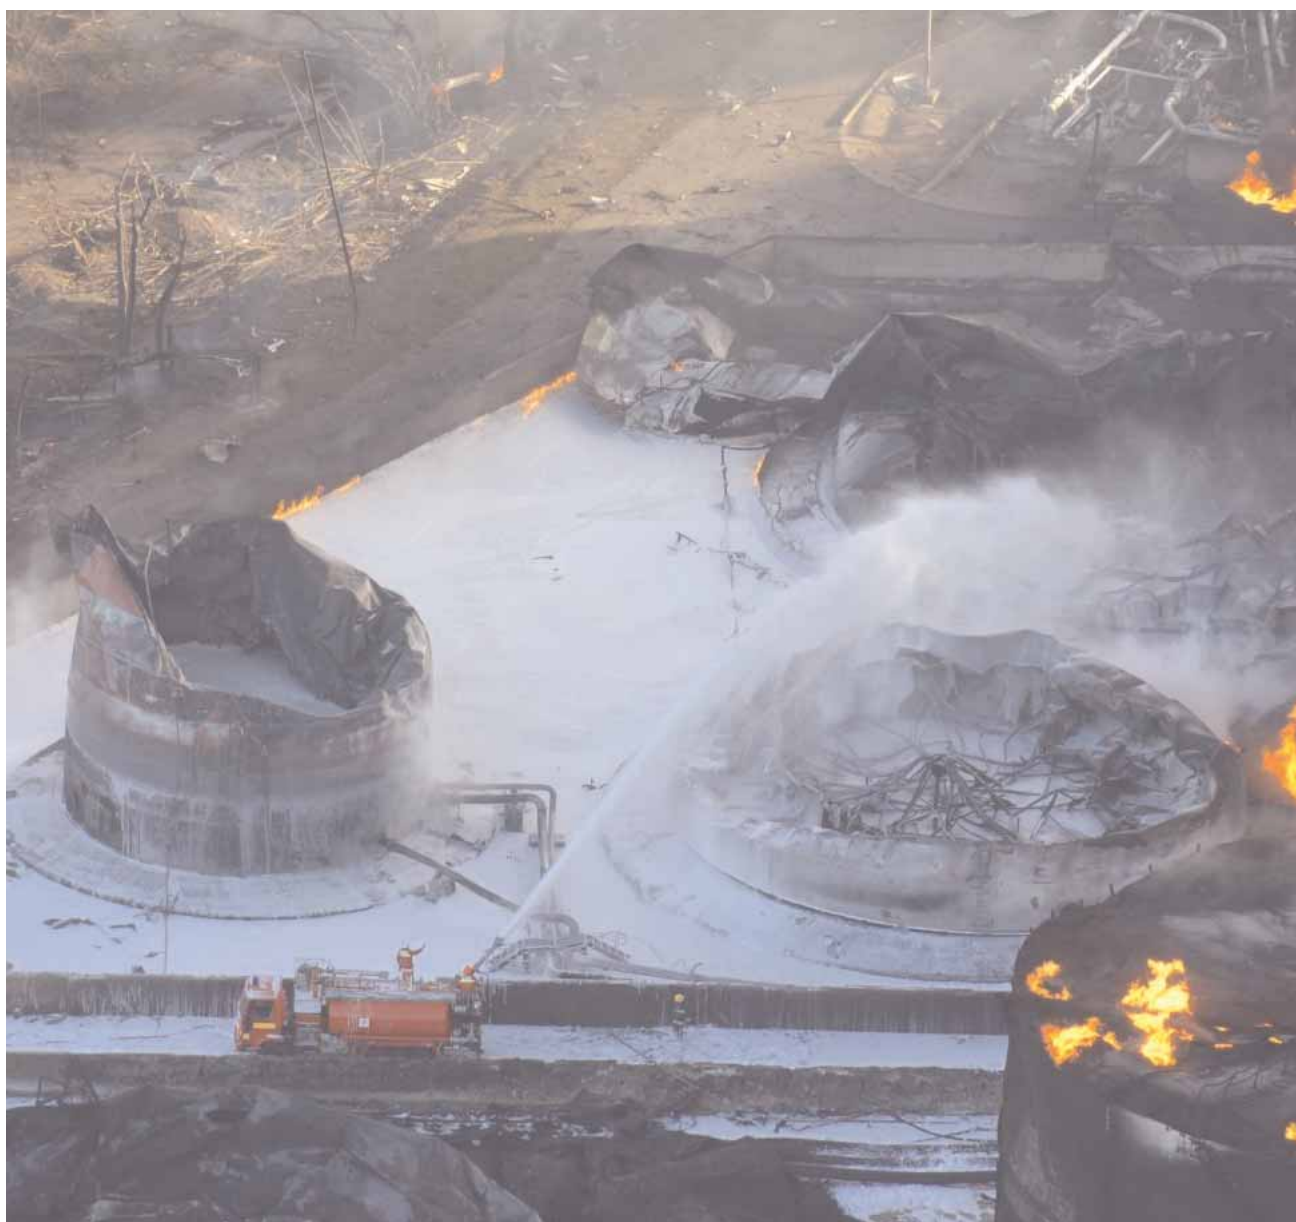
**Figure 2** This photograph shows the fire-fighting operation in progress with the appliance in the avenue between bunds 'A' and 'B'

2 The fire burned for several days, destroying most of the site and emitting large clouds of black smoke into the atmosphere, dispersing over southern England and beyond. Large quantities of foam and water were used to control the fire, with risks of contaminating water courses and ground water (see Figure 2).

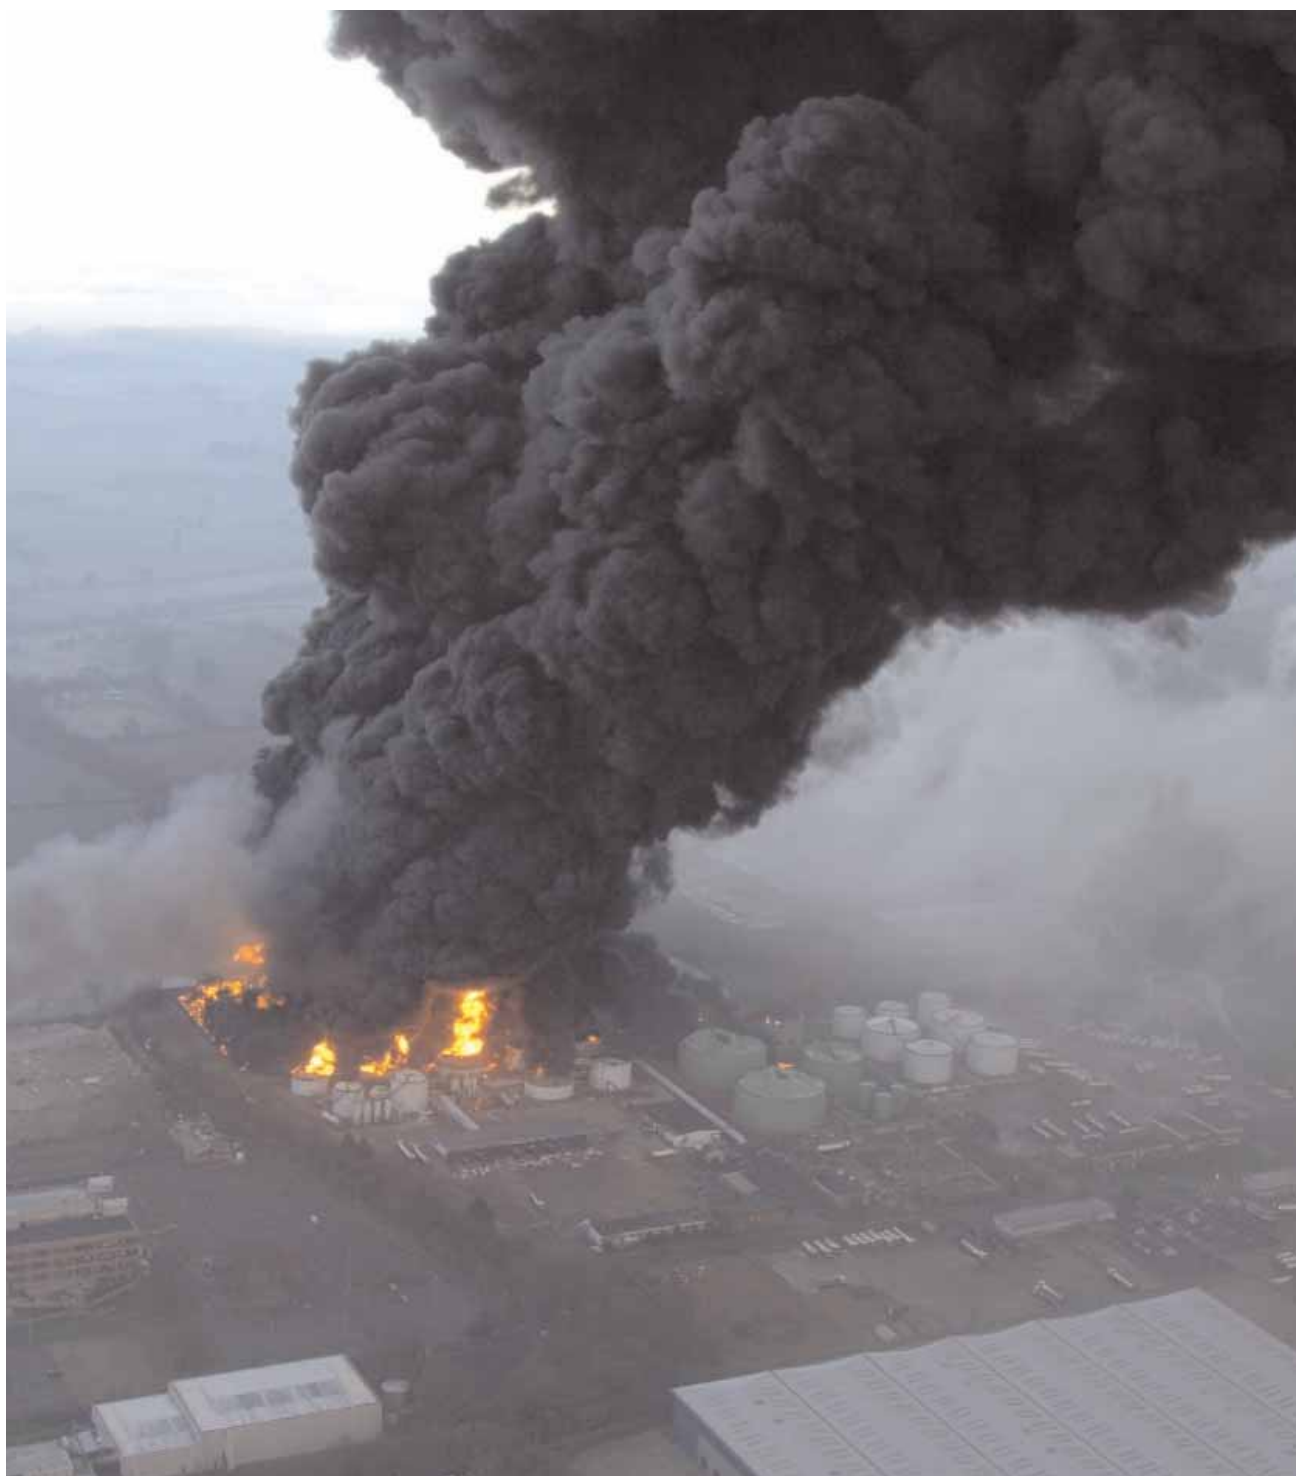
**Figure 3** The smoke plume rising and spreading above the Buncefield site.

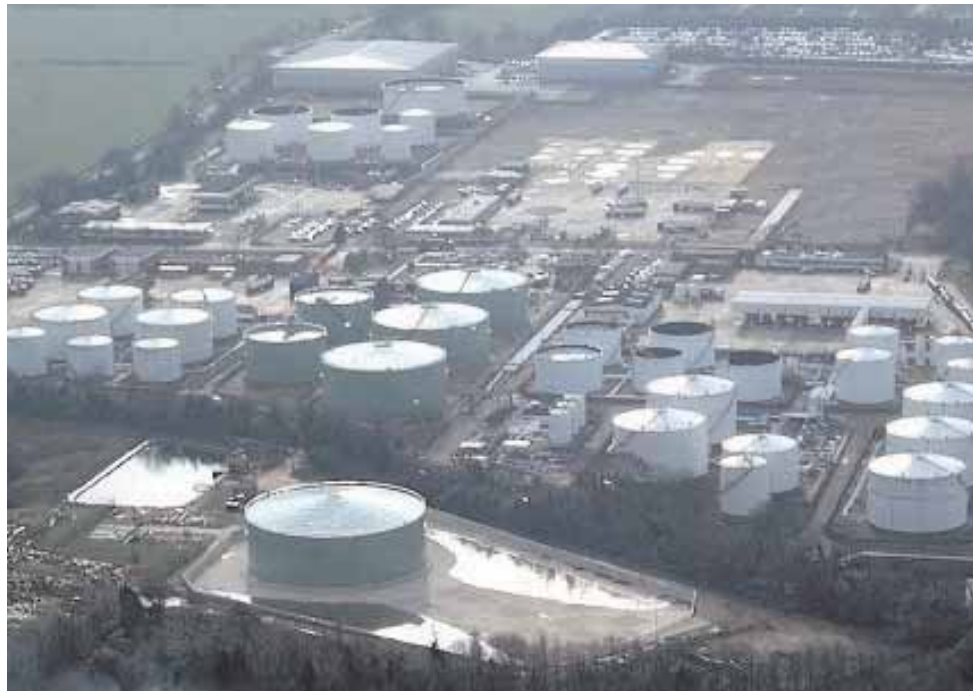
**Figure 4** Depot and surroundings prior to incident

- Witnesses describe seeing mist at about 05:50 GMT in the vicinity of one of the tanks in bund A<sup>4</sup> (see Figure 4). They also describe a mist variously between one and three feet in height rolling from bund A towards the tanker loading gantry. Witnesses also report a moving mist near the trees (along Buncefield Lane to the west of the site) about one and a half feet high and wisps of vapour on the ground near the end of the loading bay.
- These witnesses mention a strong smell at this time, variously described as petrol or aviation gasoline.
- None of the witnesses describe the flames reaching them as they moved from the tanker loading gantry towards the site exit. None of them report having suffered burn injuries.

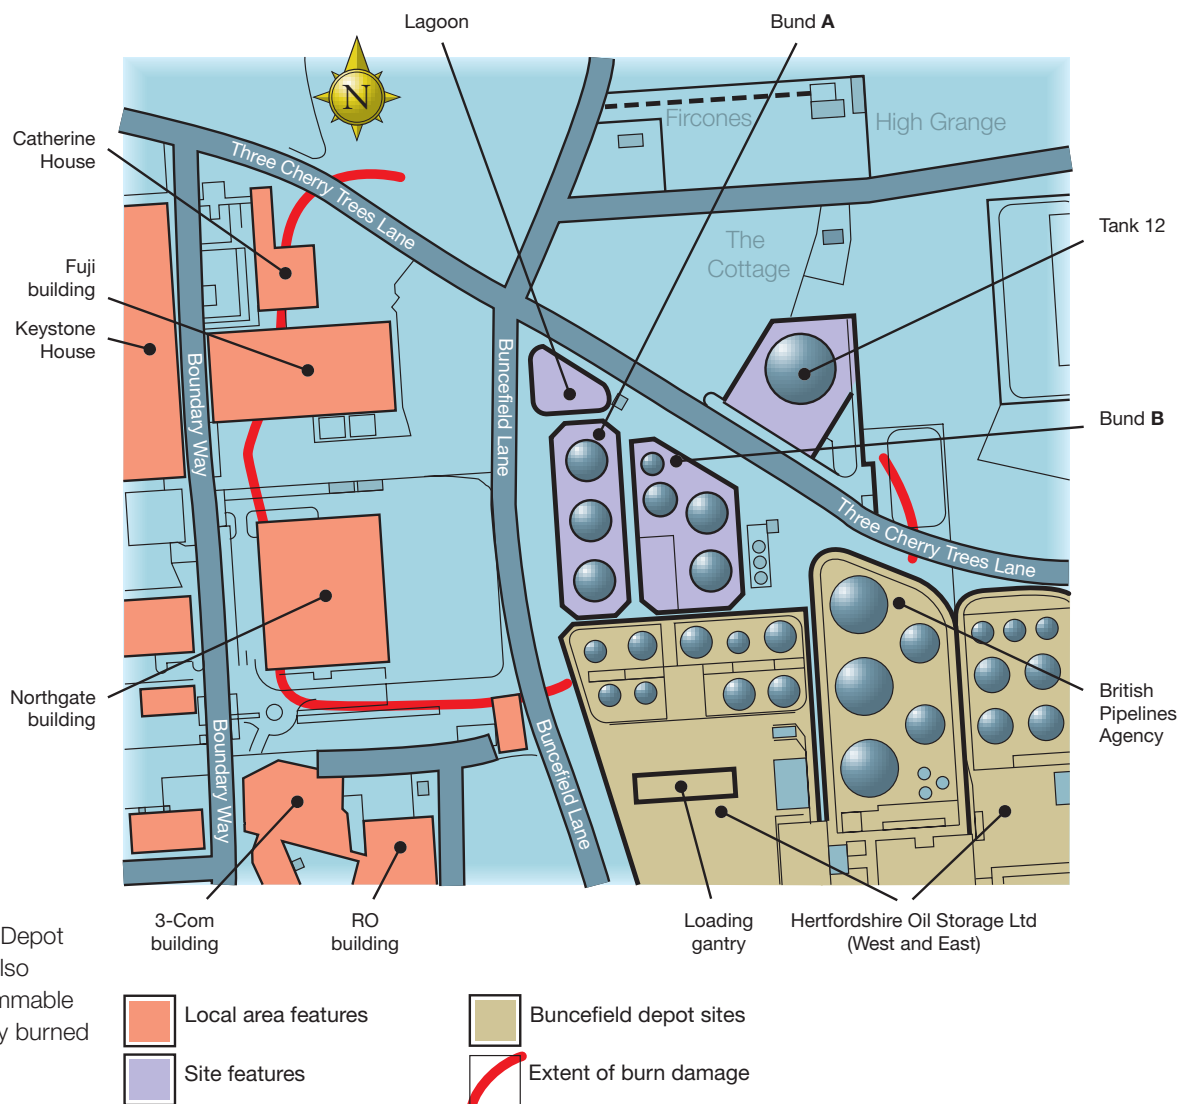
**Figure 5** Layout of Depot and surroundings also showing limit of flammable mixture indicated by burned material

<sup>2</sup> Figure 5 on page 8 shows the damaged area. For a description of the site see Part 2.1 of this report.

21 Initial examination of the evidence of damage around the site by the Health and Safety Laboratory (HSL) allows the approximate extent of the flammable mixture to be judged from the effects of the flash fire on vulnerable surfaces:

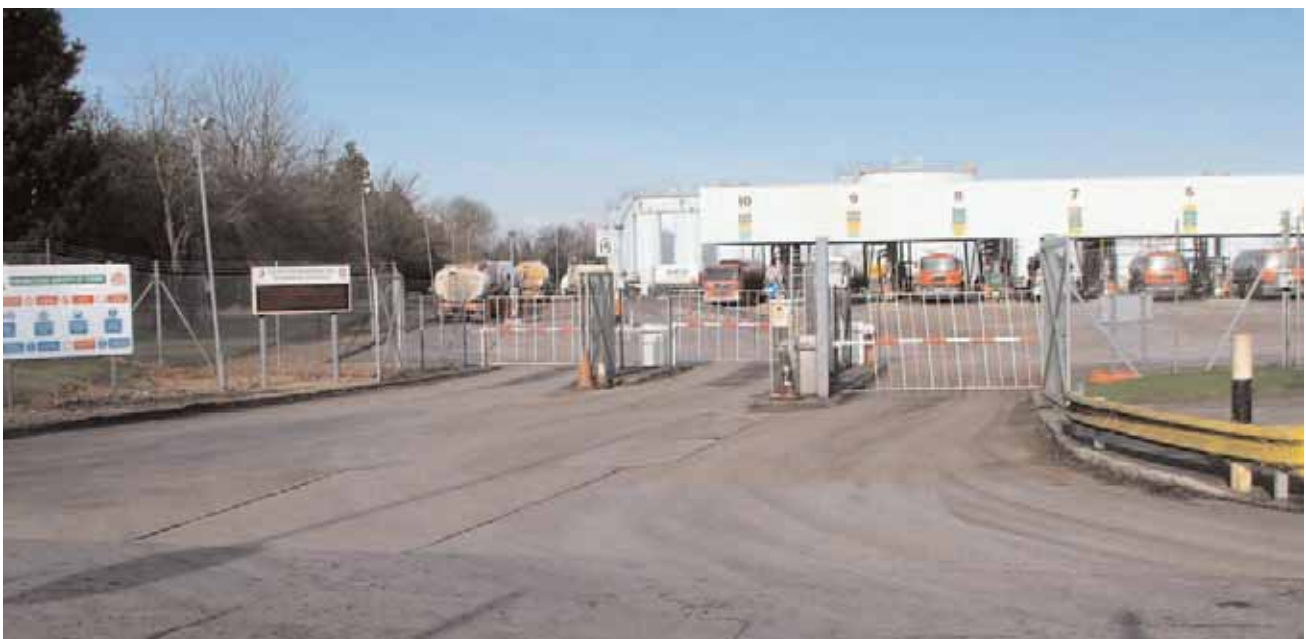
**Figure 6** HOSL West gates

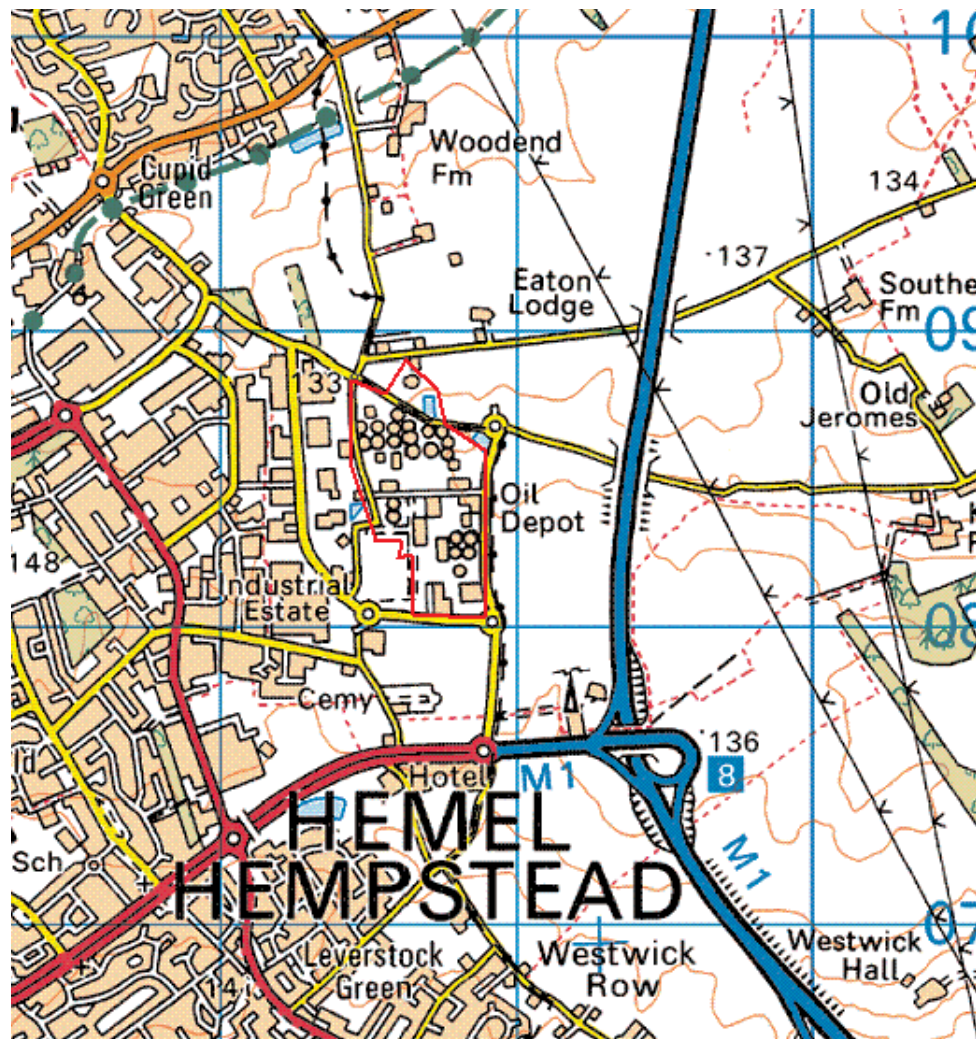
**Figure 8** Buncefield Oil terminal - Immediate surroundings of the complex

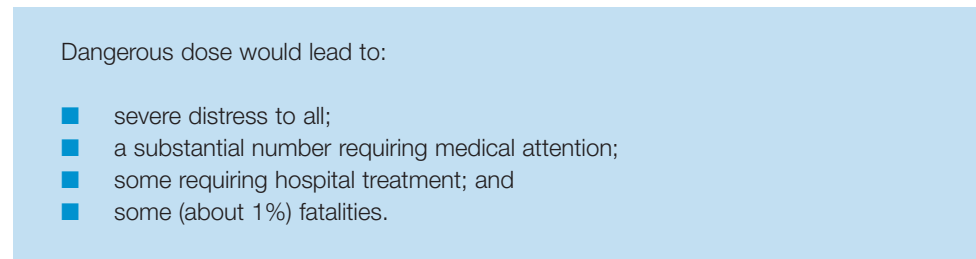
Figure 9

6 Using consent information, HSE undertakes a detailed assessment of the hazards and risks from the installation and produces a map with three risk contours representing defined levels of risk or harm which any individual at that contour

would be subject to. The risk of harm to an individual is greater the closer to the installation. In each case the risk relates to an individual sustaining the so-called 'dangerous dose' (see Figure 9) or specified level of harm. The three contours represent levels of individual risk of 10 cpm (chances per million), 1 cpm and 0.3 cpm per year respectively of receiving a dangerous dose or defined level of harm. The contours form three zones (see left), with the outer contour defining the CD around major hazard sites. The LPA consults HSE on relevant proposed developments within this CD.

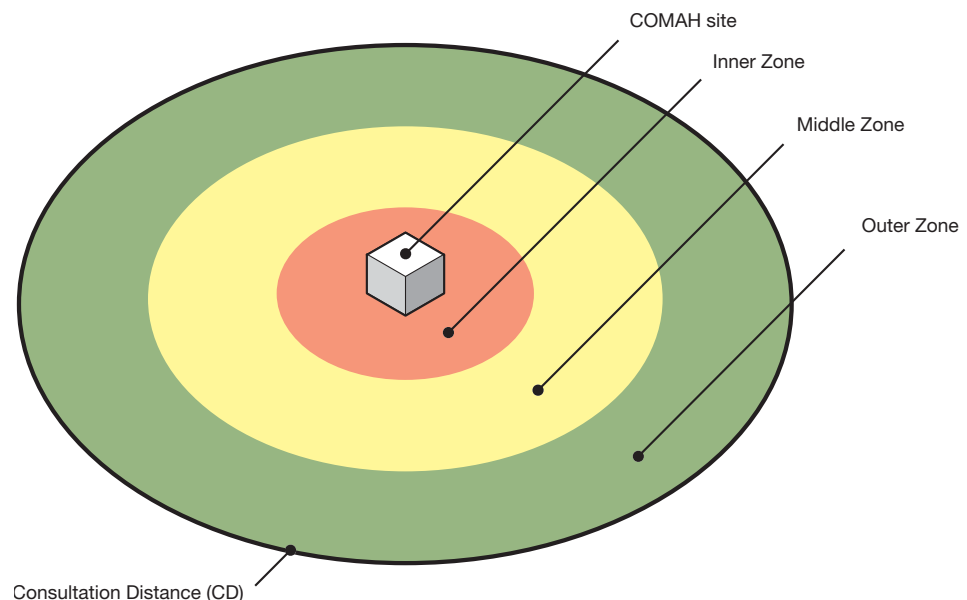
Figure 10

7 When consulted, HSE firstly identifies which of the three defined zones the proposed development is in. Secondly, the proposed development is classified into one of four 'Sensitivity Levels'. The main factors that determine these levels are the number of people at the development, their sensitivity (vulnerable populations such as children, old people) and the intensity of the development. With these two factors known, a simple decision matrix is used to give a clear 'Advise Against' (AA) or 'Do not Advise Against' (DAA) response to the LPA, as shown below:

8 The decision matrix above was developed taking into account the experience of 30 years of HSE advice on land use planning. It is built into a software tool known as PADHI (Planning Advice for Developments near Hazardous Installations) introduced in late 2002. PADHI deals with the vast majority of consultations and is operated by staff in local HSE field offices, significantly speeding up responses from previous arrangements which required some specialist HSE resource.
