Rock Backfill Protection

TEST
ASTM G13

Concrete Canvas 13mm Standard Set

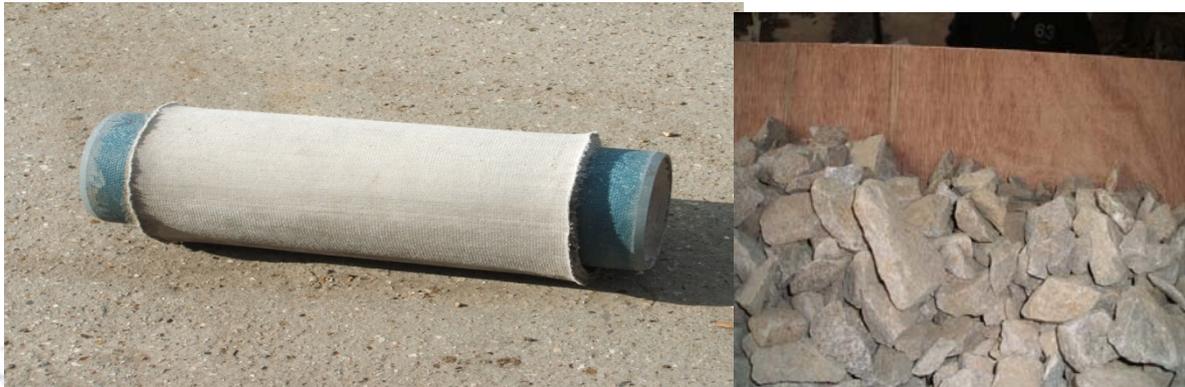
NO DAMAGE TO PIPE COATING

Concrete Canvas CC13 is a Protective concrete cloth on a roll, which is draped over or under pipelines and wetted to hydrate the cement within the system. The standard set product was used and results obtained after 24 hrs with temperatures overnight of 3C
21 KG of 50 mm hard limestone was dropped on to a section of pipe covered in the Concrete Canvas 5 times in a standard ASTM G13 test rig. The surface was analysed and photos taken after each drop.

After 5 drops no damage was apparent on the surface of the concrete cloth. It was hard and durable. No damage was recorded on the epoxy coating.
