### What happened?

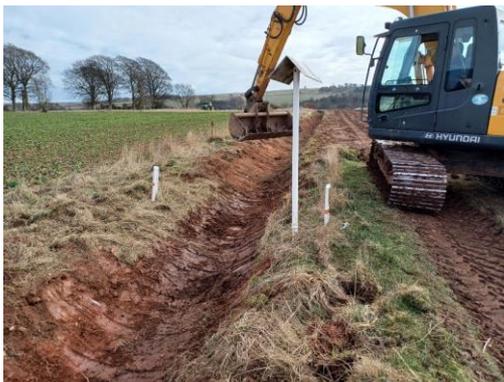
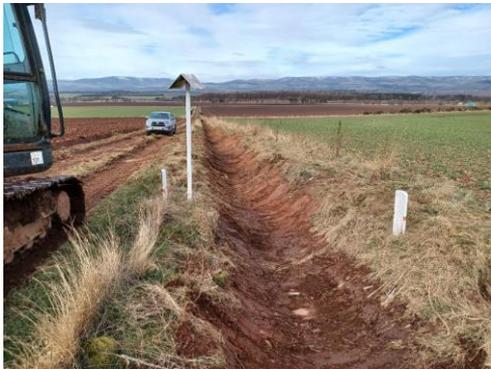
- A landowner instructed their employees to clean a ditch without notifying the pipeline operator
- The cleaning was carried out by mechanical excavator and crossed a high-pressure pipeline
- The pipeline was not damaged

- A landowner instructed their employees to carry out cleaning works via WhatsApp message
- The landowner did not advise them of the presence of the pipeline or provide any controls
- The operatives noted the pipeline marker posts but assumed the landowner had notified the pipeline operator
- The pipeline was not damaged as minimal material was removed from the base of the ditch and the concrete protection slabs were unaffected
- The operator held discussions with the landowner, highlighting the safety consequences of pipeline damage/release of content. The operator also went through the required procedures for works within 50m of their pipeline
- The operator provided additional pipeline route maps with 50m corridor highlighted. These were laminated to allow outdoor use and storage in machine cabs

- Operators should be aware that infringements can occur from operatives who have assumed that the landowner has carried out the necessary pipeline checks
