What happened?

Findings and key learning points

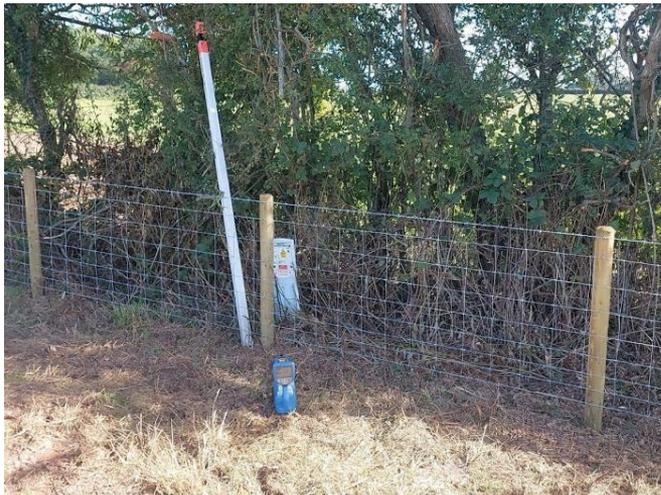
- A fencing contractor erected a fence in a pipeline easement without permission
- One post was inserted directly above the pipeline to a depth of 500 mm
- The pipeline wasn't damaged

- A pipeline operator was contacted by a landowner regarding drainage works
- On arrival at site, the operator's representative noted that a fence had been installed above the pipeline. This had not been authorised.
- The landowner had forgotten to inform the fencing contractor about the pipeline
- One post was directly above the pipeline and although the fencing contractor claimed that the posts were only driven-in to a shallow depth, it was found to be inserted to 500 mm
- The fence-post was adjacent to a pipeline marker post
- The operator explained to the contractor and the land-owner the serious nature of the incident, the potential hazard of striking a pipeline and the correct procedure to follow in future, including the need to contact LinesearchbeforeUdig (LSBUD)
- The post was removed

- Operators to reinforce the message to landowners that it is:
 - a) their responsibility to inform contractors and
 - b) that they need to contact the operator prior to any works near pipelines
