# HSEQS FEEDBACK NOTICE

### Potential for electrocution – Pipeline Transformer Rectifier

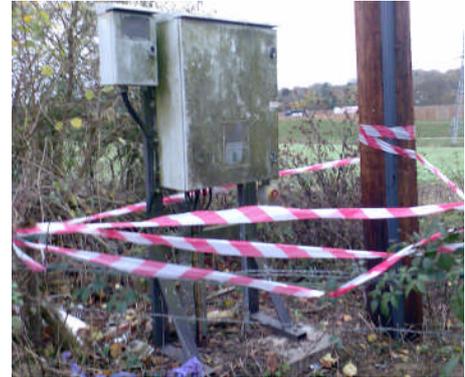
- On 13<sup>th</sup> November 2009, following a maintenance requirement, there was a need to inspect a transformer rectifier that had not been in use for some time. After opening the cabinet, the contractor pushed the cabinet door open with the back of his hand and in so doing, experienced an electric shock, which he described as a tingle.

- In 2007, EDF Energy had carried out modifications as part of a Motorway widening project. During the reconnection of the low voltage single phase service connection to the overhead line, the neutral and live phase were reversed by EDF Energy. It appears that this situation remained until it was identified by a CP contractor in November 2009. The electrical connection used is called PME (Protective Multiple Earthing). This is where the earth connection for the system is derived from the incoming neutral from EDF. The metal cabinet containing the system is bonded to earth. If the neutral connection is mis-connected to a live conductor, the outer metal cabinet will become live.

- It should be noted that there was a real and potential danger that either technicians or members of the public could have come into contact with the faulty equipment. The equipment is within a fenced field, and is a good distance from casual public access. However, there was a potential for electrocution as the metal box was in fact live.

- Review reports, produced following internal or external inspection, for relevant maintenance recommendations.
- Consider replacement of cabinets with plastic cabinets on any change of cabinet.
- Ensure contact details are clearly displayed for any remote installations to allow contact to be made before any work (including inspection) is carried out on such installations.
