**UKOPA/SA/10/0051**

# ***UKOPA SAFETY ALERT***

## **Leak on an underground pipeline due to drilling operation**

**Site: Rome / Date : 13th of May, 2008**

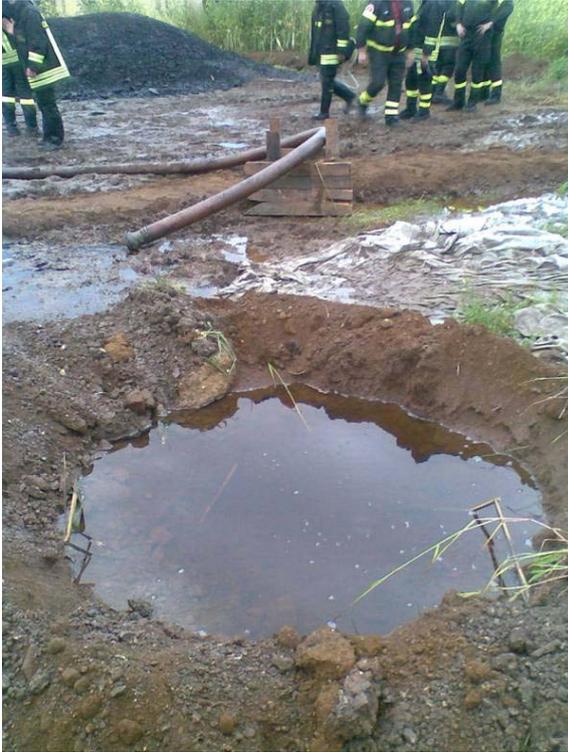
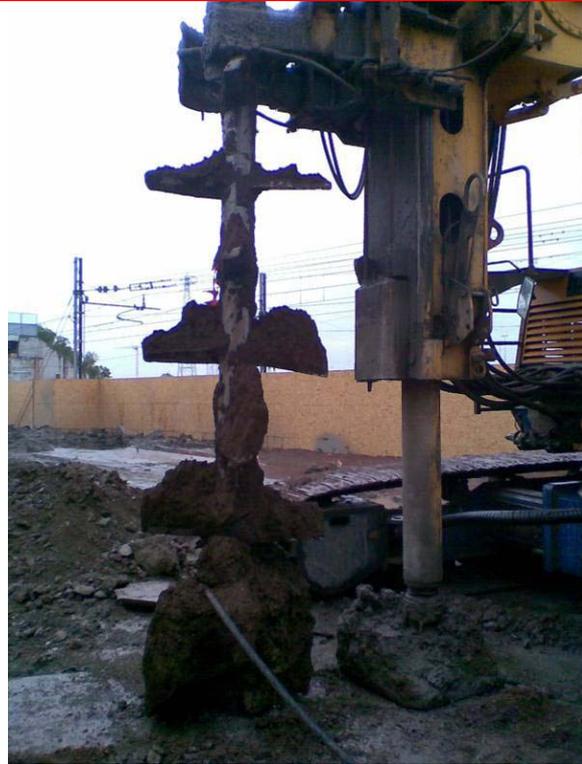
At around 4:00 pm on the 13<sup>th</sup> of May 2008 there was a hydrocarbon leak from the 8" low pressure pipeline delivering kerosene to the aviation depot at Fiumicino airport. A vertical drilling rig used in the motorway roadwork construction nearby the pipeline area has drilled into the pipeline which was buried at 3,5 m deep.

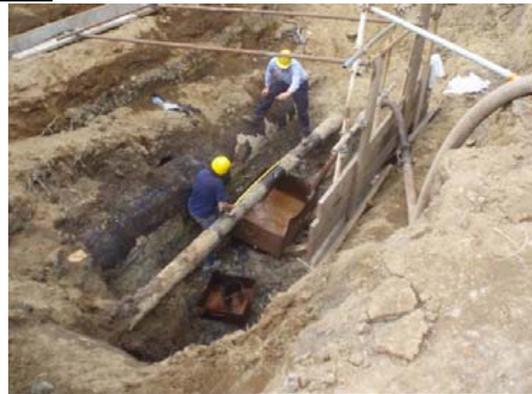
The point of impact was at 5 km from the refinery. As the pipeline was shut down when the loss of confinement occurred, only a few cubic meters of kerosene spilled. Hydrocarbons were partially recovered and the remaining stayed on the ground. Contaminated soil was removed after the pipeline had been repaired.

Repair work to the pipeline was carried out quickly and the pipeline was brought back into service three days after the accident.
