Subject: Hammer injury to hand during bolt removal task.

Incident location: Peterborough Power Station

Incident date: 06/03/2014

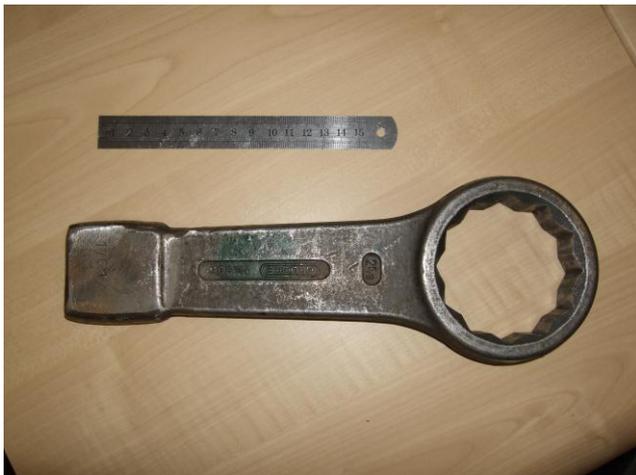
The bolt was being removed for condition analysis. A flogging spanner and hammer was used to loosen the bolt and during this procedure a timing and communication error led to the IP's finger being struck with the hammer as he attempted to reposition the spanner.

Flogging spanner used for task.

- Full investigation to be undertaken into the cause of the injury.
- Ensure that learning from the investigation is used in the review of the work risk assessment and method statement
- Share learning with contract partners to avoid a repeat of the accident.

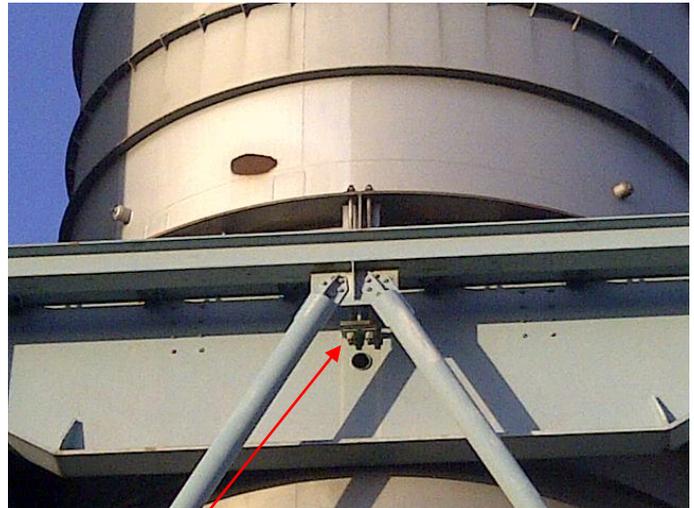
During work to remove a holding down bolt from the bypass stack on GT 2, one of the operatives suffered a hammer impact on the ring finger of his left hand (next to little finger). This caused a cut/split on the finger from the nail to first knuckle and a chipped bone.

Bolts being removed
